Relief Well Rehabilitation Options in Chief Joseph Dam Right Abutment Drainage Tunnel

Katherine Anne Garon

A report prepared in partial fulfillment of
the requirements for the degree of

University of Washington

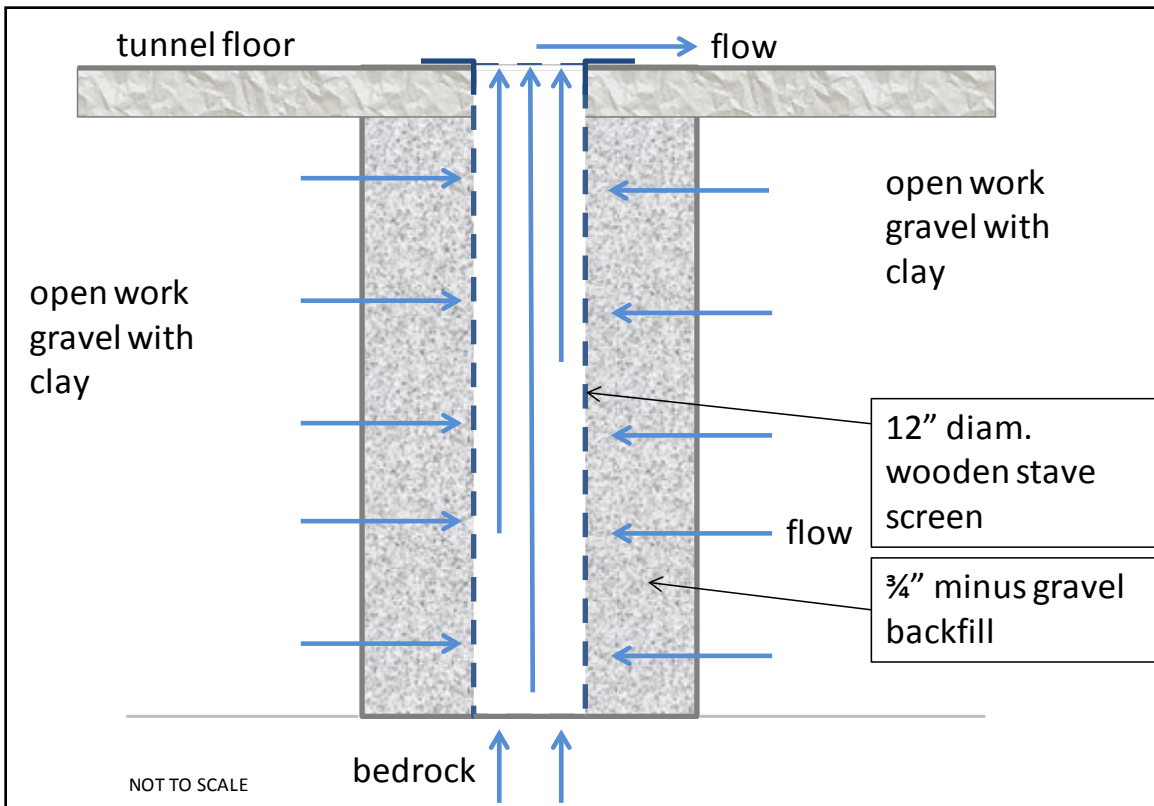
These relief wells are now over 60 years old. The wooden staves are always under water and are in relatively good condition. However, video inspection revealed that some wells have bacteria accumulation, offset joints, and the end plugs are dislodged. The dislodged end plugs may allow sediment from the formation to enter the well and then exit through the tunnel thus initiating a backwards erosion and piping failure mode.

Figure 2-4: Relief Well Problem Definition.

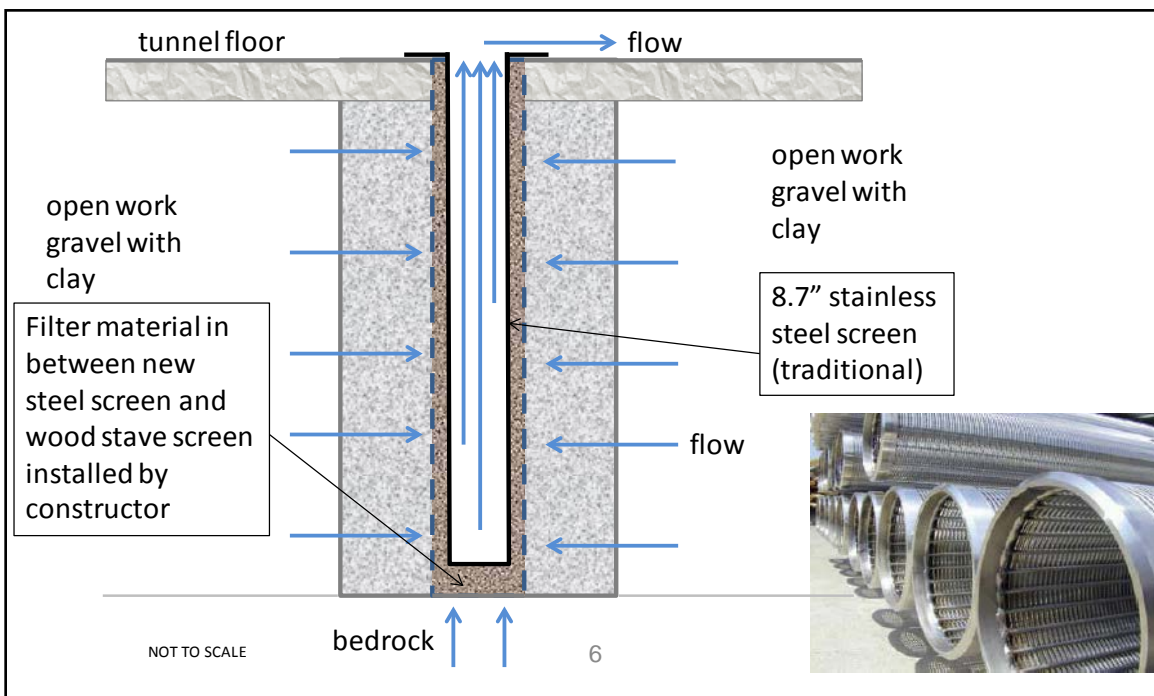
Figure 2-5: Relief Well Proposed Rehabilitation Design.

The selected option is Option 6, which is to line the existing wells with standard well screen with sand and gravel backfill between the screen and the existing wood staves (Figure 2-5). This option consists of lining the existing wooden stave wells with rod-based wire-wrapped stainless steel well screens. Following steel screen liner installation, sand and gravel backfill graded to prevent native formation materials from passing through the filter will be installed as a filter pack material between the old and new well screens. The diameter of the stainless steel screen will be sized so that it fits inside the existing wooden screen, with approximately 1.5-in open area between the steel screen and the wooden stave. The stainless steel screen will have sufficient open area to pass flows in excess of the maximum observed historical flow at each

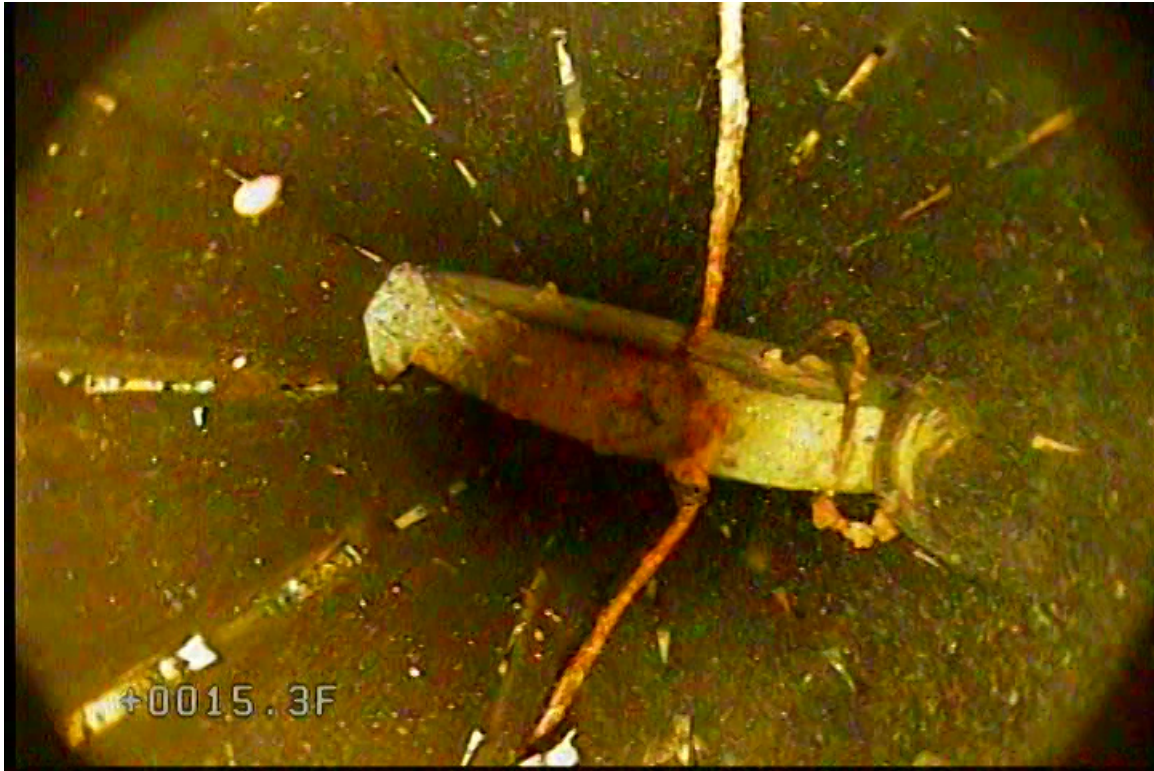
Figure 3-2: Well 6. Obstruction, possibly part of dislodged end plug at ~ 21.7 ft depth.

4	195	784.95	753.1	31.85	31	12.6	-	A piece of wire was stretched across the well at about 12 feet. The camera broke it off as it was lowered down the well. The camera only made it down to an approximate depth of 12.6 feet because of an obstruction blocking half of the diameter of the well. The obstruction could be part of the end plug of the well that got forced up. The wood stave pipe above this depth is in good condition. Obstruction at 12.6 ft. 2011 video showed wire and part of end plug partially obstructing at 12.6 ft.
5	245	785.45	749.2	36.25	35	34.2	-	The slots are partially blocked by a white substance. There was fine gravel and a wire mesh screen sitting on the bottom of the well.
6	295	785.95	748	37.95	21.7	33.8	-	A piece of wire was stretched across the well at about 10 feet. The camera broke it off. There was an obstruction at approximately 21.7 feet that prevented the camera to pass. The obstruction was likely the end plug of the well that got forced up. The open depth of the well below the obstruction is unknown. Tape initially caught on partial obstruction at 26.0 ft. Partial obstruction in 2011 reported at 21.7 ft. (video showed to be end plug vertically aligned).

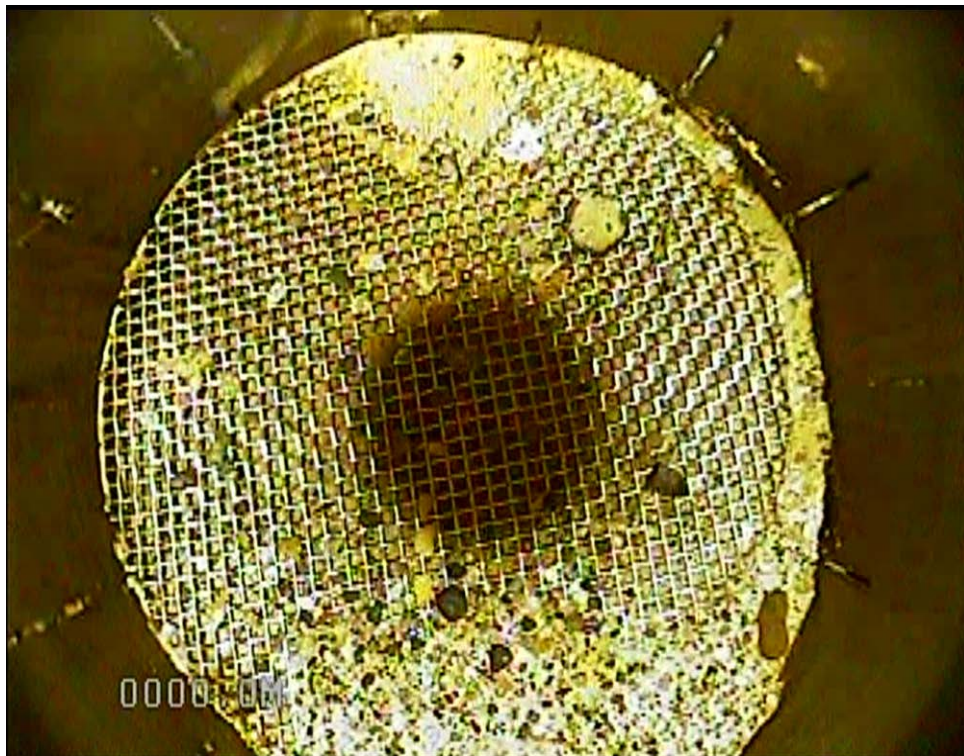
Figure 3-3: Well 8 Televue: Screen was knocked down the well when the top cap was removed in 2013, sediment on the screen accumulated between 2013 and 2015.

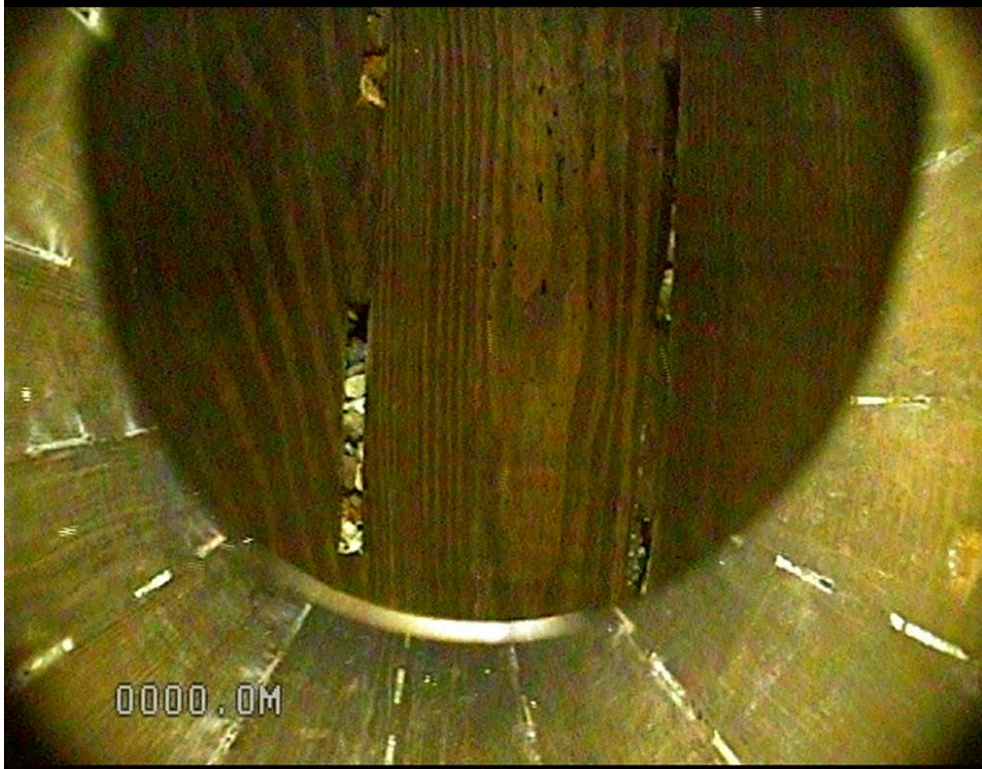
Figure 3-4: Well 8 side-camera view of existing well, sediment can be seen behind the screen slots.

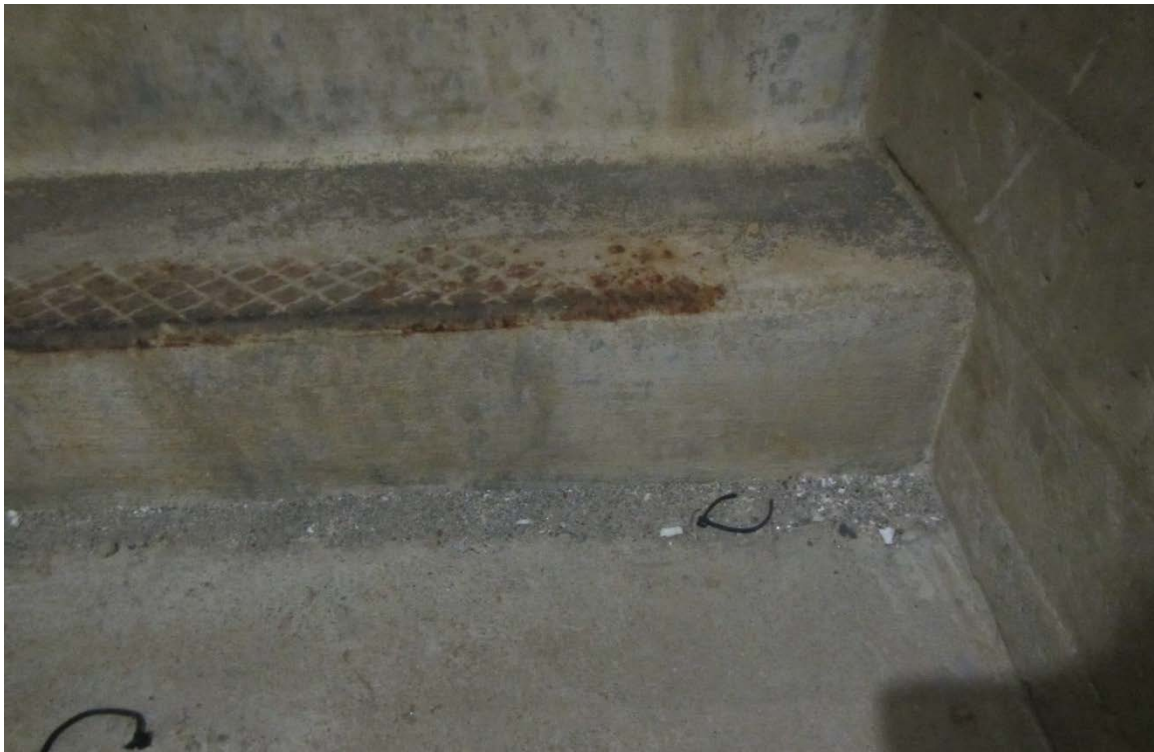
These observations including: dislodged end plugs, sand and gravel at the bottom of the wells, shallower measured depths compared to as-built conditions, and sediment accumulating at the bottom of the stairs, support the idea that sediment from the abutment could be exiting the

Figure 3-5: Sediment accumulating below stairs.

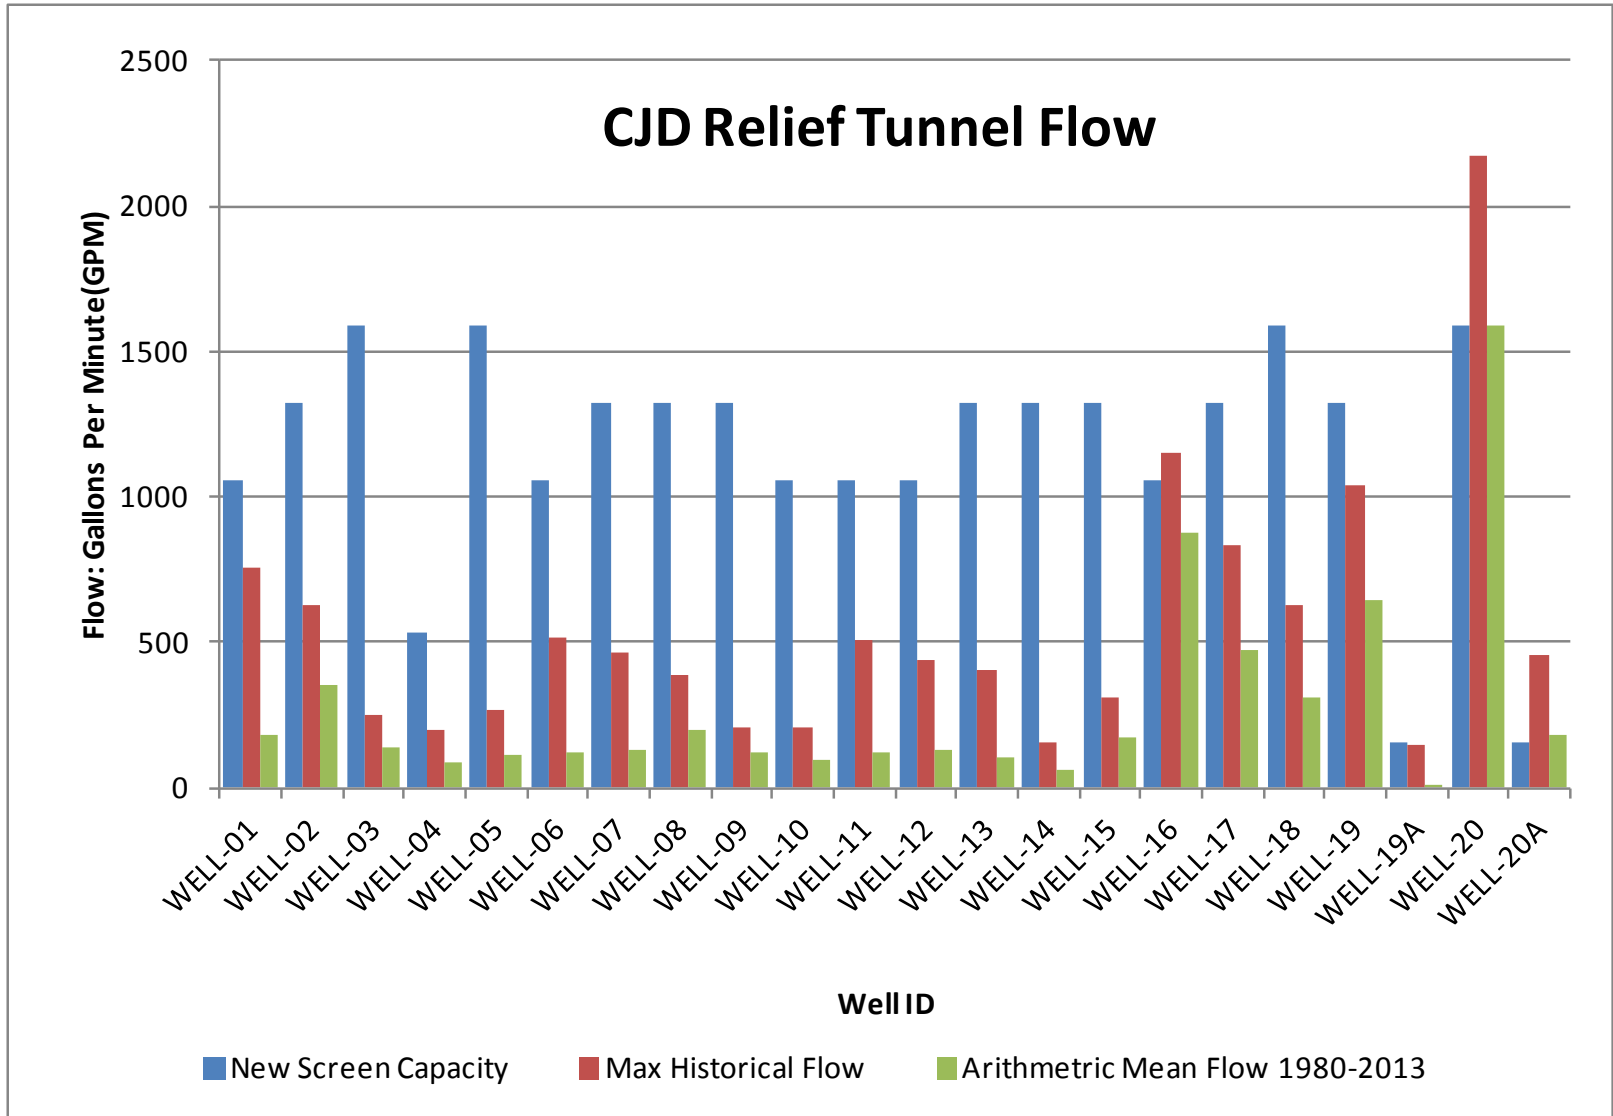
Appendix, Table A- 3 gives the results of these calculations. Figure 4-5 shows the results in a chart. For most wells, the new screens have enough transmitting capacity to pass the maximum flow out of the well. Wells 16, 20, and 20A have a factor of safety below one, and could not pass the maximum discharge. Figure A- 1, Figure A- 2, and Figure A- 3 show frequency histograms of the flow measurements from 1980 to 2013. The red bins are the discharge that the wells would not be able to fully pass. These wells can pass the mean flow, only well 20A has a factor of safety below one for mean flow. The 100 slot screen with an 8-in diameter and about 30 ft in length is sufficient to pass maximum flow in most wells.

The 100 slot, 8-in diameter screen allows most wells to pass their historic discharge. Two of the three wells that can't pass the maximum discharge, can pass the mean discharge. Well 20A has a factor of safety below one for both maximum and mean discharge, but because this well is only 3-ft deep, and does not pass much flow, we decided preventing failure of the screen and installing a filter pack is more important than keeping the entrance velocity below 0.1 ft/s. Another factor is that the relief tunnel has a gravel drain below the tunnel floor. This drain contains a perforated tile pipe. It is unknown how much flow out of the wells actually flows

Figure 4-5: Historic Max and Mean Flow in each Relief Well Compared to the Calculated New Screen Capacity.

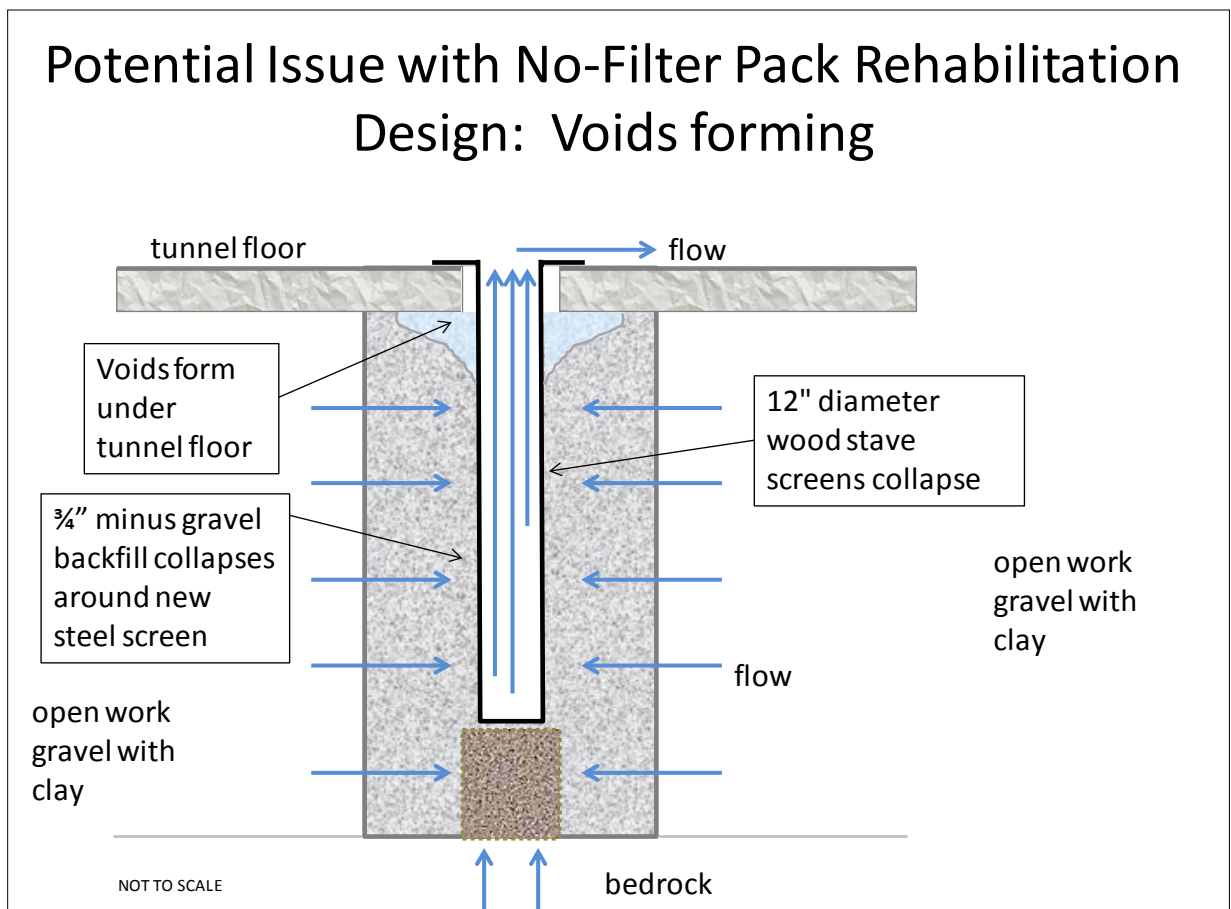
Figure 6-1: The Potential Issue with Option 7 is Forming Voids Under the Tunnel Floor.
