Vasa Creek Channel Conditions and Slope Stability, Bellevue, Washington

Audrey C. McHugh Britton, GIT

A report prepared in partial fulfillment of  
the requirements for the degree of

December 2013

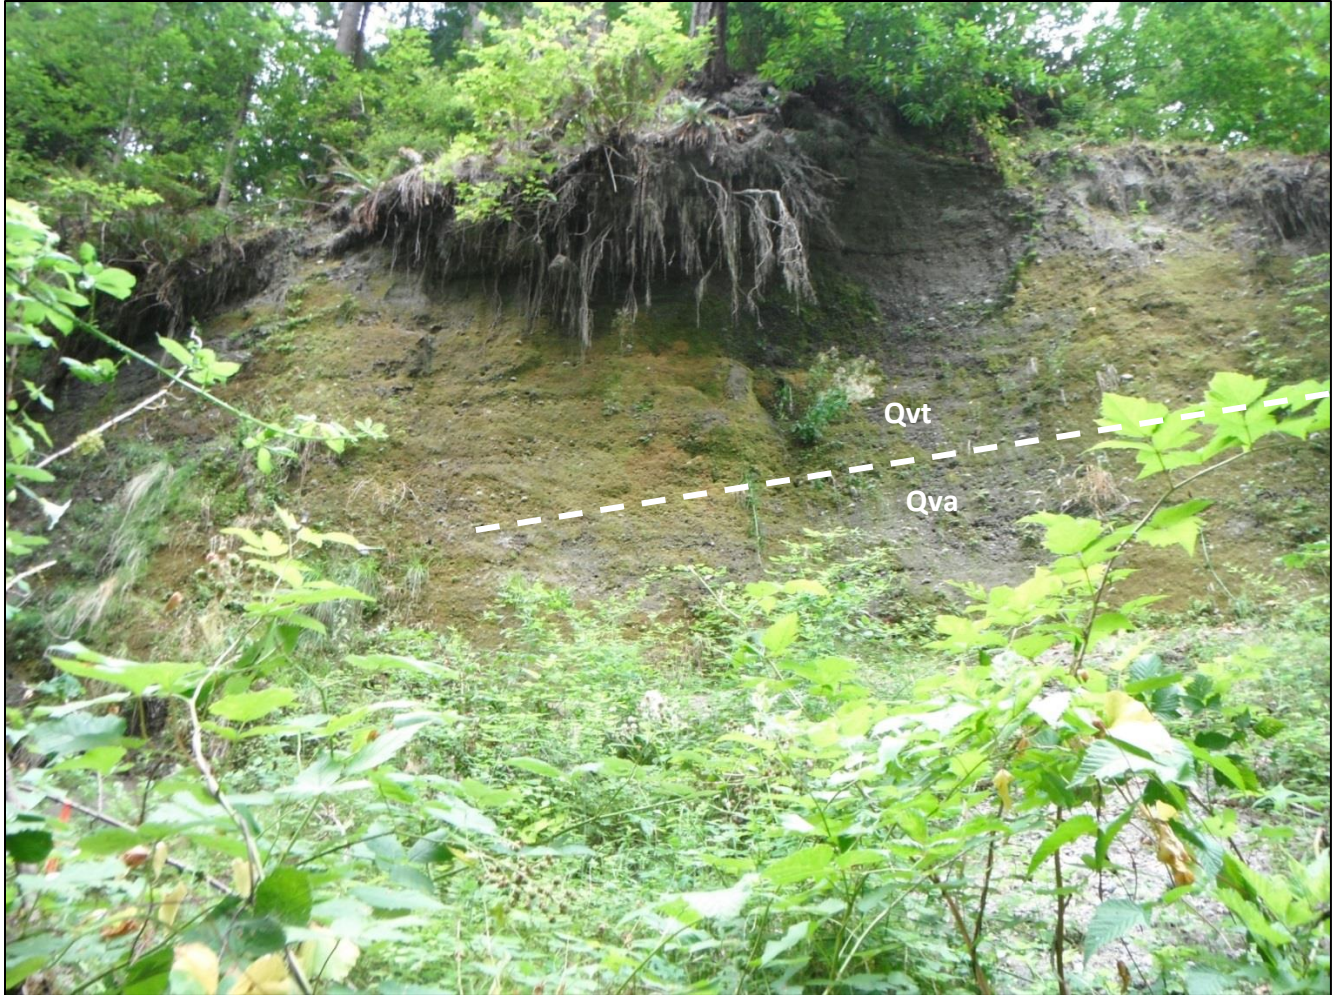
On the slopes I observed that there is a weathered cap of Qvt with Qva exposed below (Figure 8). The Qva is capped by Qvt which is very thin and weathered downstream, gradually becoming more consolidated upstream, reaching a thickness of approximately 3.5m.

**Figure 8.** Landslide scarp and exposure of Qvt over Qva. The contact was interpreted where bedding associated with Qva was no longer observed.

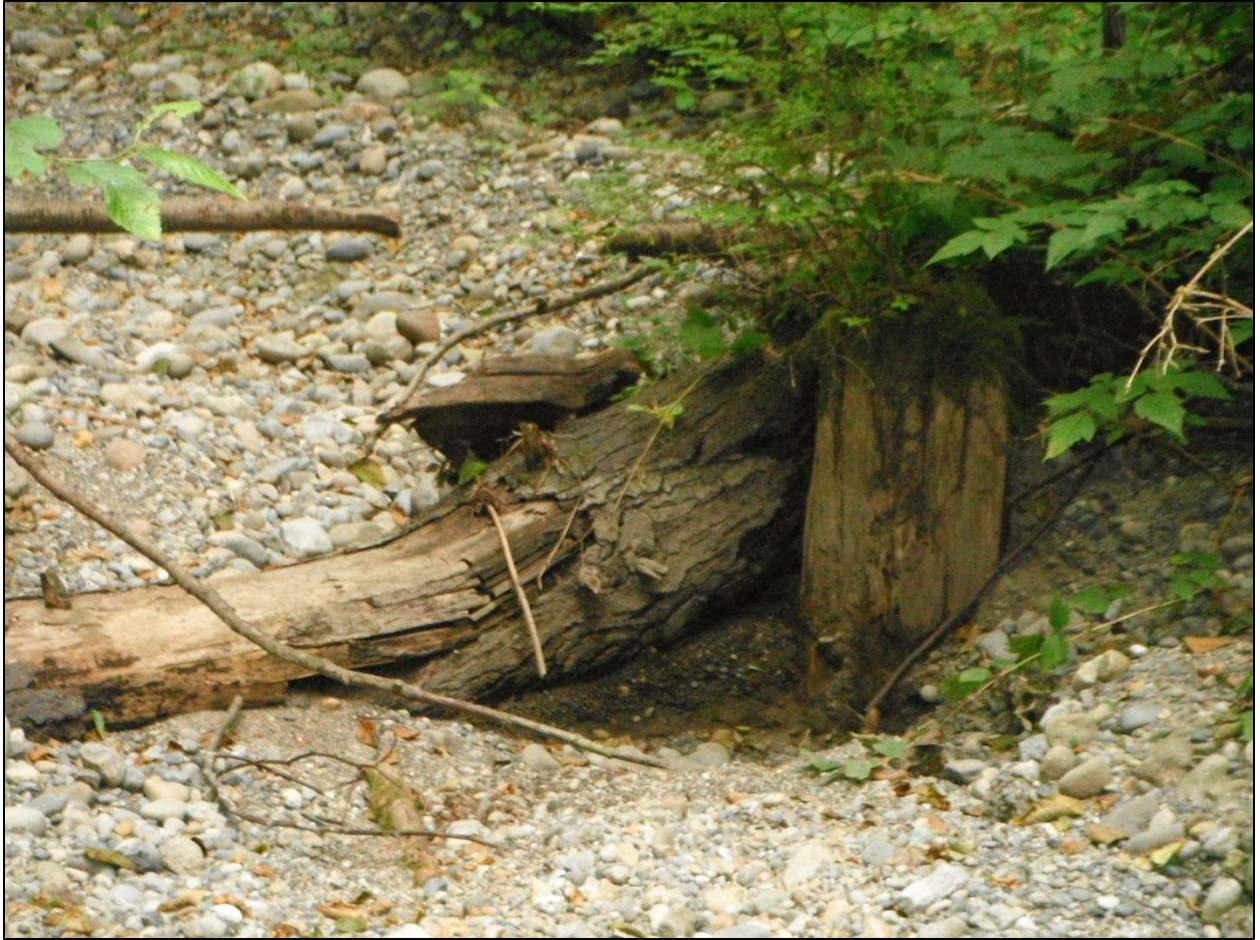
**Figure 14.** Photo of an embedded log within the channel creating a pool by scour.

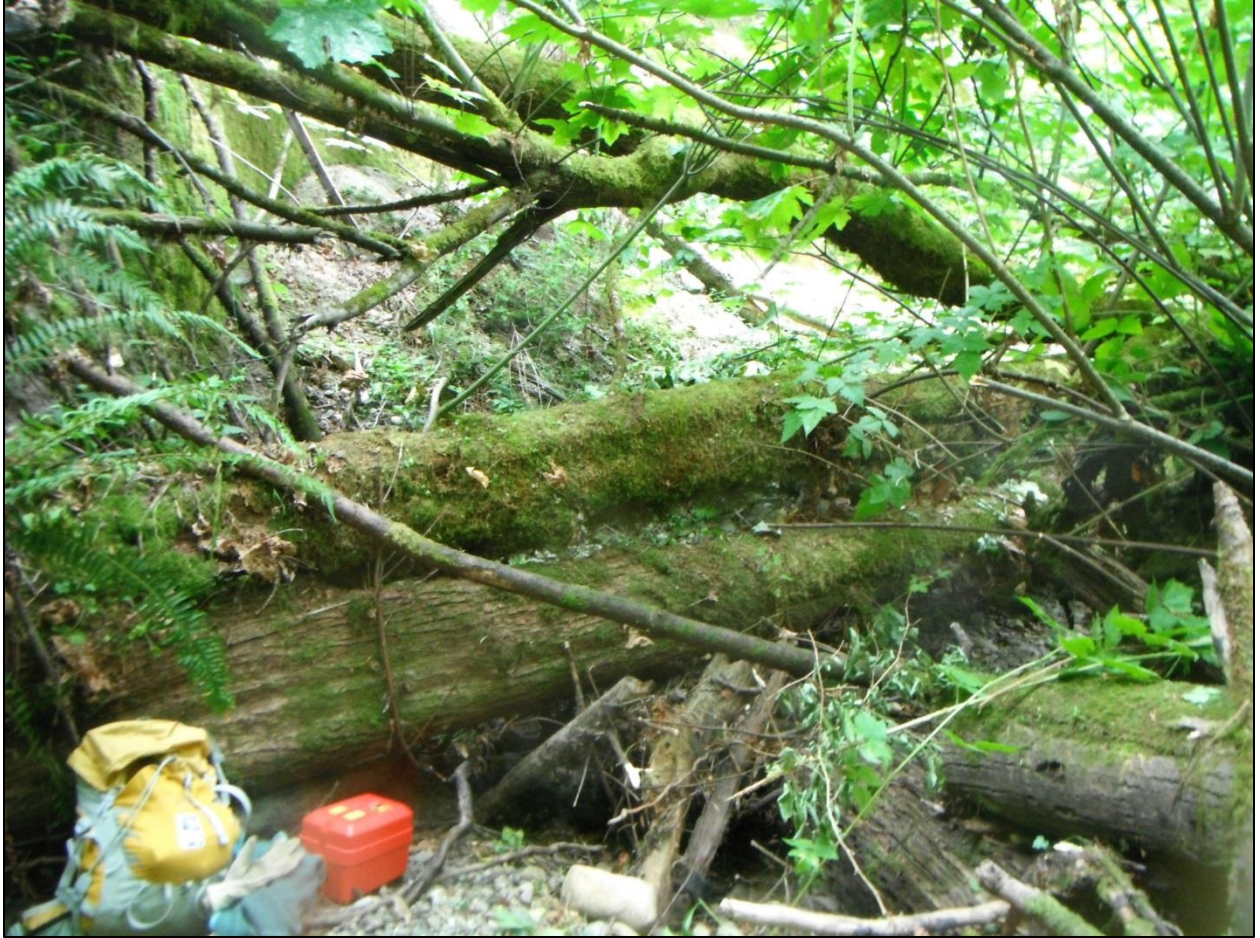
**Figure 15.** Example of what is considered significant woody debris. The debris is assumed to influence flow and sediment accumulation within the channel.

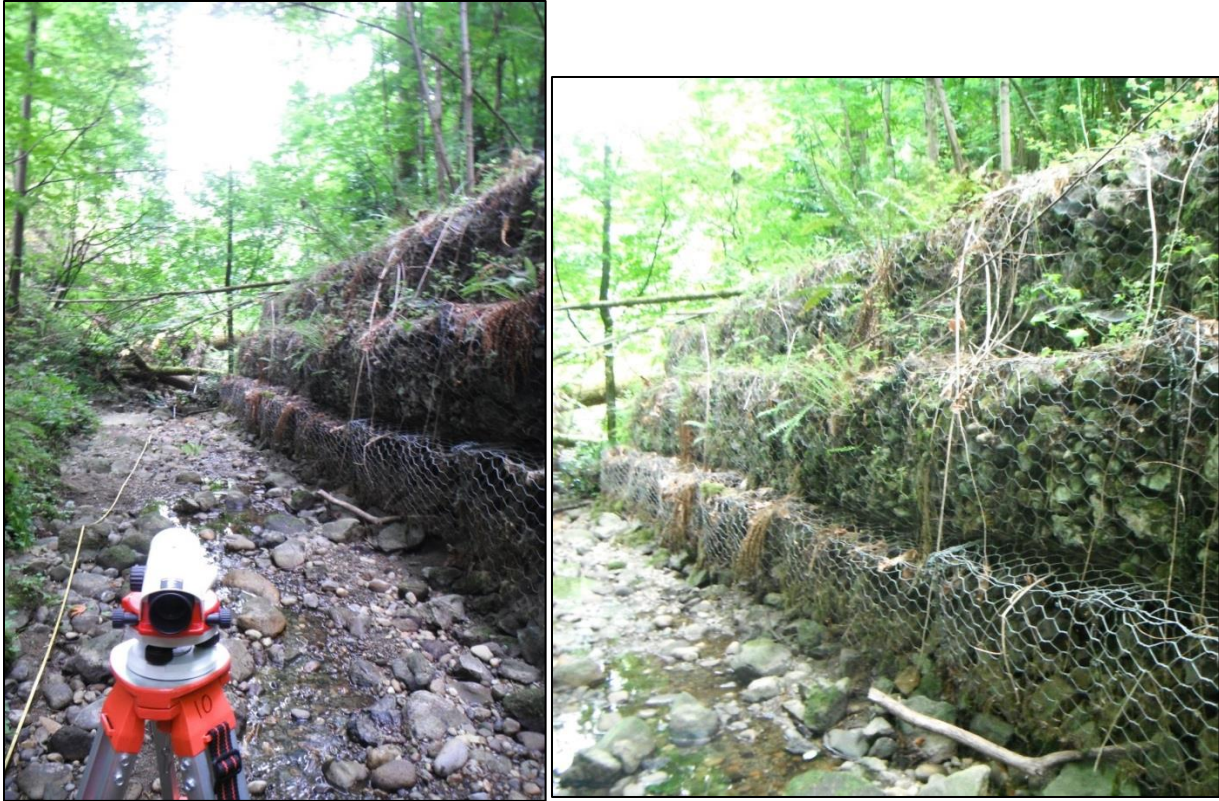
**Figure 16.** Photo of a gabion wall that was installed to stabilize the west slope. Undercutting by the stream has led to angular blocks falling out from under the wire.

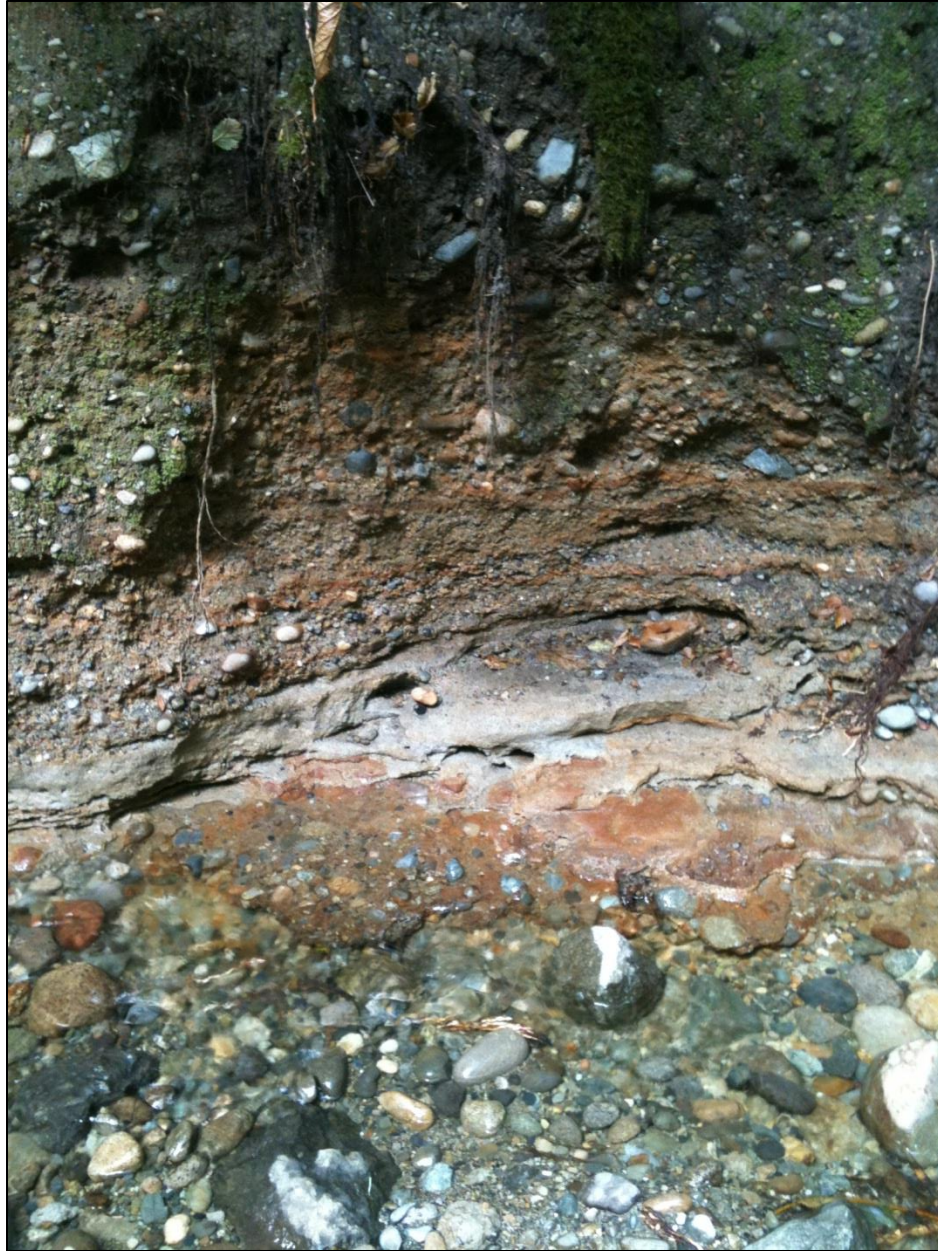
Within the next segment the channel and the valley have become much narrower with little to no floodplain. Water is first observed within this segment at 600m, trickling over a plane-bed streambed with few locations of significant woody debris. Just beyond where I observed the surface flow there is gabion wall (Figure 16). It is located on the east side of the channel, locally armoring the bed. Moving upstream, defined walls of Qvt and Qva confine the channel. At the base of these walls there has been slight undercutting and erosion occurring (Figure 17).

**Figure 17.** Photo of erosional feature within the channel. A slight exposure of Qva being undercut by the stream. Photo was taken after heavy rains so water is present.

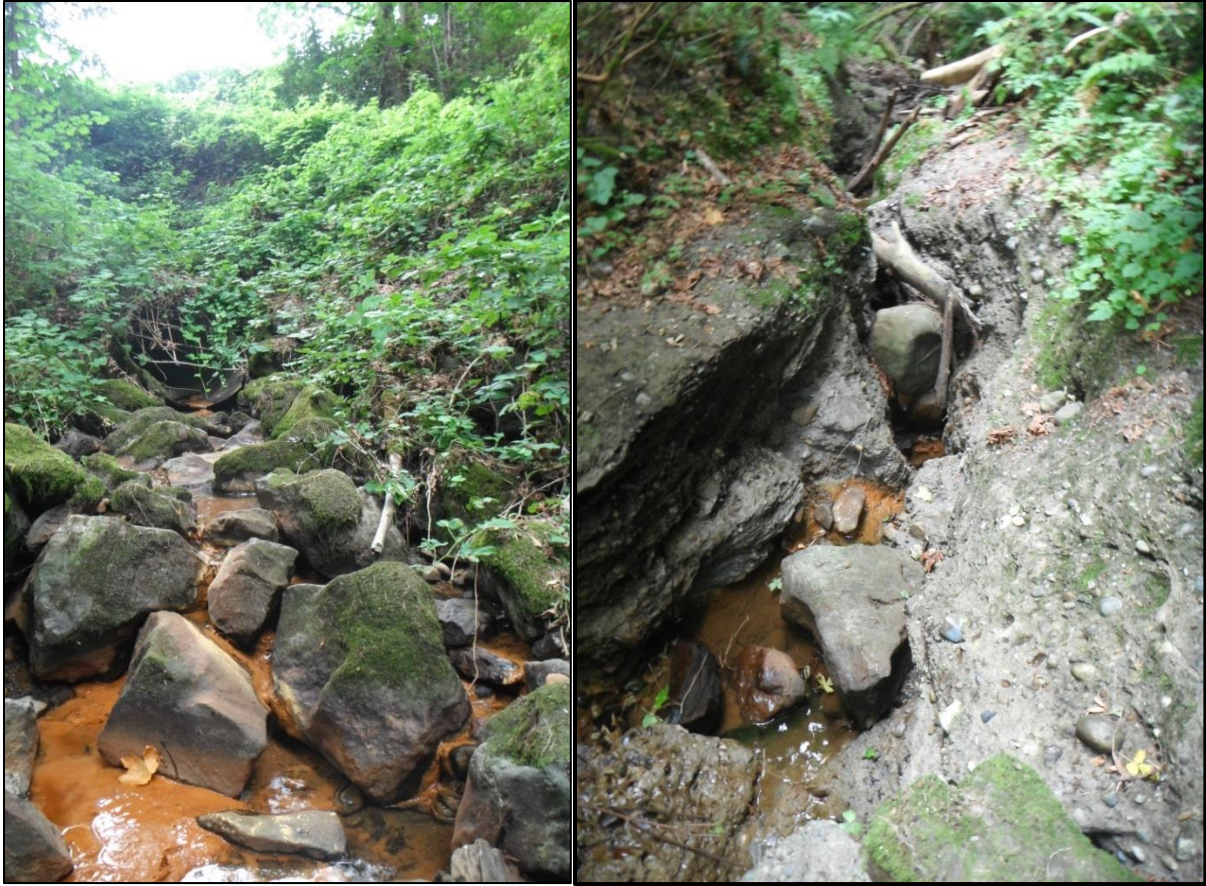
I also observed within the upstream slot-canyon the potential for slope failure. The channel has created a knickpoint that is continuing to erode upstream. As this occurs, it will cause the adjacent slopes to fail. This is located within a dense residential neighborhood and would affect local homes, roads, and other infrastructure. This type of failure may also occur in the event of the drain rupturing and discharging a greater amount of water, i.e. a blowout, in which there would also be a high influx of sediment into the channel.

Included in the survey should be an evaluation of the current conditions of the culvert, drains, and overflow structure. In the field I observed that the drain from the east tributary of Vasa Creek appears to have been damaged by failure of fill material from above.

**Figure 18.** Photo of the upstream drain (left) and the slot-canyon.

With the upstream erosion occurring in the slot-canyon, there should be an assessment/monitoring of that slope and the flow from the drain in order to hopefully prevent damage to local property.

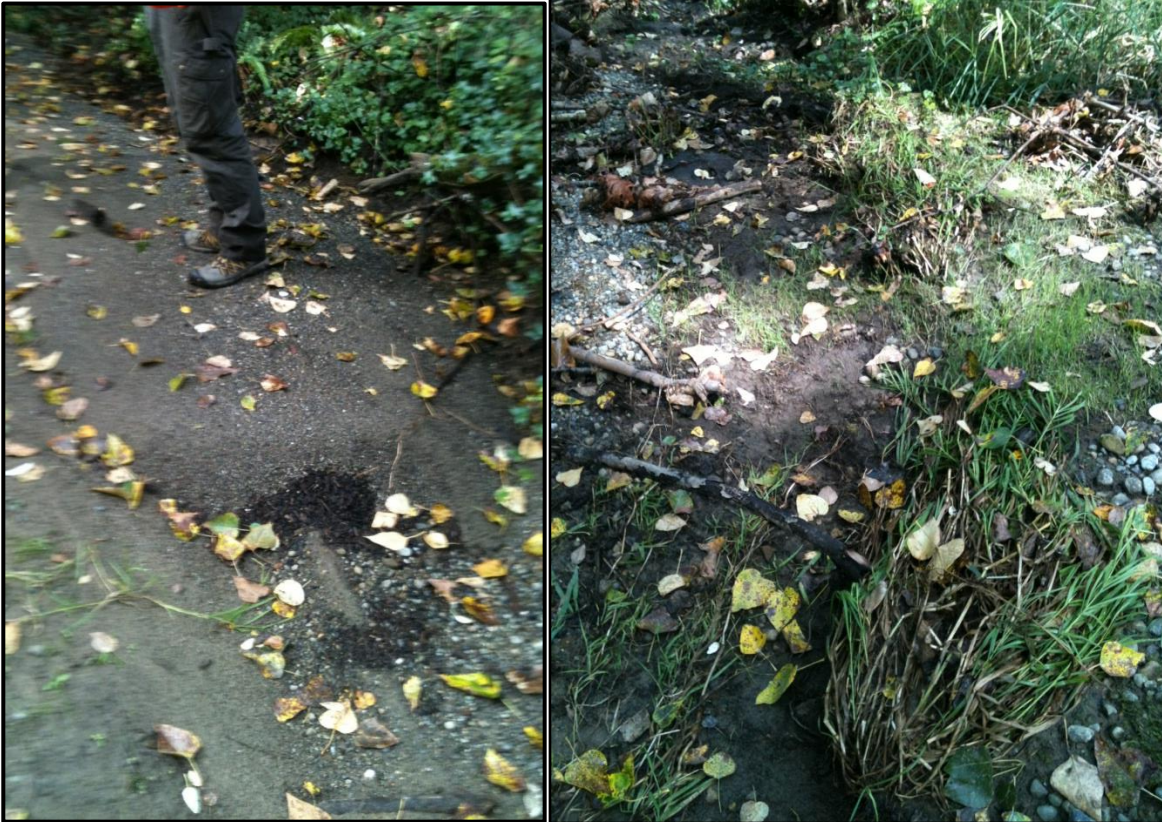
After heavy rains I returned to the study-reach and observed water 300m upstream instead. There was also evidence within the channel that water had been flowing throughout the entire channel. The evidence included fresh scouring, the deposition of the sand bars, and vegetation blown in the direction of flow (Figure 24).

**Figure 24.** Photograph of a fresh deposit of fine sediment after heavy rains (left) and blown vegetation in the direction of flow (right) within the study-reach.

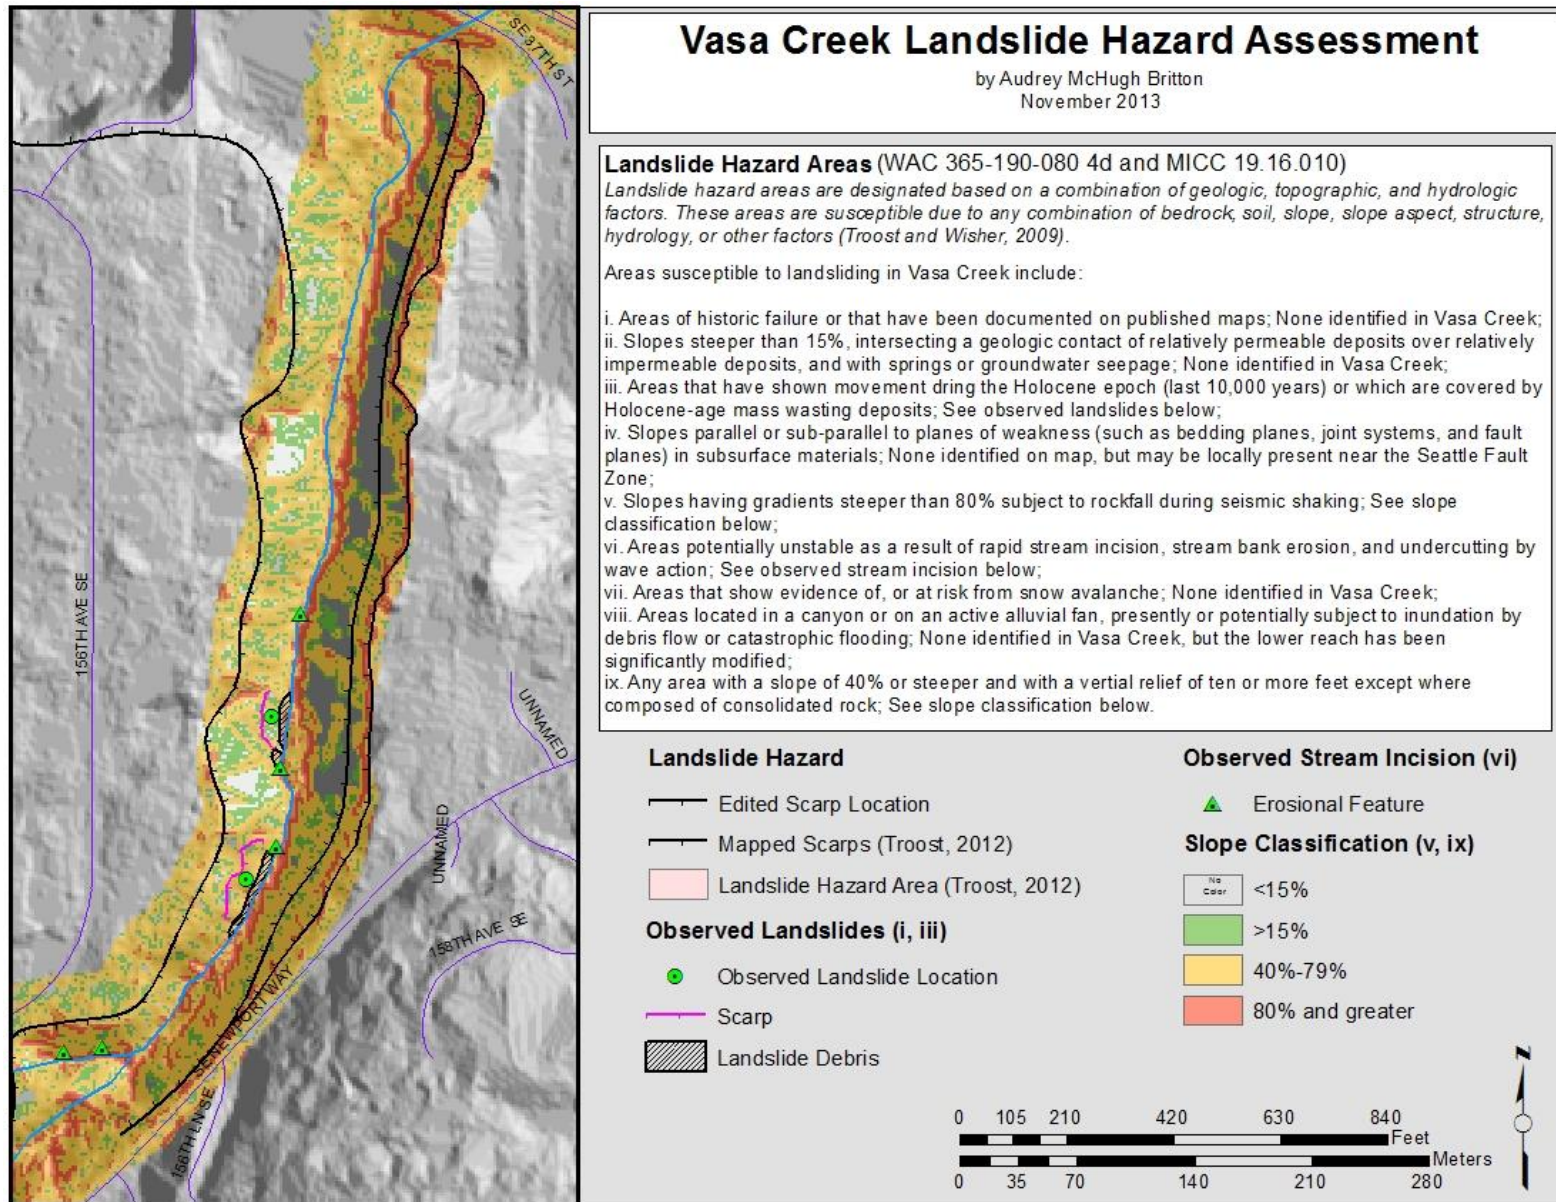
The only landslides, scarps, and outcrops observed occur on the west side of the channel. The west slopes are at risk of failure due to recent landsliding events, stream erosion, and having a grade

≥40%. According to the map, however, the steepest slopes primarily occur on the east slope with grades 80% and greater which causes them to be at risk as well (Figure 26).

enough to severely alter the existing channel. Landslide debris does choke the channel and create hummocky terrain, but it does not appear to be impassible. In the landslide assessment map, though the only observed landslides occur on the west side of the channel, the east side has a steeper slope. I did not observe many signs of slope instability in the field, however, dense vegetation on the slope may have obscured what are clear indications of movement. What I did observe included few pistol-butt trees, few areas of jack-straw trees, and hummocky terrain. It could also be attributed to a lack of landslides; the west side may have in effect stabilized itself for the time being and so overall has a lower gradient while the east side remains unstable and steep.

**Figure 26.** Completed slope stability assessment map of the 720m study-reach.
