# I-82 Prosser Landslide Investigation Benton City, WA

## **Technical Report**

**Re: Prosser Landslide site MP 91.9, I-82, Benton City, WA**

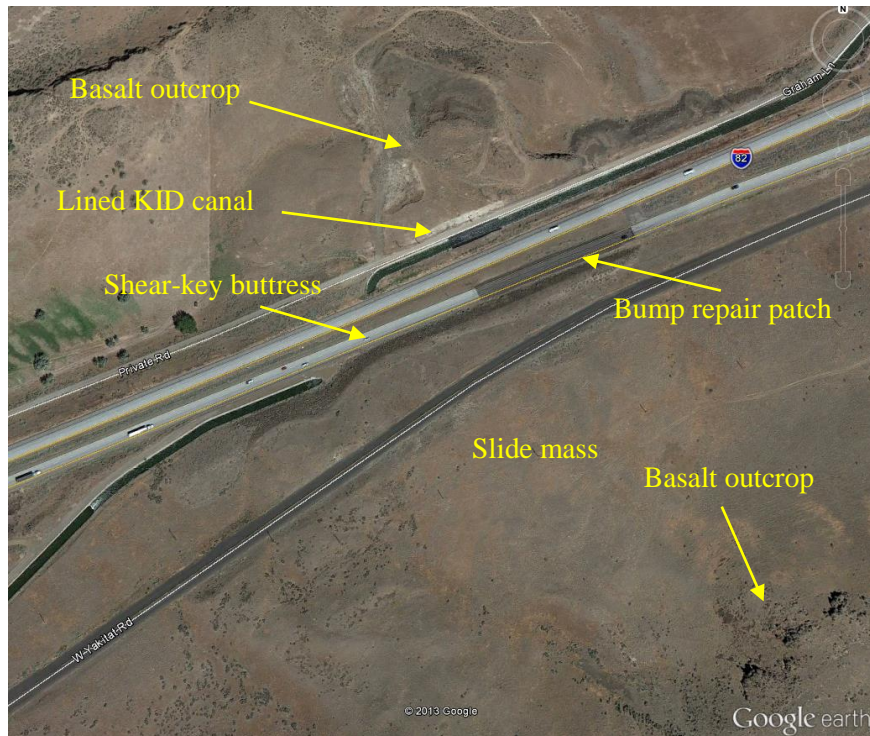
Figure 3: A satellite imagery of the Prosser Landslide site, I-82, and the shear-key buttress. The bump repair patch consists of darker asphaltic concrete pavement. Image modified from Google Earth satellite imagery.

WSDOT eventually decided against pressure grouting the buttress. 12 panels of PCC in the eastbound lanes of I-82 road surface were eventually replaced with ACP Class A in response to the deformation. The subgrade was left undisturbed during the surface replacement.

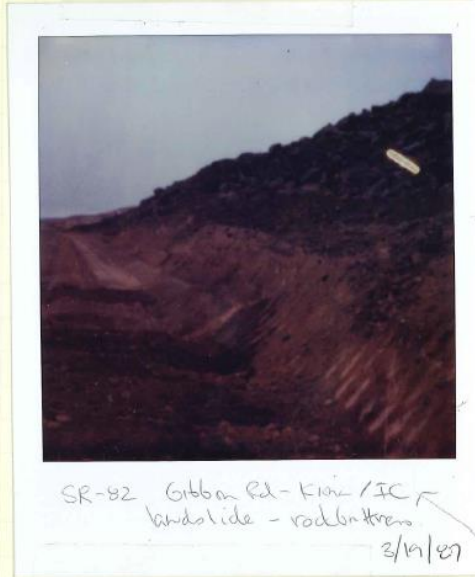
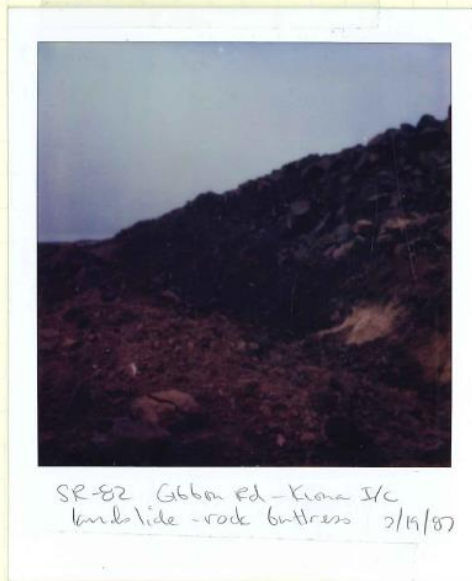
Of important note during this time is an internal WSDOT memo dated March 20, 1987 from Dave Jenkins and Steve Lowell to the Project File of Contract 3204 with the following subject: "Contract 3204 I-82 Landslide Vicinity Gibbon Road to Kiona I/C". The memo states that in addition to their assigned tasks of identifying and mapping recent landslide scarps and developing a survey-controlled landslide monitoring grid at the Prosser Landslide site, they also noted a serious discrepancy in the location of the constructed shear key buttress and its specified design sections, namely that the buttress was constructed above the specified elevation. Specifically, they note that the buttress was constructed 5 to 7 feet above the low elevation in the ditch on site where it was designed to be constructed (Figure 12). In addition to the photos, they also attached an annotated to-scale drawing of the buttress as it was designed by Todd Harrison. The annotated portions show that the buttress is not seated below the clay layer and is instead resting on the sediments several feet above it.

That the buttress lacks a key below the clay layer is consistent with observations made by Tom Badger in his undated field notes from the time of buttress construction, which state that much of the buttress east of the KID canal crossing has no key below the clay and is in fact resting upon alluvial sediments. However, as also noted in the March 20, 1987 memo, statements from the site inspector, Dave Fassler, contradict what is stated in both the March 20, 1987 memo by Dave Jenkins and Steve Lowell and Tom Badger's field notes, namely that the buttress was constructed to specifications and is keyed below the clay layer in dense gravels. Additionally, Dave Fassler's construction diaries do not mention that the buttress was not built to specifications, except to say that the key excavation was exceptionally difficult.

actual cut for rock buttress

proposed cut for rock buttress (low elevation of ditch)

Figure 12: The second page of the March 20, 1987 Jenkins and Lowell memo showing annotated Polaroid photos of the shear-key buttress as it was being constructed. They argue that the buttress was not constructed to the specifications laid out by Todd Harrison. Specifically, in the photos they show that the buttress key is constructed above the planned grade. The buttress was not seated in the cut (ditch) at the bottom of the photos. Image courtesy of WSDOT via the Washington State Archives.

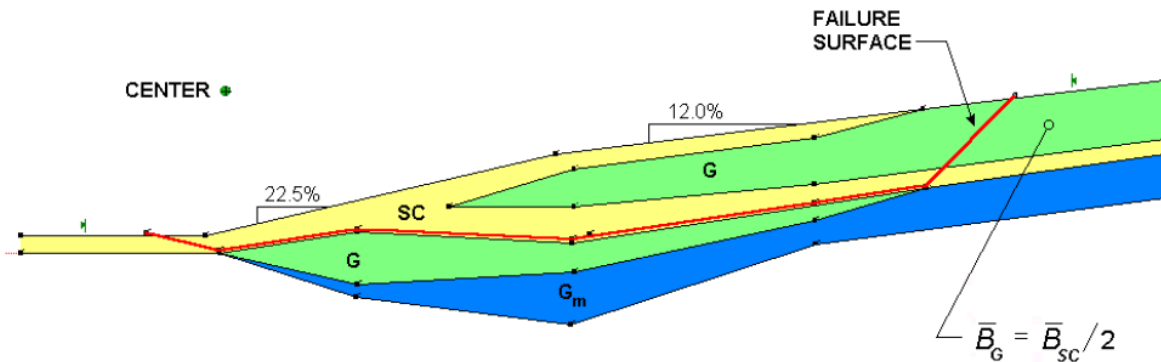
Figure 16: C-Core here hypothesizes that the failure surface follows the interface between the silty clay unit and the lower gravel contact. Gravels (G), silty clays (SC), and gravels-with-matrix ( $G_m$ ) are modeled). Again, the buttress is not included in the model. No scale is given. From C-Core (2006) Appendix B Figure 2.

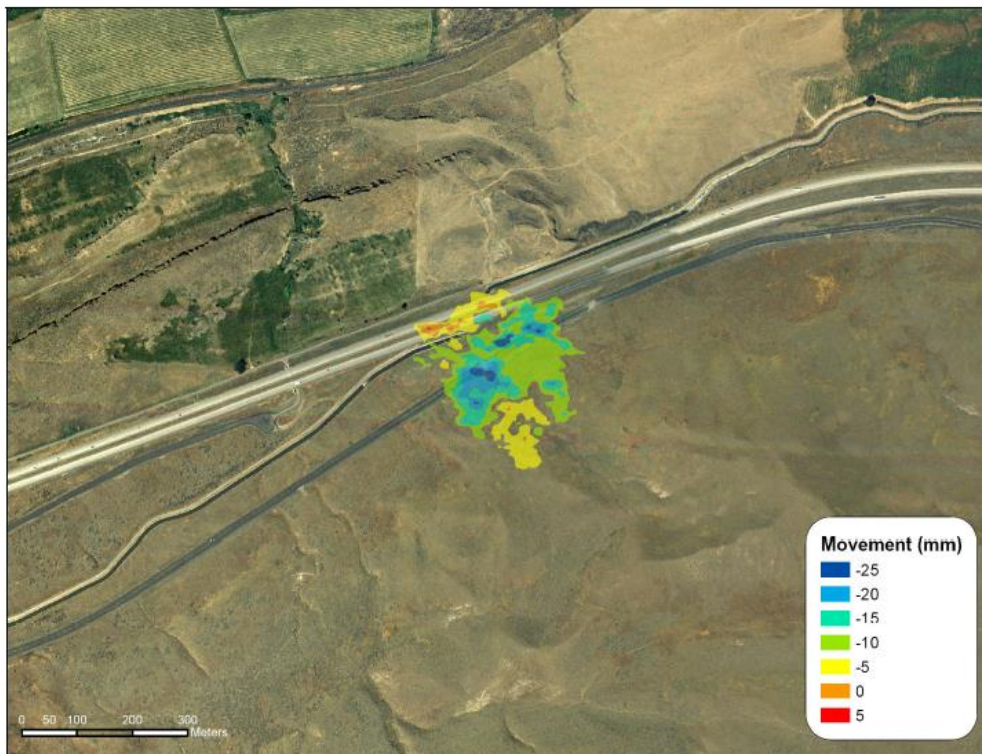
Figure 18: A composite image of the ground movement reported in FHWA (2006). The figure generally shows subsidence in the hillside (blue to yellow) and heave in the roadbed (red). However, the magnitude of the deformation of the roadway this figure is within the 10 mm of error reported in the original FHWA (2006) report. From C-Core (2006) Figure 21.

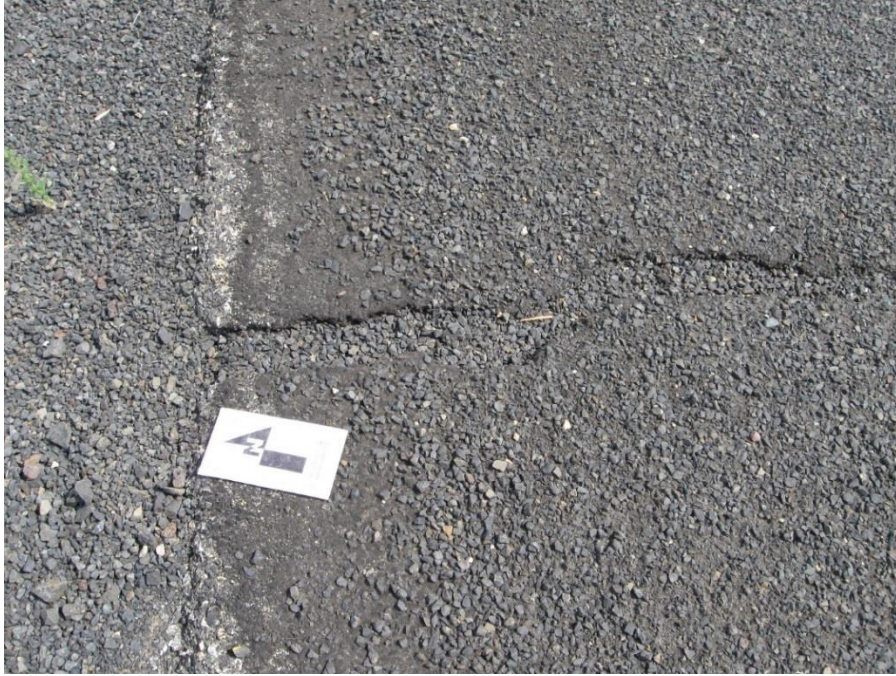
Figure 19: A photo of the surface of W Yakitat Road showing an open tension crack in the asphaltic concrete pavement. The road was recently (prior to my August 2013 visits) paved with chip seal, seen as the black gravel on top of asphaltic concrete pavement and in the tension crack. This particular crack is located on the edge of the northern shoulder of the westbound lane uphill of the buttress. Scale arrow faces north. The black fields on the scale measure 1.96 inches (5 cm). Photo was taken August 2013.

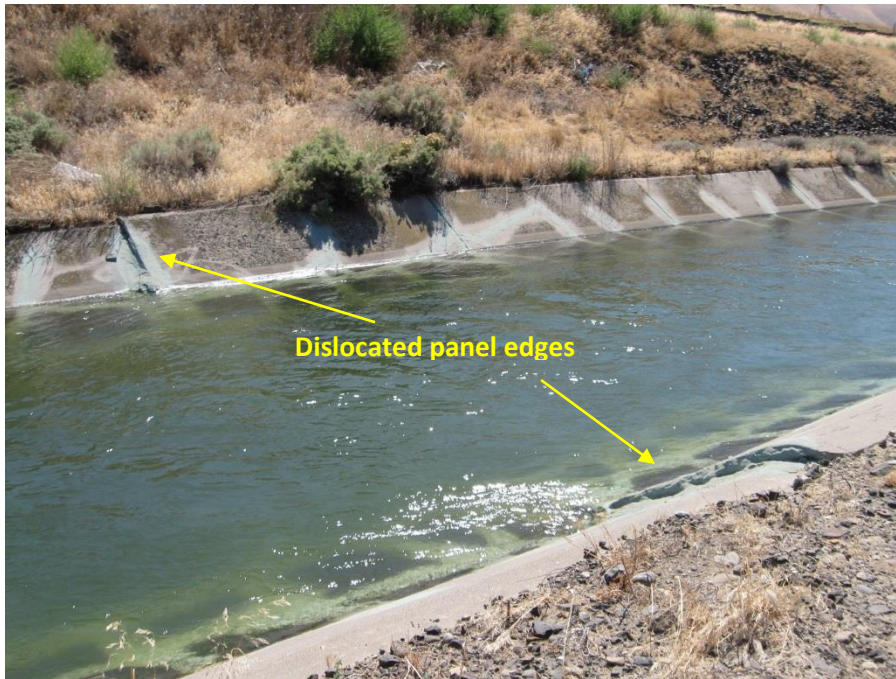
Figure 20: A photo of the KID canal taken during August 2013 showing an unlined section. The panel at the center of the photo has been dislocated from its original position. The KID reported that this was due to frost heave. Canal joints have been sealed with a green substance.

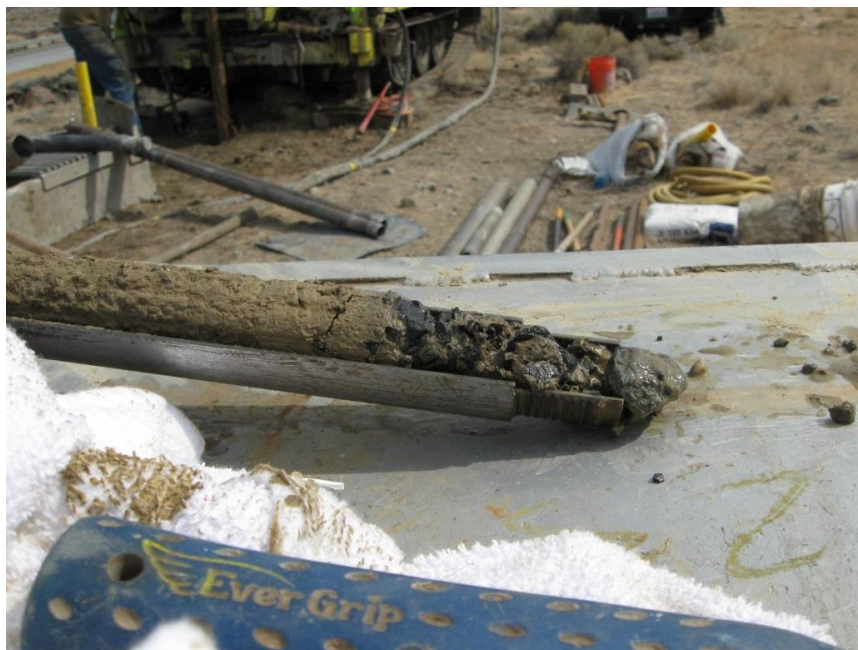
Figure 21: A photo of the silty clay and gravel with matrix contact taken immediately after the split spoon sampler was opened. Sample is D-8 and was taken at a depth of 28 feet from borehole H-101vwp-13.

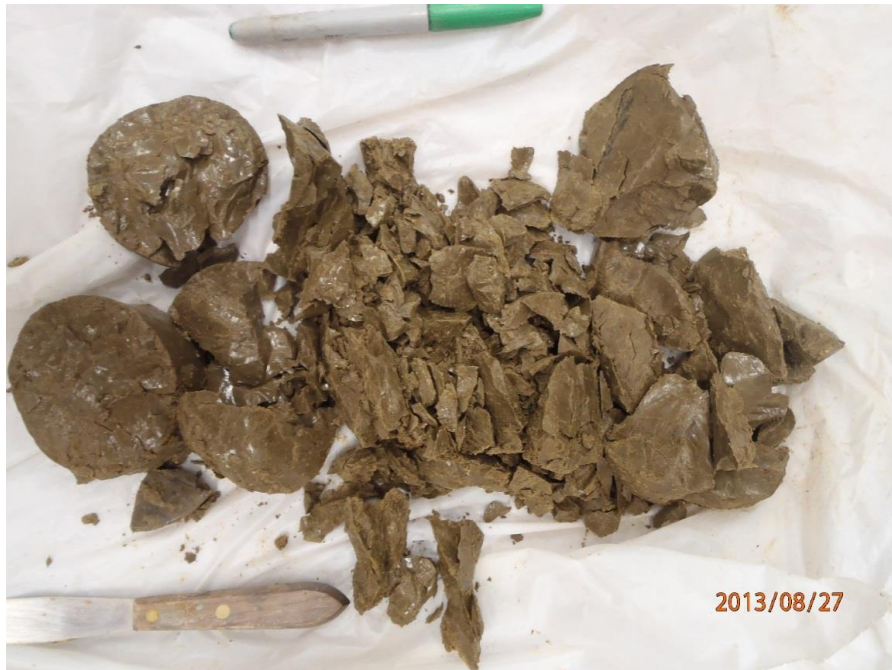
Figure 22: The contents of the Shelby tube taken at a depth of between 24 feet and 26 feet from borehole H-101vwp-13. I observed as I picked apart the silty clay the material could be easily separated by hand along abundant polished surfaces, especially in material from a depth of around 25 feet. Small metal spatula and Sharpie marker for scale.
