OBSERVATIONS OF JOINTS
PRESENT IN THE LAWTON CLAY MEMBER OF THE VASHON STADE,
EXPOSED AT A COASTAL BLUFF IN DISCOVERY PARK, SEATTLE, WASHINGTON

Amanda Dovich Ong

MASTERS OF EARTH AND SPACE SCIENCES: APPLIED GEOSCIENCES

UNIVERSITY OF WASHINGTON

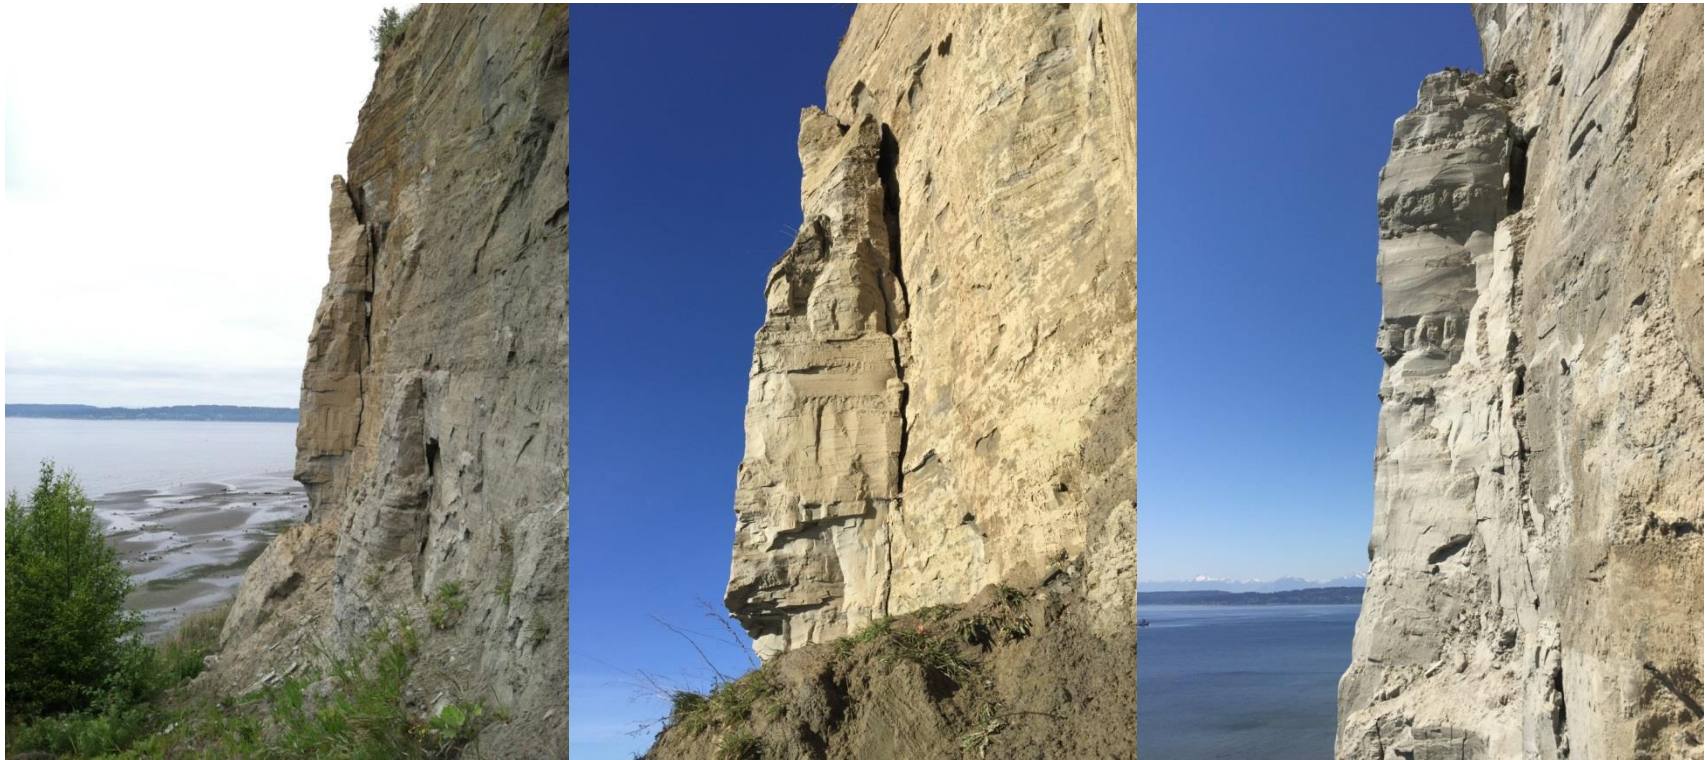
Figure 9 shows a large fractured corner wedge at the bluff that changed dramatically over the course of months, most likely due to the combination influence of increased water movement throughout the slope and failure along preexisting planes. Tubbs (1974 and 1975) theorized that landslides along the Puget Sound were the direct result of groundwater buildup. During winter, when there is an increased volume of water moving through a permeable unit, the intergranular pore pressure increases and thus reduces the coefficient of friction in the slope. This, in conjunction with the unique stresses generated by the aquifer overburden of the Esperance Sand over the Lawton Clay, result in mass failures characteristic of this area.

Figure 9: Photos taken 5/17/2015, 11/21/2015, and 4/20/2016 respectively showing the change occurring over time at a distinctive fractured wedge at the northwestern corner of the bluff.

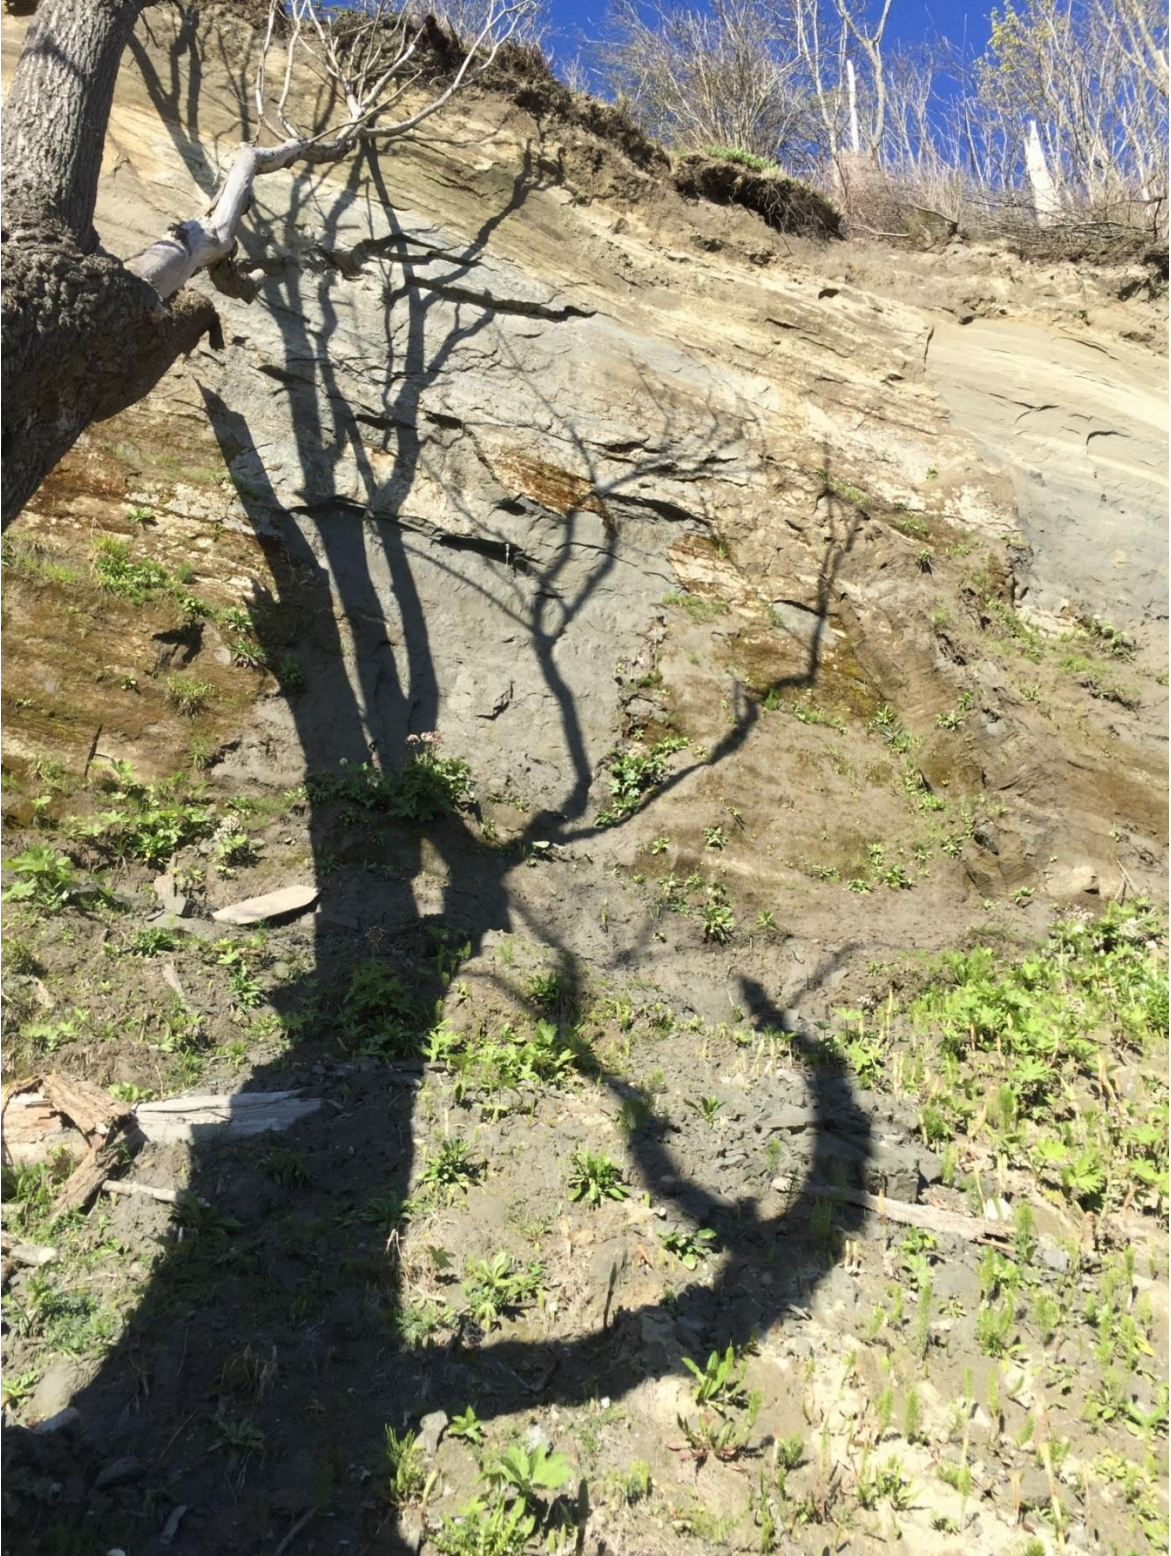
Fieldwork was restricted to periods of drier weather to avoid increased instability due to wet weather; however, during a field excursion on a clear day I observed a sudden sheet failure at the area shown in Figure 10, indicating that larger failures at this could happen at any time, even during longer stretches of dry conditions.

Figure 10: Site of sudden sheet failure witnessed by me and Dr. Juliet Crider, taken 4/8/2016.

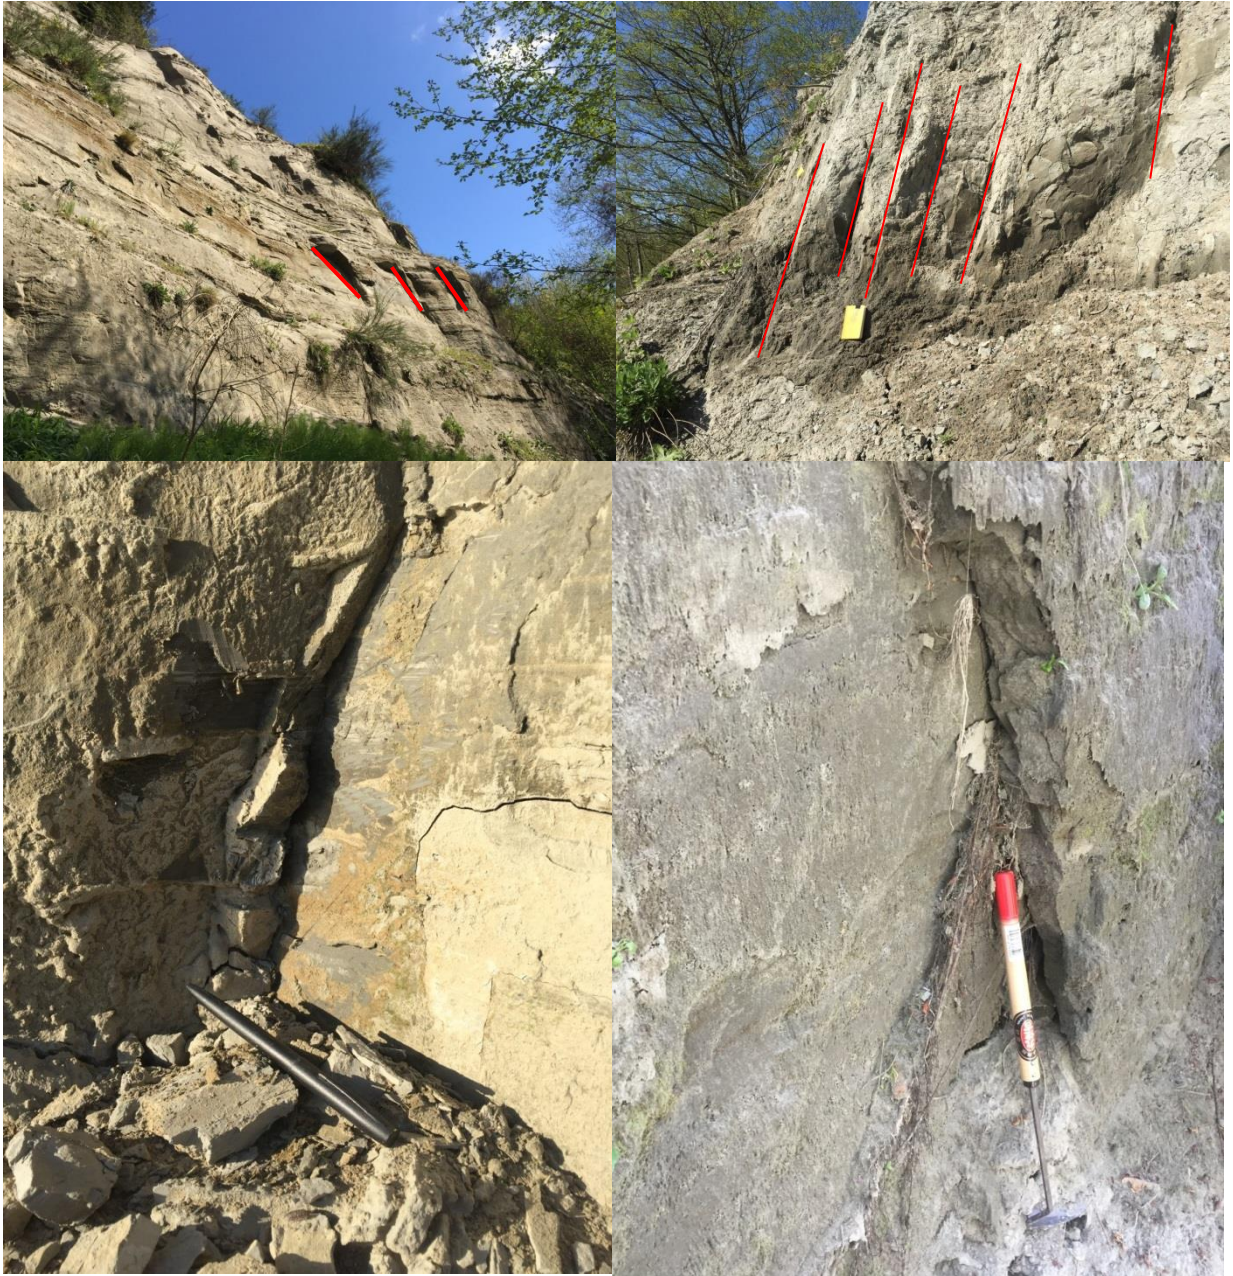
The bluff exhibits joints throughout the exposed clay unit and into the sand/clay transition zone, as seen in Figure 11. These were split into three primary groups pertaining to accessibility: 1) joints present at the upper portion of the bluff in the lower part of the Esperance Sand and sand-clay transition; 2) joints present at the middle portion of the bluff that can be visually observed; and 3) joints present at the lowest portion of the bluff at bench level that can be easily measured by hand without use of additional

Figure 11a (upper left): inaccessible joints marked out in red at the southeastern end of the study area.
Figure 11b (upper right): a joint set marked out in red and oriented parallel to the local bluff face at the northwestern end of the study area.

Figure 11c (lower left): red-black surface staining on joint surfaces.
Figure 11d (lower right): root infilling at the far southeastern forested end of the study area.

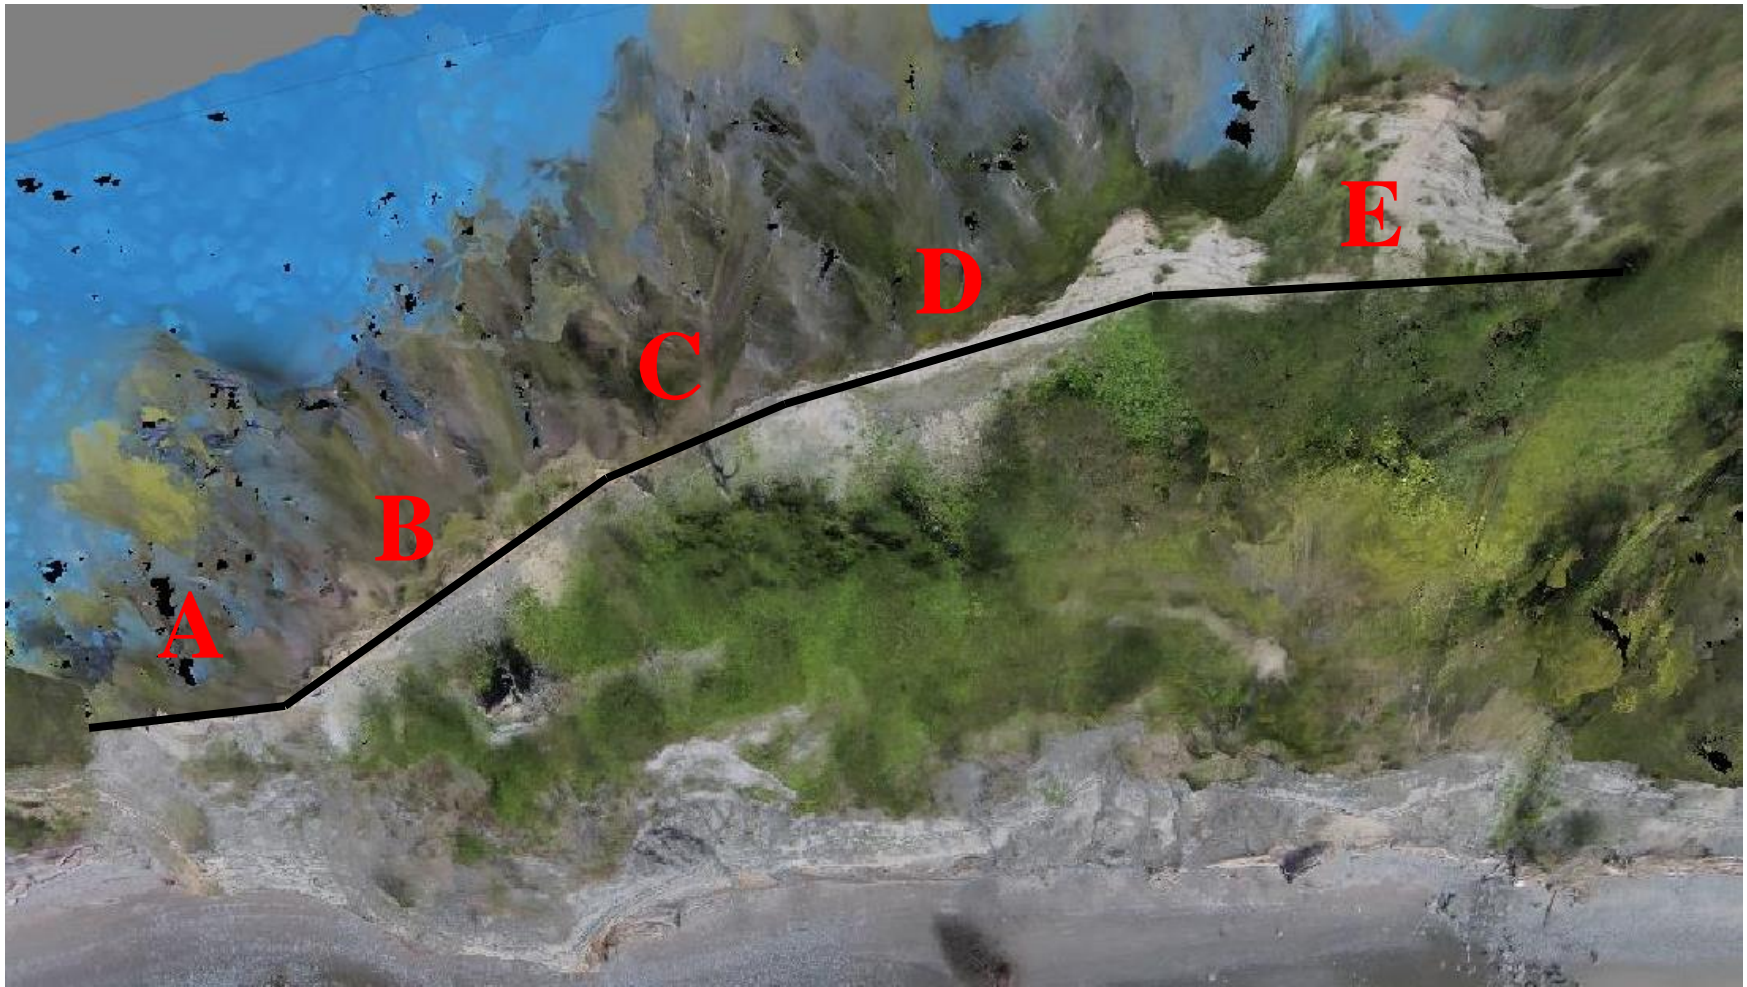
Due to the changing conditions of moisture, vegetation, and elevation across the bluff, it was simplest to characterize the bluff in terms of general domains, separated from one another by distinguishing differences in such attributes like bluff section orientation, joint frequency, seepage, and primary talus slope material. Five domains were distinguished, and are identified in Figure 15 as domains A, B, C, D, and E.

Figure 15: Oblique view of SfM model marked with domains.

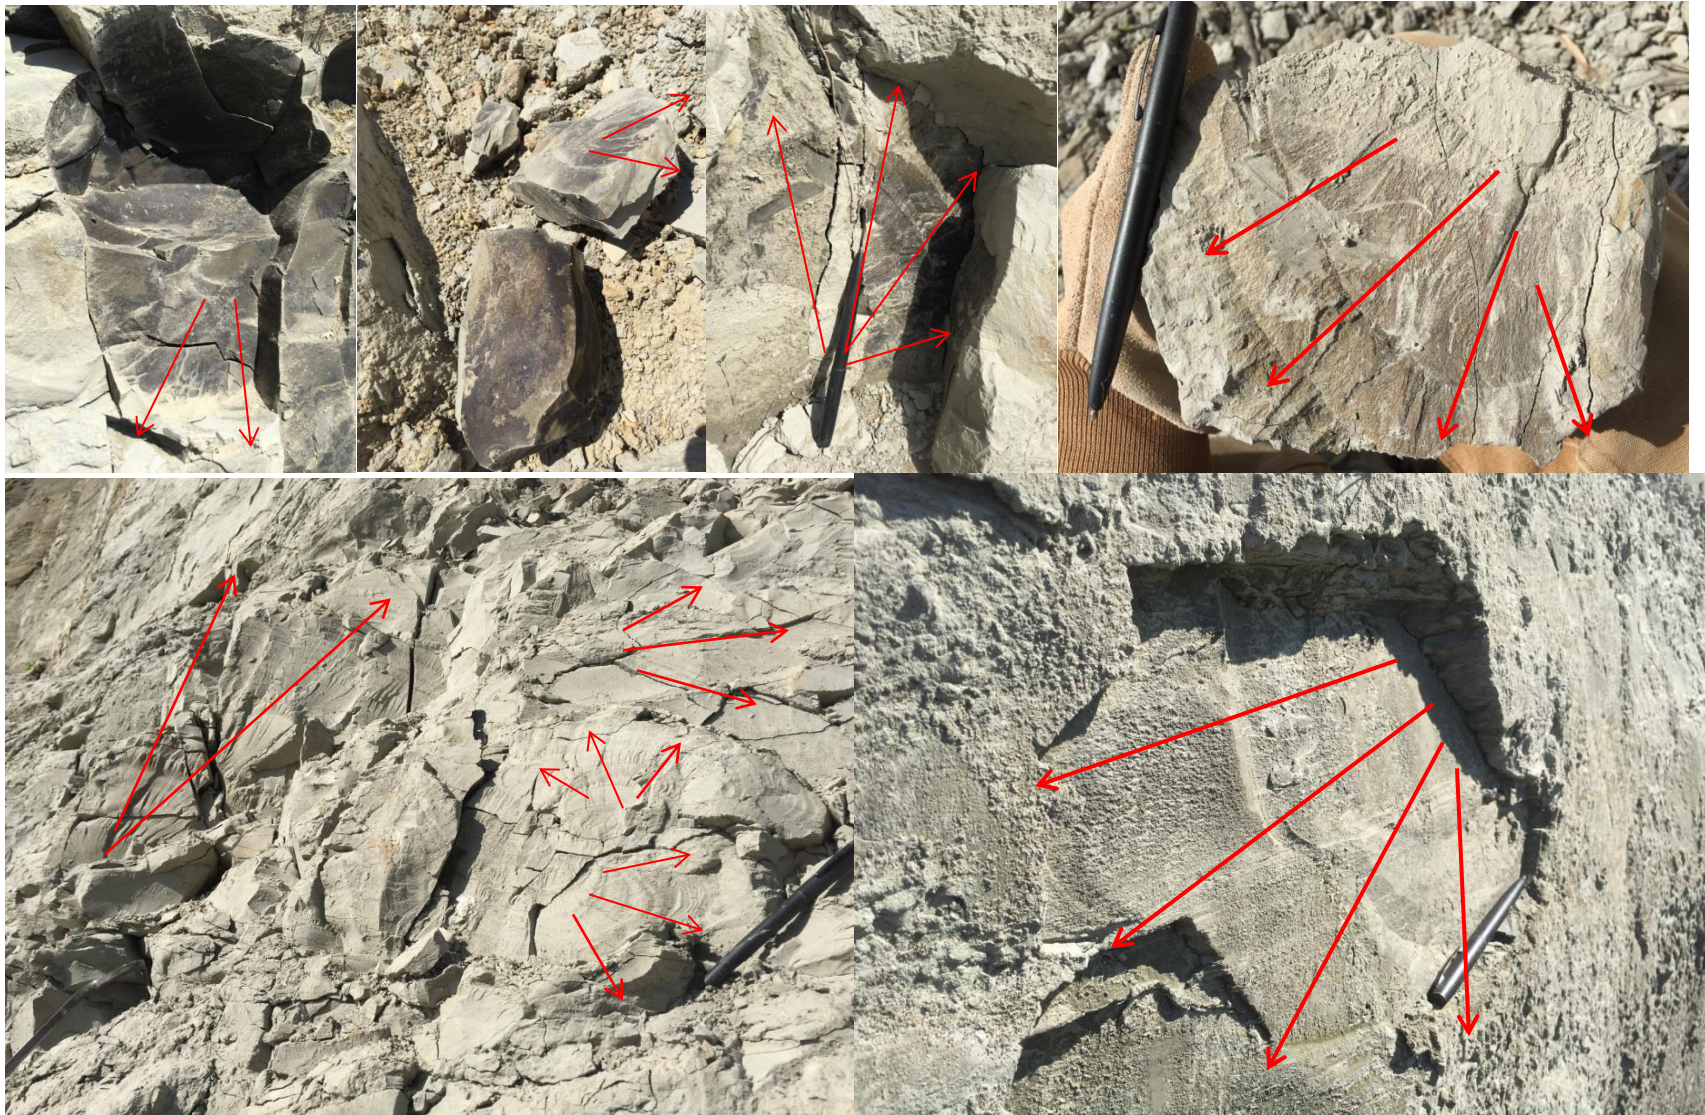
Figure 16: Radial plumose surface texture and concentric arrest marks in the clay, marked with red arrows that indicate the directions of fracture development out from a (or several) point(s) of origin.

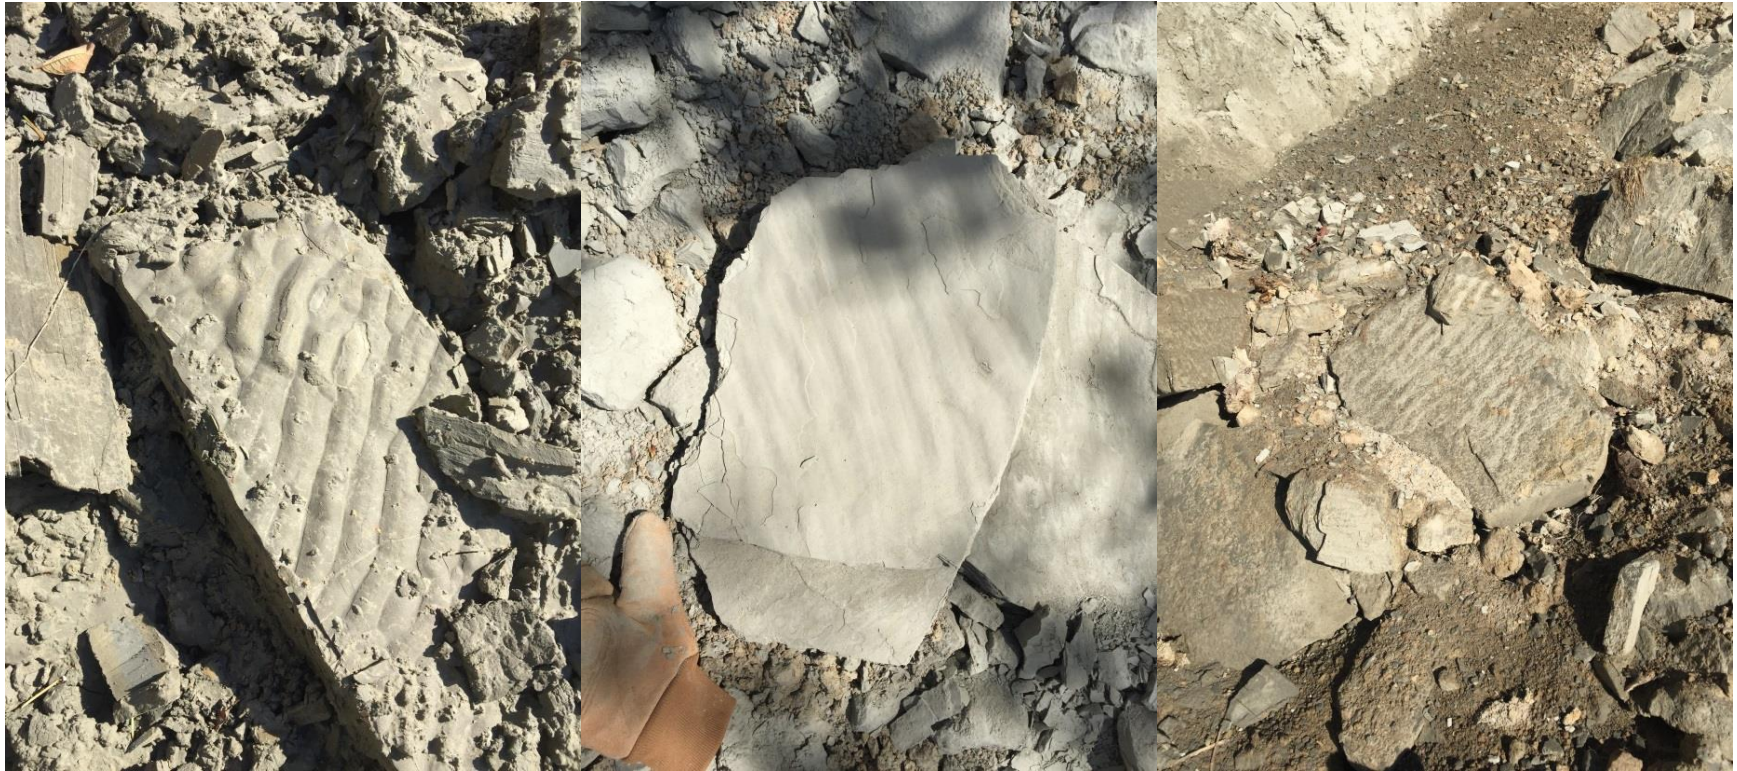
Figure 17: Ripples present in clay bedding.

same amount of weathering. From bench-level, the upper half appeared primarily intact, with very minor perpendicular fractures that were often covered in soil wash and organic debris from above. Most of the fractures appeared to be shallow and roughly parallel to the bluff face, with the apertures only discernable by the stairstepping pattern produced by sun shadow. Some wedge blocks above the talus slope exhibited very particular radial fractures, seen in Figure 16. The very dry, crumbled blocks fallen from above and lying at bench-level broke easily along the bedding in sheets, revealing the ripple structures in Figure 17.

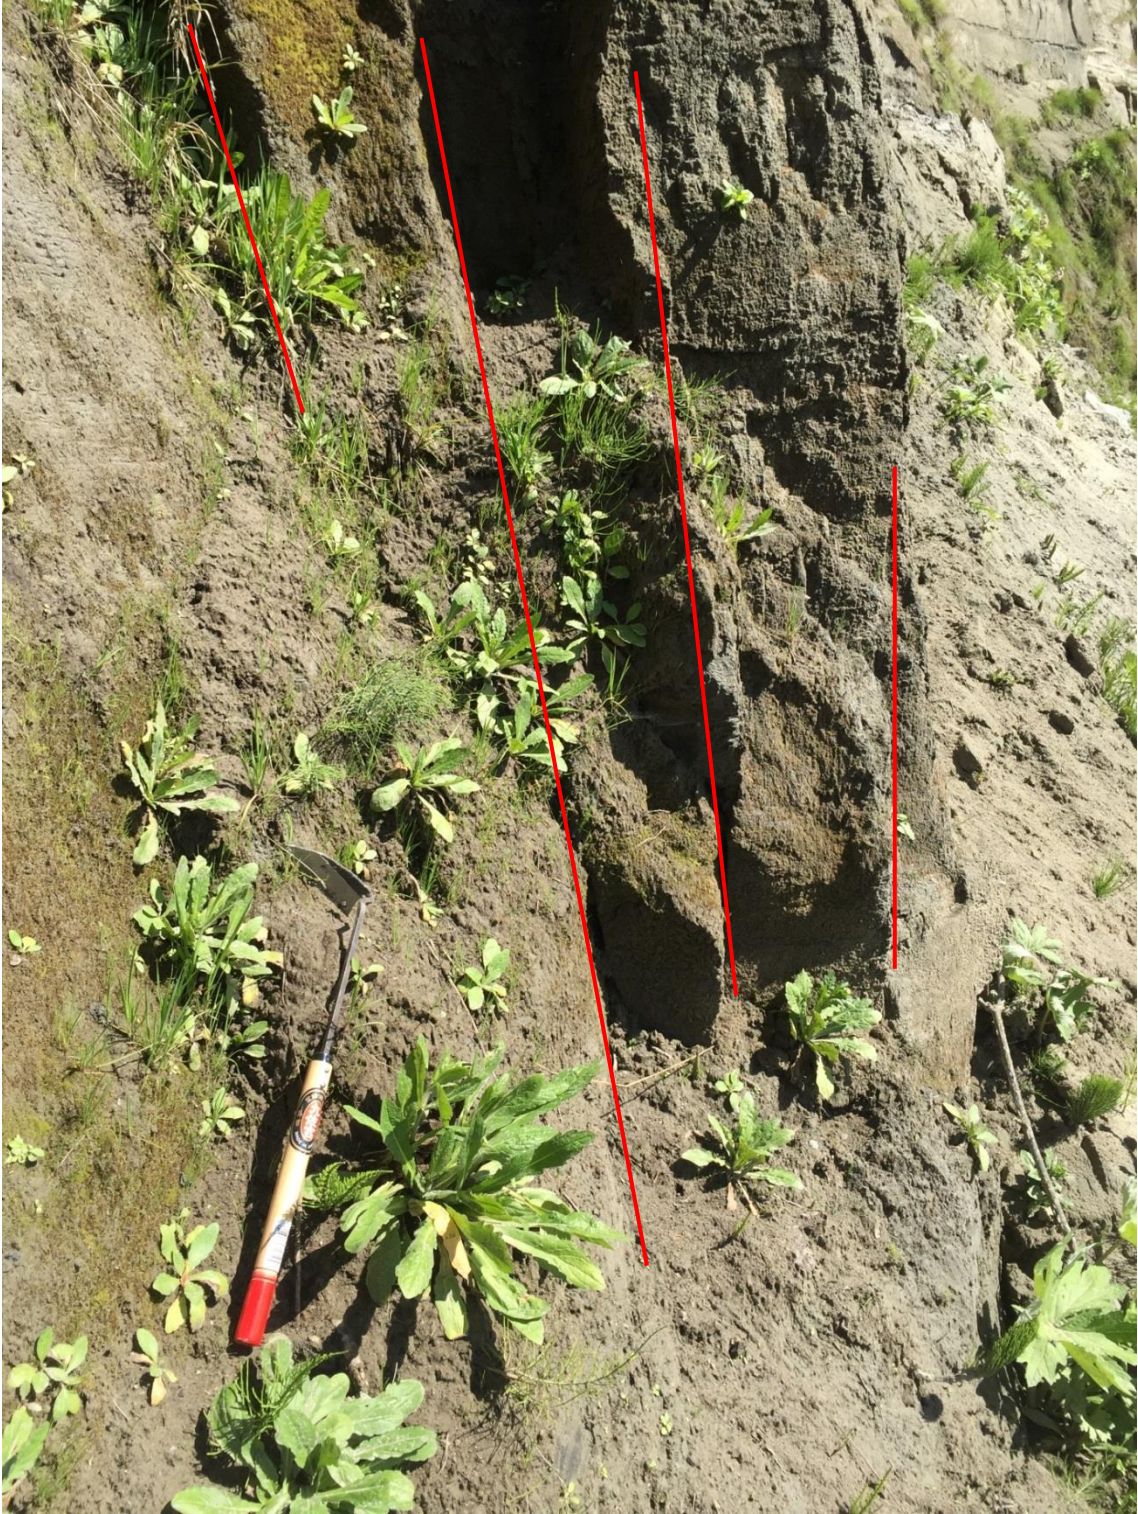
Figure 18: Stair-stepping series of fractures marked out in red.

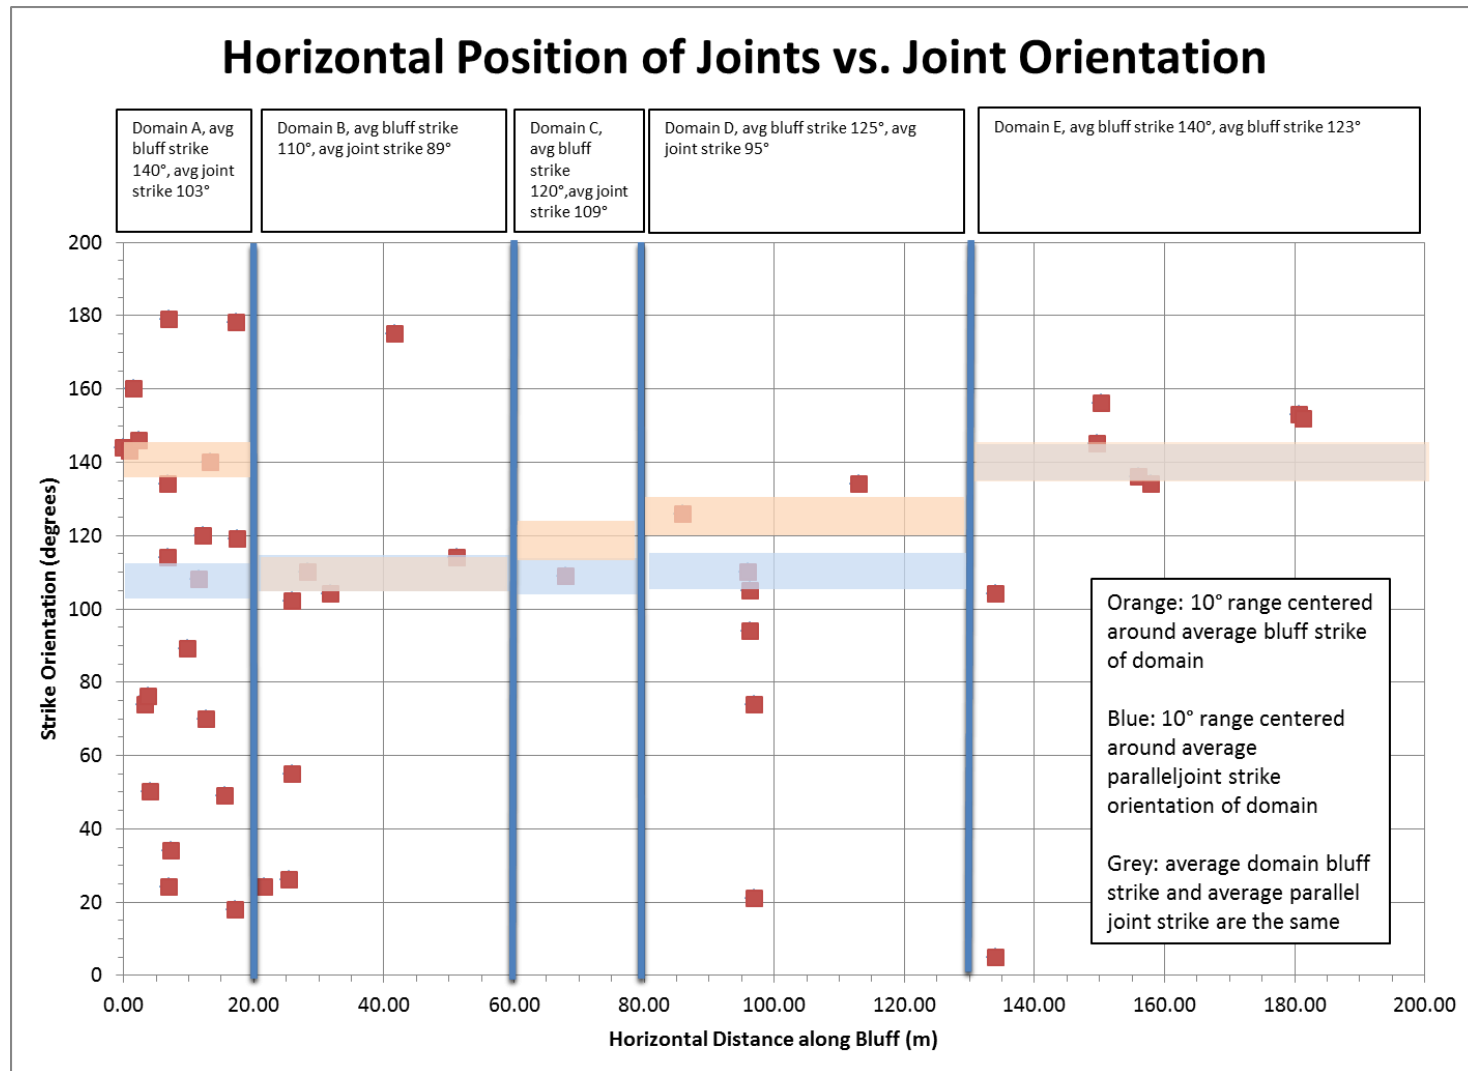
Figures 22 and 23 roughly demonstrate that the parallel joint orientations change along with that of the bluff, within a range. The high-angle dips of all joints measured are reflective of the high-angle dip of the bluff itself. Given that Figures 22 and 23 show the measured joint orientations correlating roughly with the orientations of the bluff, it's likely that the tension stresses generated by the sheer bluff surface are at fault for the parallel-to-surface sheet and block failures; the near-vertical orientation of these tension joints in the horizontally-bedded Lawton Clay and the irregular nature of the perpendicular fracture planes in the uppermost, clay/silt/sand part of the bluff correspond with observations by Selby (1993) of tension joints in horizontally-bedded sedimentary rock frequently being near-vertical, and in mudrock and other weak rock as frequently curved and discontinuous. At the most exposed corner end of Domain A, where the properties of the clay more closely resembled that of rock due to the extreme dryness, failure occurred not only in sheets, but also in blocks and wedges. Elsewhere on the bluff, where more moisture was present as seepage out of the interbedded clay/silt/sand between the Esperance Sand and the Lawton Clay, failure was primarily in large sheets, parallel to the bluff. In light of this, it is less accurate to describe the parallel joints as one joint set—but rather as an approximate series of five different parallel-to-bluff joint sets corresponding to the five bluff domains where they are located.

Figure 22: Scatterplot of joints plotted vs. horizontal location, showing joint orientation, the 5 domains, and the 10° range for bluff strike (orange) and parallel joint strike (blue) per domain, centered at the average. Domains B and E had the same average strike for bluff and parallel joint orientation, and overlap as a greyish band.

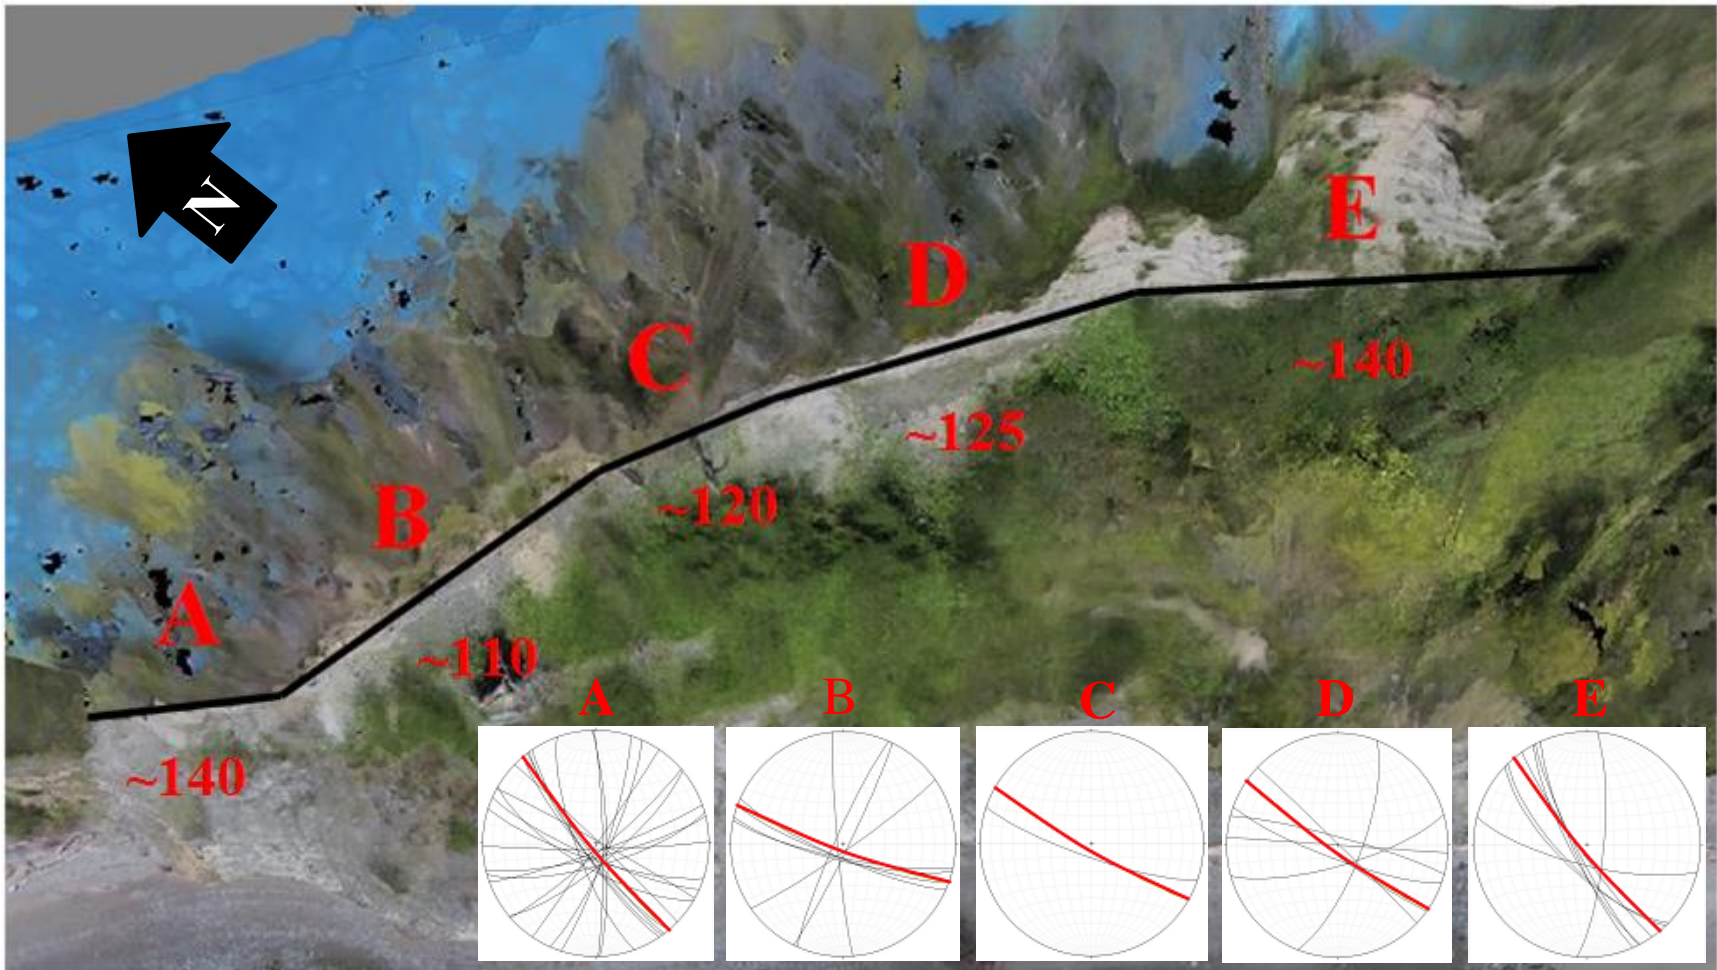
Figure 23: Oblique view of SfM model marked with domains, domain orientations, and stereonets containing joints measured within that domain, with a yellow-highlighted joint corresponding to the strike of the domain and to the average dip of 85°.
