2009 Rockslide, Interstate 40, North Carolina

Comps Exam Question

New Sewer Line

2005 La Conchita landslide case study

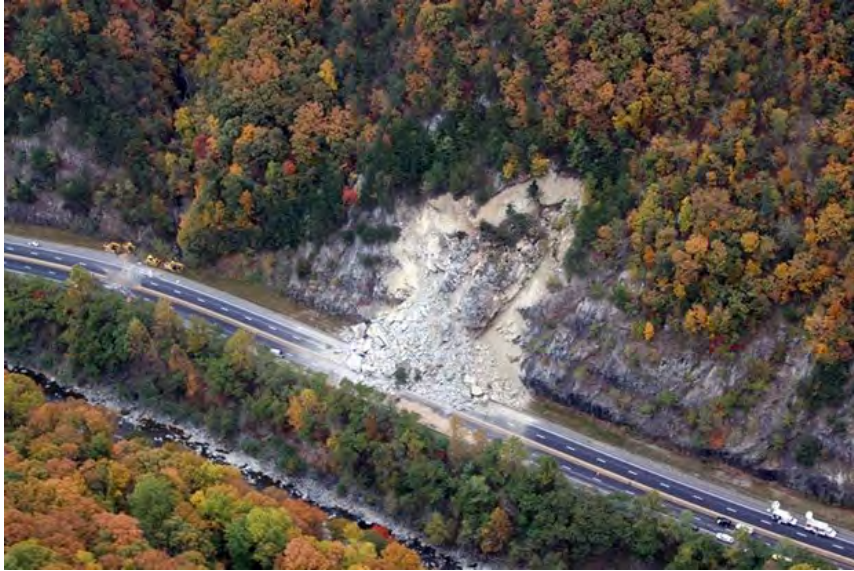
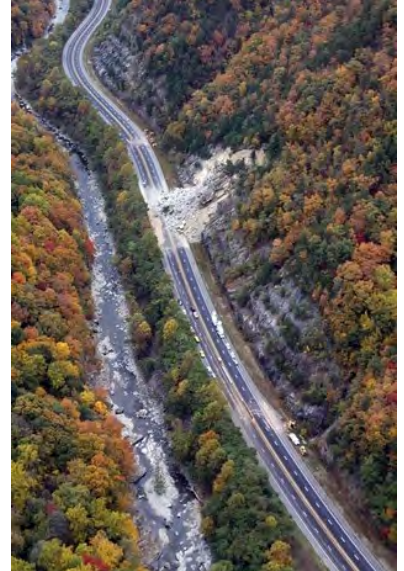
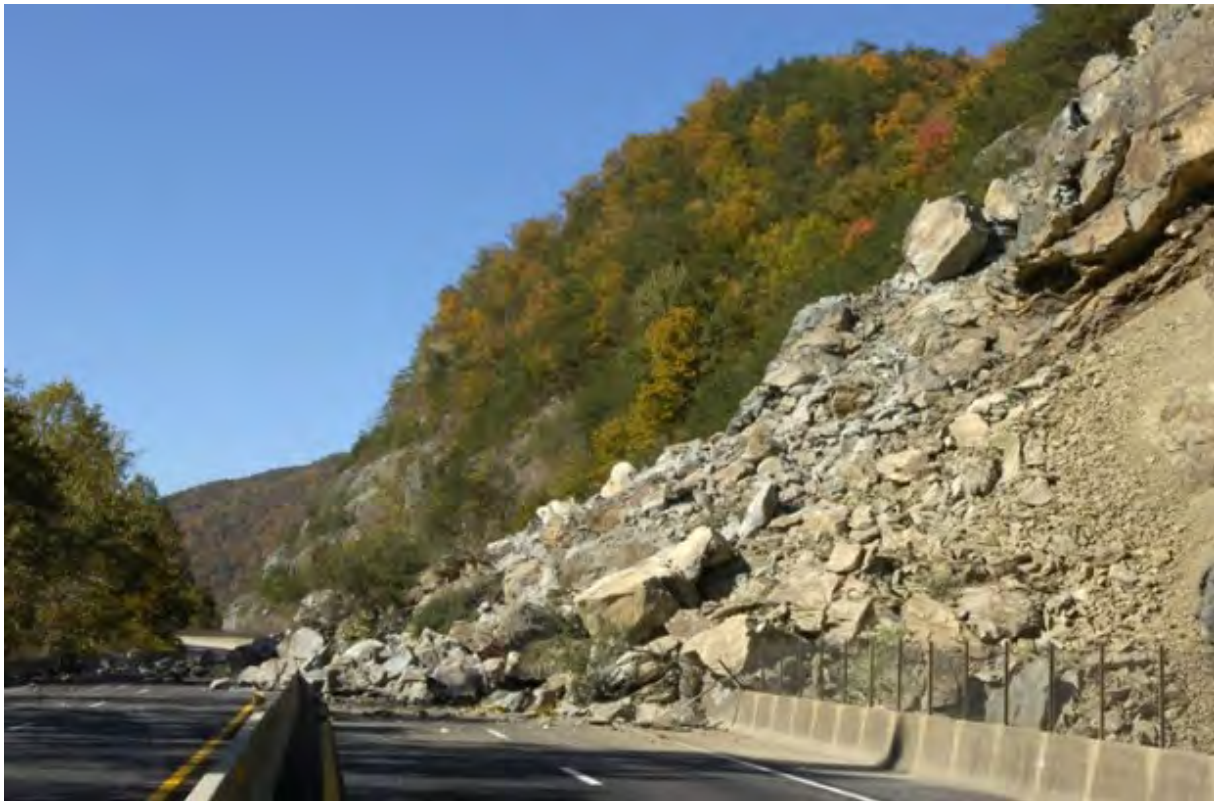
Examine the images on the following page and consider these questions:

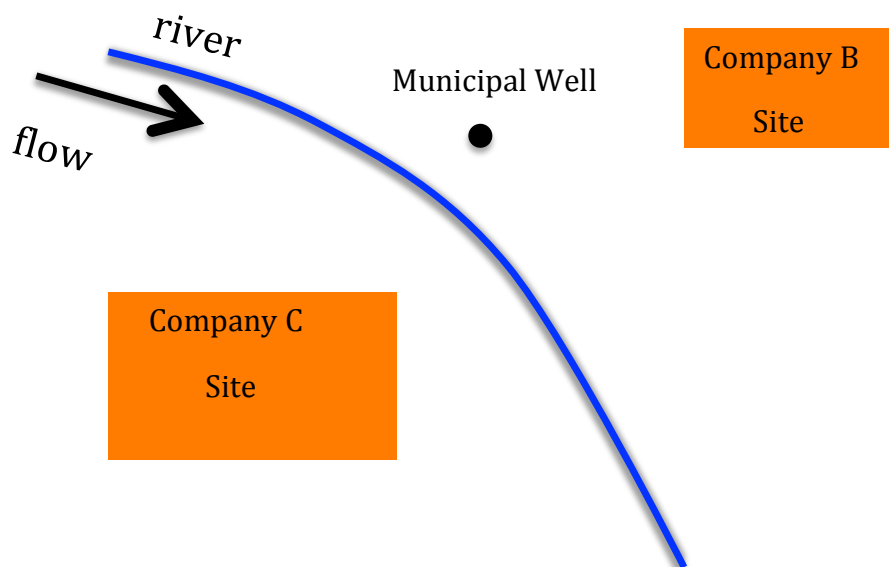
Site map:

- Low relief river valley with 100' of alluvium over bedrock.
- Unconfined shallow aquifer.
- Riverbed of peat and silt.

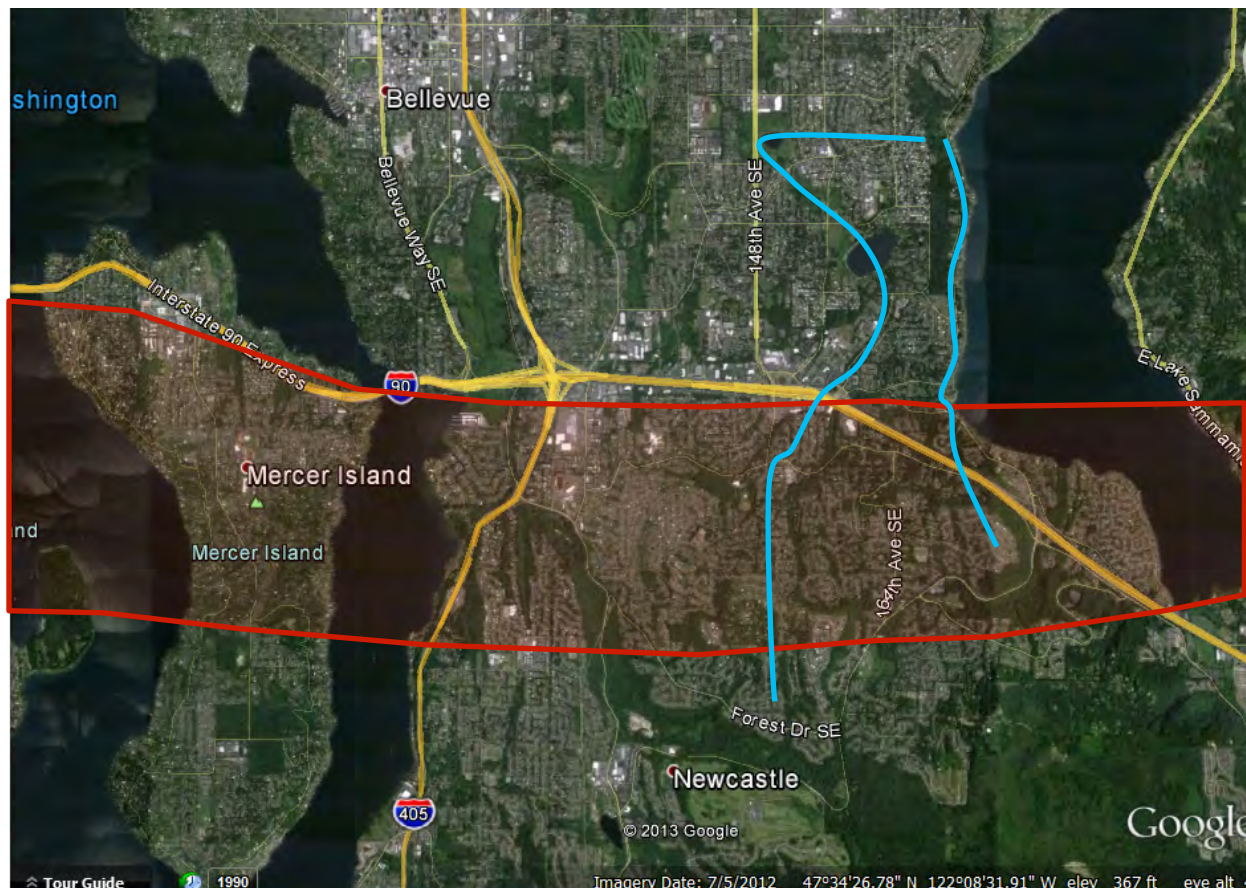
Figure 1. Location map showing Seattle fault zone in red and proposed sewer lines in blue.

King County engineers are evaluating the addition of and location of two new sewer lines in East Bellevue at locations shown by the blue lines on Figure 1. Both proposed lines cross the Seattle fault zone, outlined in red on Figure 1, with strands shown on Figure 2. The pipelines would be located as deep as 65 m bgs, depending on topography. Construction techniques therefore would consist of a combination of excavation at pump stations, cut and cover for shallow segments, and bored tunnel.

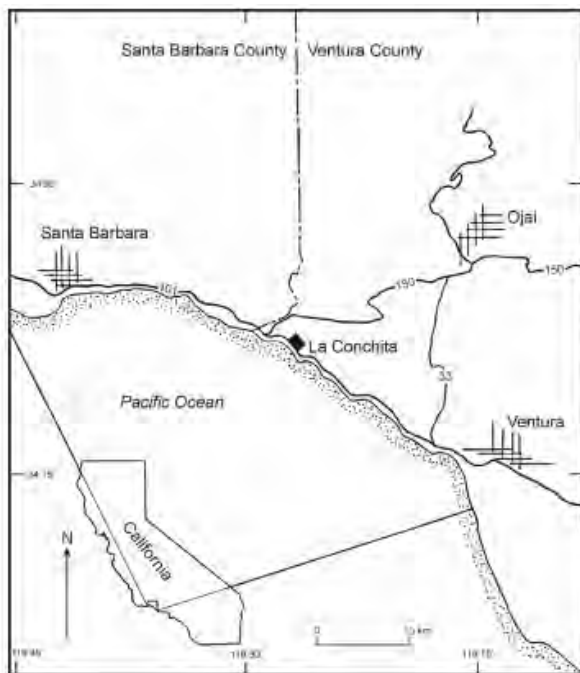
La Conchita is located on the southern California coastline midway between Ventura and Santa Barbara (see Map below). The 11-ha (28-acre) community was first established in 1924 when subdivision created about 200 lots that mostly contain single-family residences. La Conchita lies on a narrow coastal strip about 250 m (800 ft) wide between the shoreline and a 180-m (600-ft) high bluff having a slope of about 35 degrees. Above the top of the bluff is a gently rising terrace surface covered by avocado and citrus orchards.

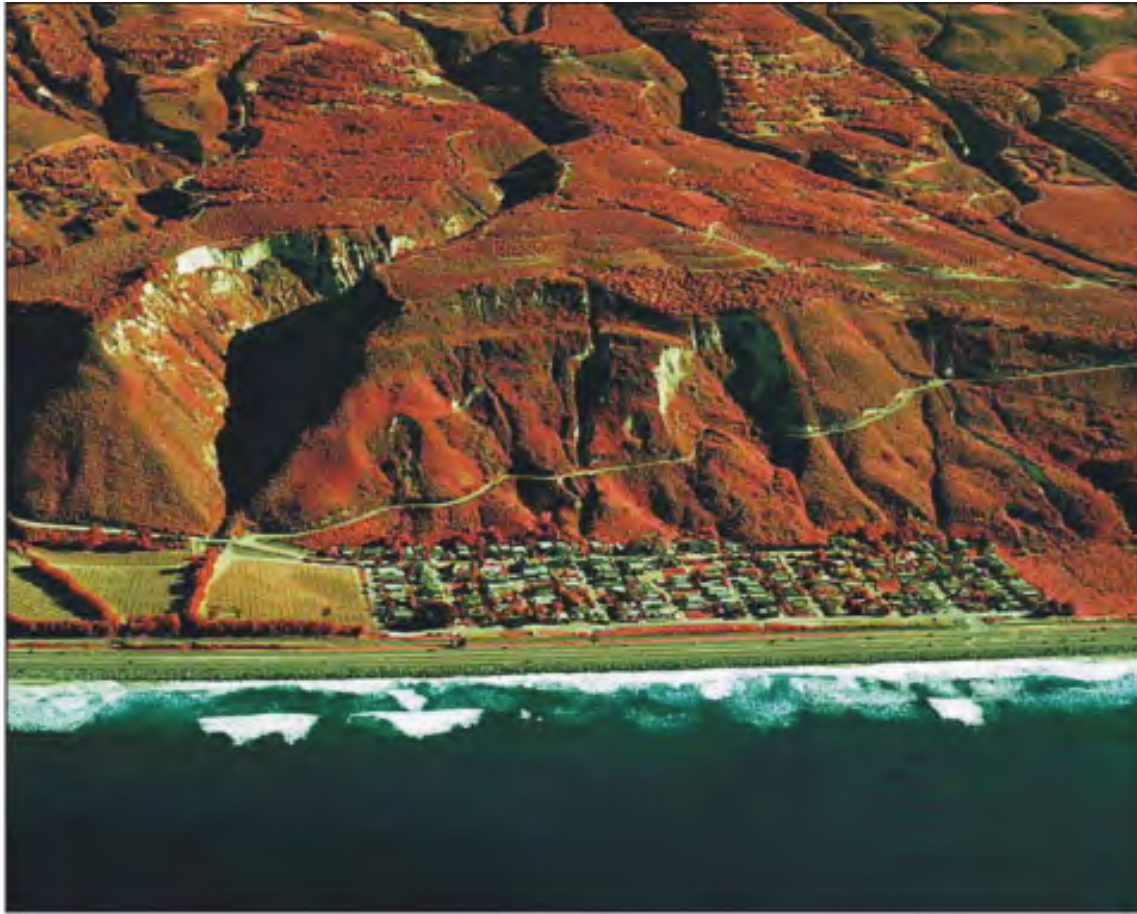
The bluff above La Conchita has been unstable and produced a variety of landslides over an extended period of time. Using the overlain LIDAR and false-color infrared image of the bluff from 2002 (three years before the most recent big slide of 2005), identify and discuss the evidence for hillslope mass wasting events of various size, type, and age.
