Relief Well Rehabilitation Options in Chief Joseph Dam Right Abutment Drainage Tunnel

Katherine Anne Garon

A report prepared in partial fulfillment of
the requirements for the degree of

University of Washington

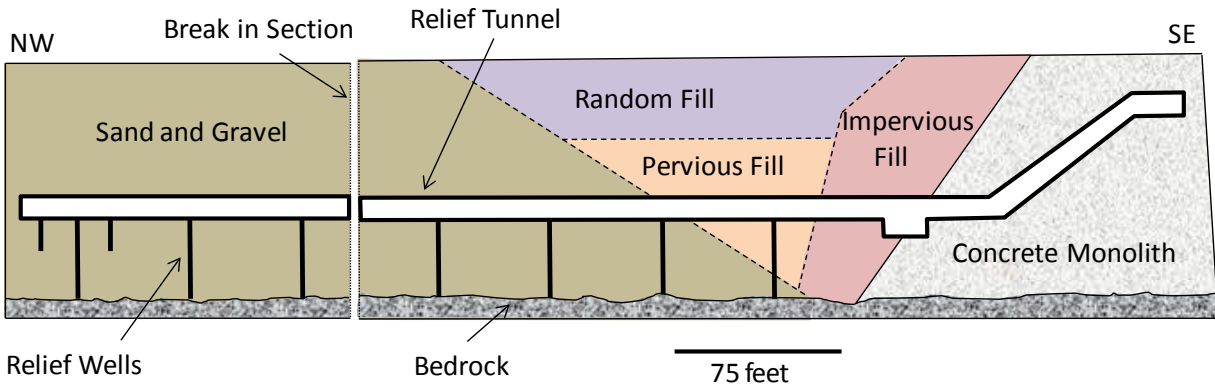
Figure 2-3: Generalized Cross Section of the Relief Tunnel, looking upstream.

The relief tunnel is located in the right abutment of CJD. The tunnel is accessed through the spillway monoliths of the dam (Figure 2-2). The tunnel is 1,020 ft long, 8 ft tall and 5 ft wide (Figure 2-3). The bottom of the tunnel floor rises with a 1% slope from the drainage sump to the distal end within the abutment. A two-foot high catwalk runs along the length of the tunnel. The drainage sump and drain to the river are at the southeast end of tunnel. There are 22 wells along the length of the floor of the tunnel, 20 of which are spaced every 50 ft along the tunnel. The first well is 45 ft from the entrance of the tunnel. Two wells (19A and 20A) are located 15 ft offset on either side of Well 20, which is the last well in the tunnel.

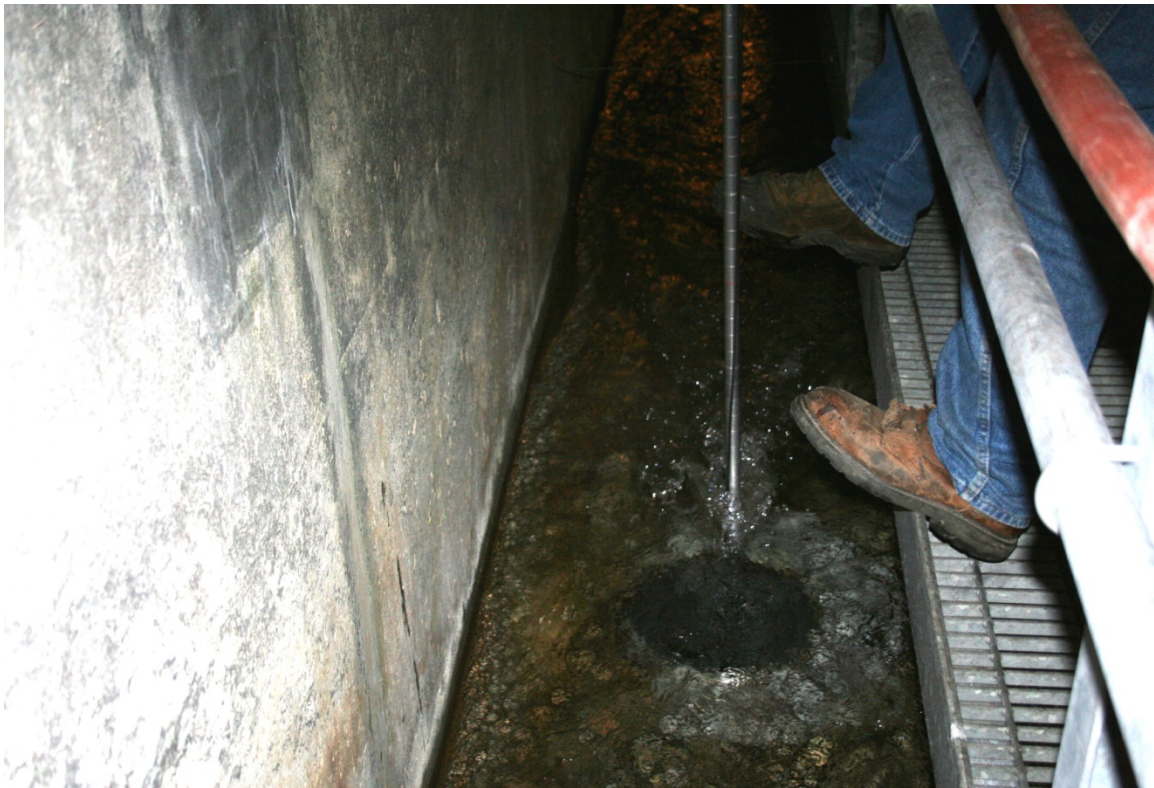
Figure 4-1: Monthly Flow Reading.

Flow from the tunnel is manually monitored during monthly tunnel inspections. Once a month, CJD staff access the relief tunnel and use a flow meter to measure the flow from each well. Each well had a temporary top cap installed in 1979. The mesh screen of the cap is about 1.5 ft below the tunnel floor, which allows the monthly flow measurements to be made with the flow meter in the well as shown in Figure 4-1. These monthly readings have occurred since 1980.

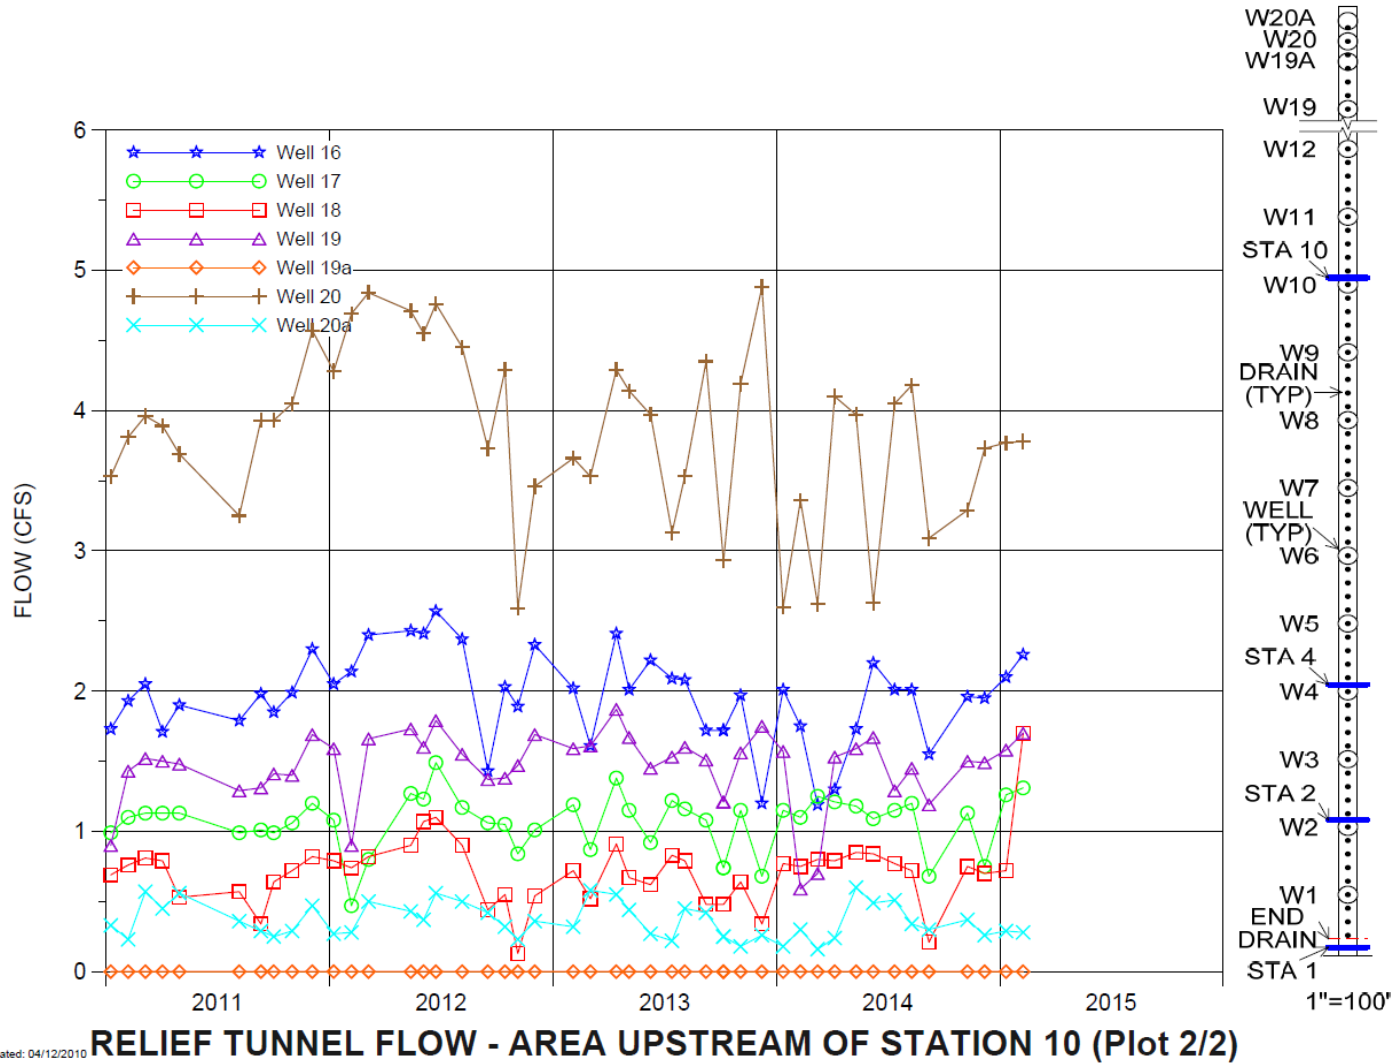
Figure 4-2: Example Plot from Instrumentation Web Site with Flow at Wells 16 to 20A.

Figure 4-2 is an example of the data that is taken by CJD and monitored by NWS Geologists. The data are kept in a database that goes back to 1980. Data before then are recorded in paper records and periodic inspection (PI) reports. According to the 2012 PI report (USACE, 2012), average flow in the tunnel decreased from 90 cfs in 1953 to 25 cfs in 1977. From 1977 to 2010, the total tunnel flow rate remained relatively constant between 20 and 25 cfs. There was no apparent increase in tunnel flows that could be attributed to the pool raise in February 1981 when the normal full pool was raised from elevation 946 feet to elevation 956 feet. From 2010 to 2012 the total tunnel flow increased an average of a few cfs due to increasing trends in flow from wells 16, 17, 18, 19, and 20. The increase is most evident in well 20 with an increase from ~3.5 cfs to approximately 4.5 cfs (Figure 4-3). The flows then dropped again, so more time will be required to determine if that increase was a one-time event or part of a larger pattern. The historic flow in the relief tunnel is shown in Figure 4-3. Figure 4-4 shows the maximum and mean flow from 1980 until 2013. The upstream wells have the highest flow, and well 20 has consistently higher flow than the other wells.

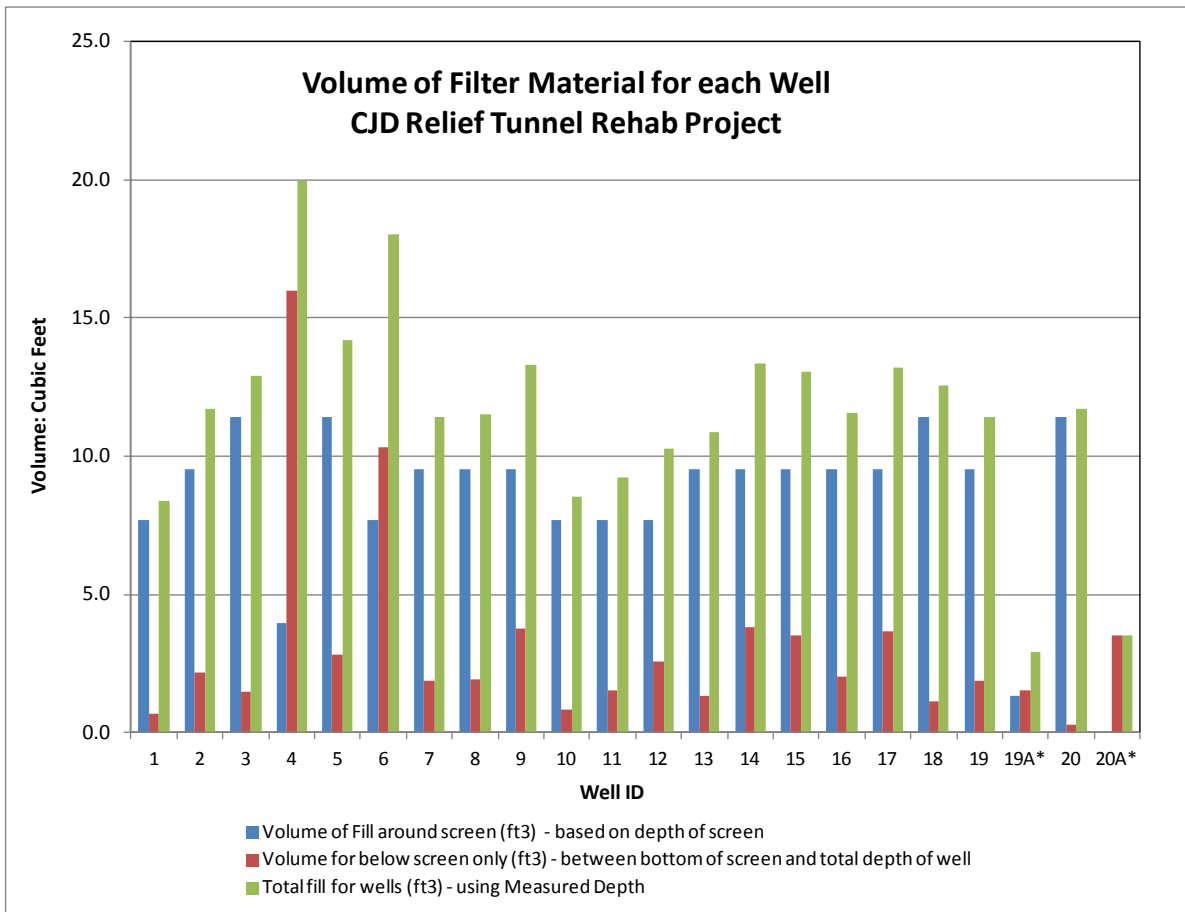
Figure 6-2: Volume of Filter Material for Each Well in the CJD Relief Tunnel.

This gives us the volume in cubic feet (ft^3) as seen in Table 6-2 and Figure 6-2. Table 6-2 and Figure 6-2 both include the volume around the screen, the volume under the screen (below the lower limit of the proposed stainless-steel screens, and the total volume of filter required for each well. This calculated volume equals the potential void space around each well. I calculated the void space for all wells.
