Vasa Creek Channel Conditions and Slope Stability, Bellevue, Washington

Audrey C. McHugh Britton, GIT

A report prepared in partial fulfillment of  
the requirements for the degree of

December 2013

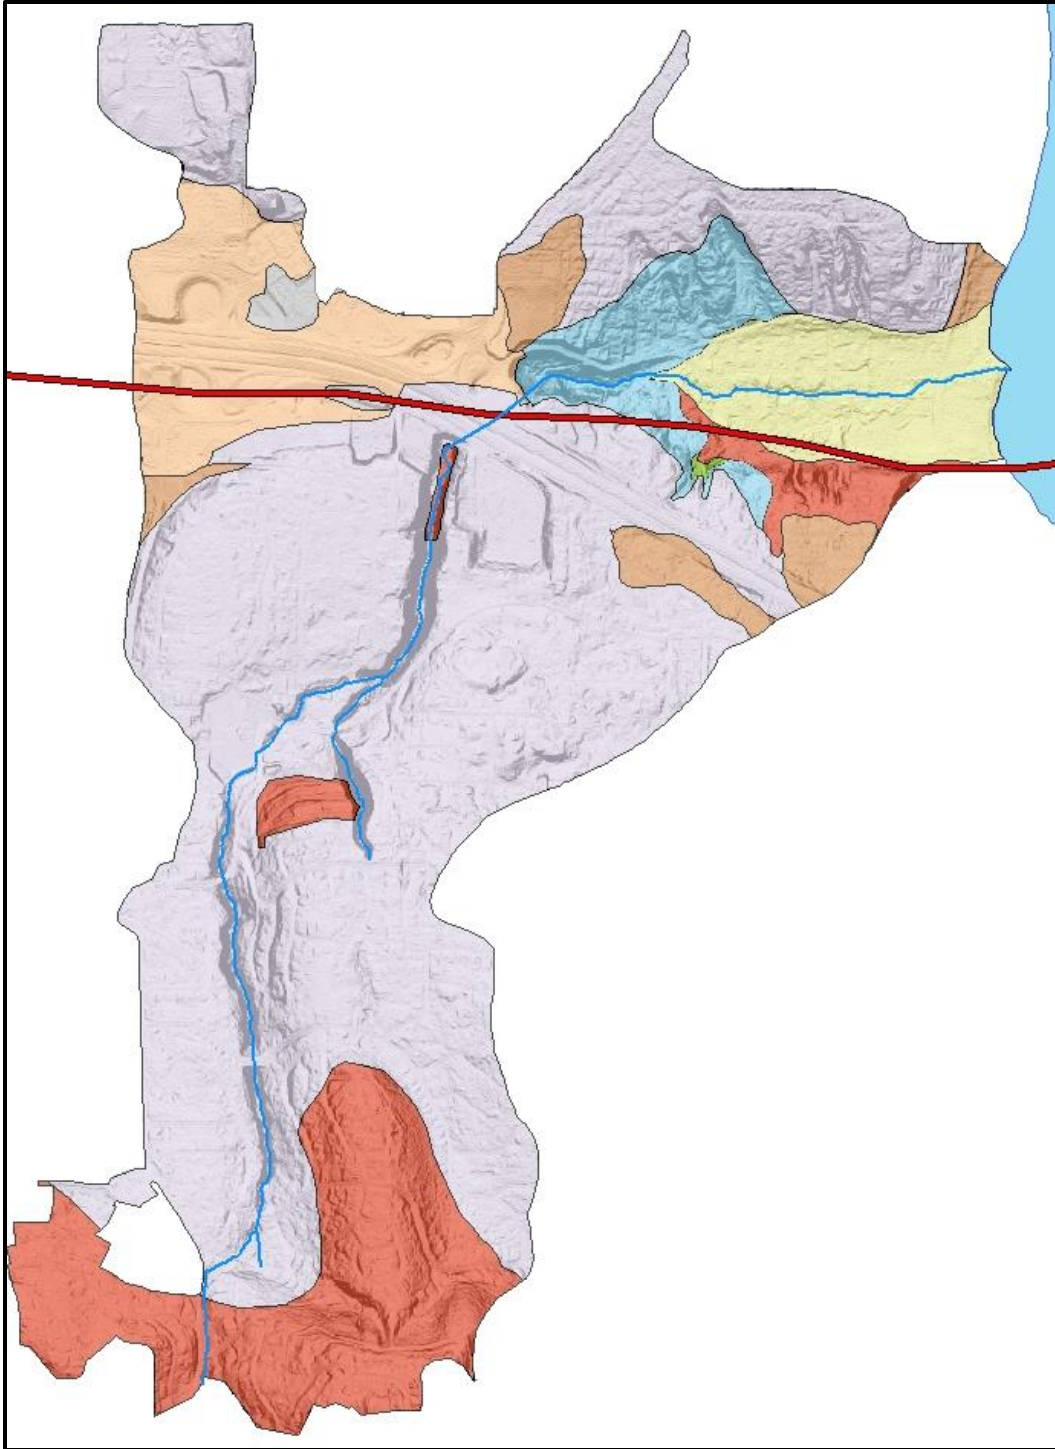
**Figure 3.** Location of the Vasa Park Fault, a strand of the Seattle Fault. The entire basin lies within the boundaries of the Seattle Fault Zone.

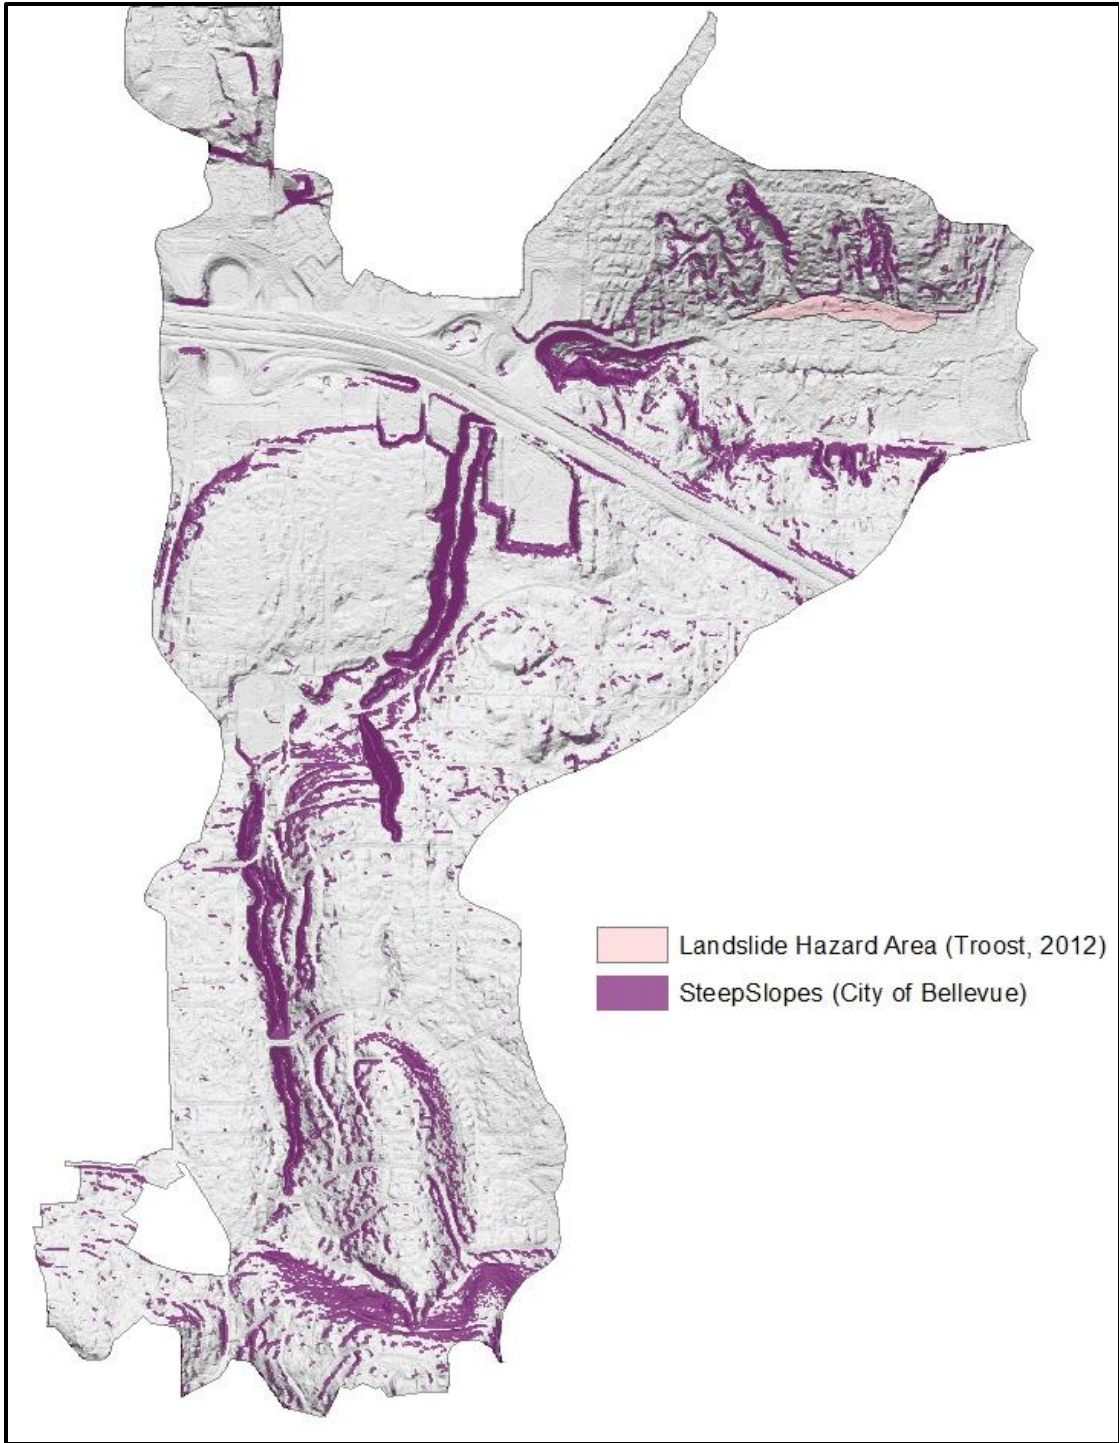
**Figure 4.** Previously mapped areas susceptible to landsliding. The City of Bellevue defines steep slopes at those >40%. Though steep slopes are mapped within Vasa Creek, no locations of landslides occur here. This is not a complete landslide hazard assessment.

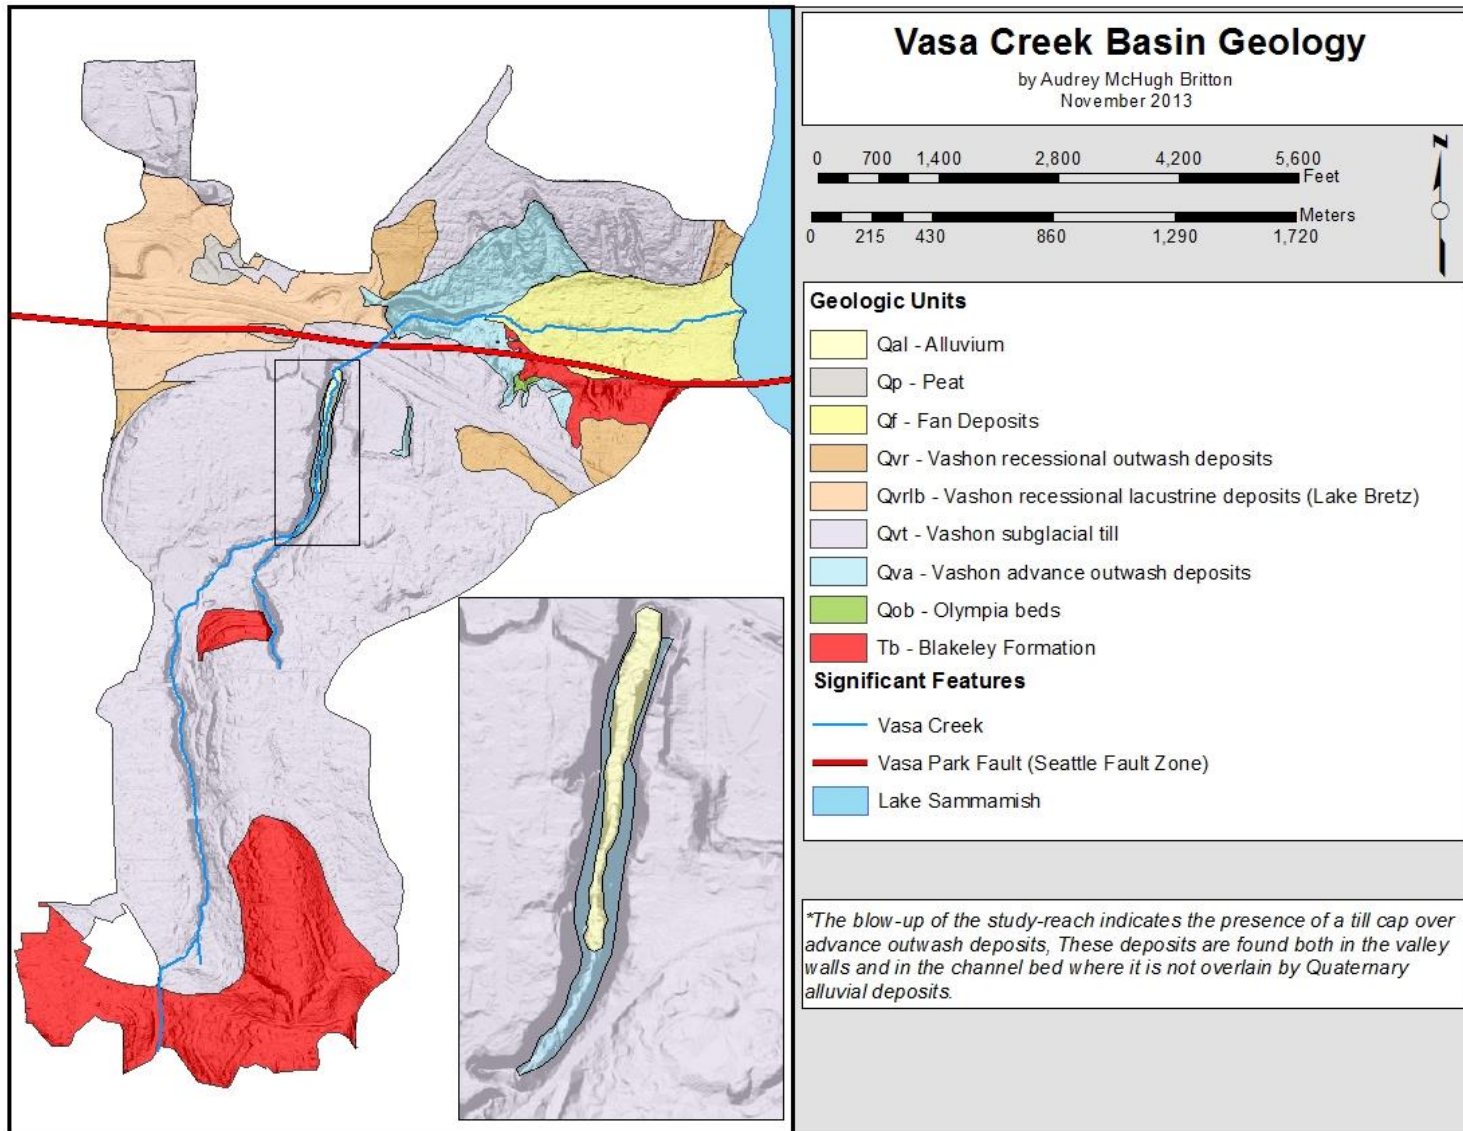
Borehole data provides, in most cases, detailed descriptions of the subsurface material. Though there were several inconsistencies between what was mapped and what borehole data said, most of these were minor changes in geologic contact locations (Figure 9). The geologic units that make up both the channel bed and slopes directly impact stream conditions. Since much of the area is defined as either Qvt or Qva, there is a significant input of gravel into the channel bed. According to my updated map Vasa Creek now flows through Tb, Qvt, Qva, Qal, briefly through Qvrlb, and finally through Qf before draining into Lake Sammamish.

**Figure 9.** Updated geologic map of the Vasa Creek Watershed. Field observations and borehole data provided the information necessary to alter the previous map.

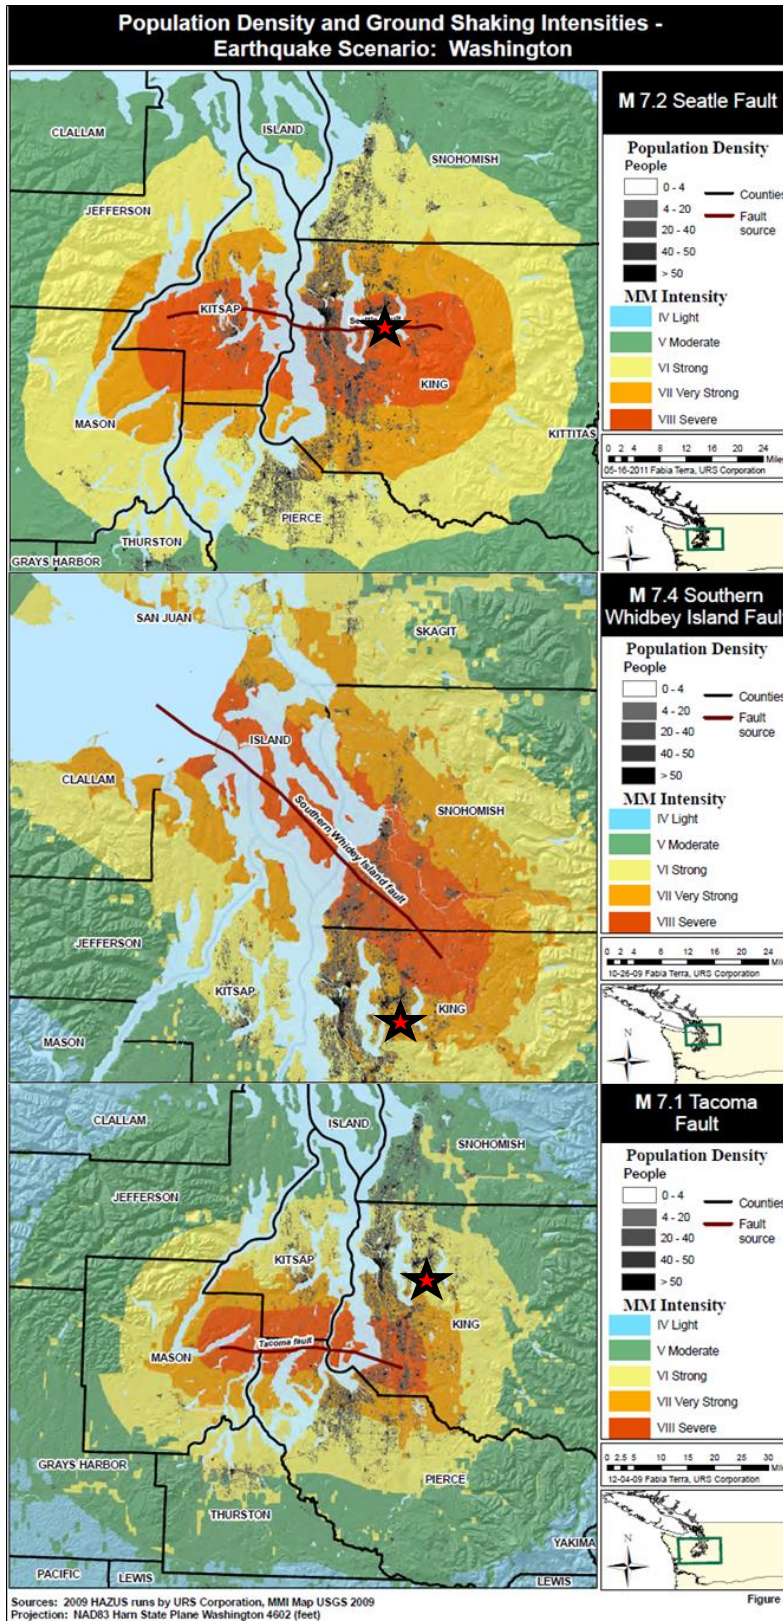
According to the maps based off of probabilistic seismic hazard analysis by the US Geological Society, in the event of an earthquake triggered by the SFZ, my project area would incur violent shaking (Figure 10). However, there are several other major fault systems that may also induce

**Figure 10.** HAZUS maps created by FEMA to display ground shaking intensities. Location of the Vasa Creek Watershed is indicated with a star. This information can be found in the Washington State Seismic Hazards Catalog.

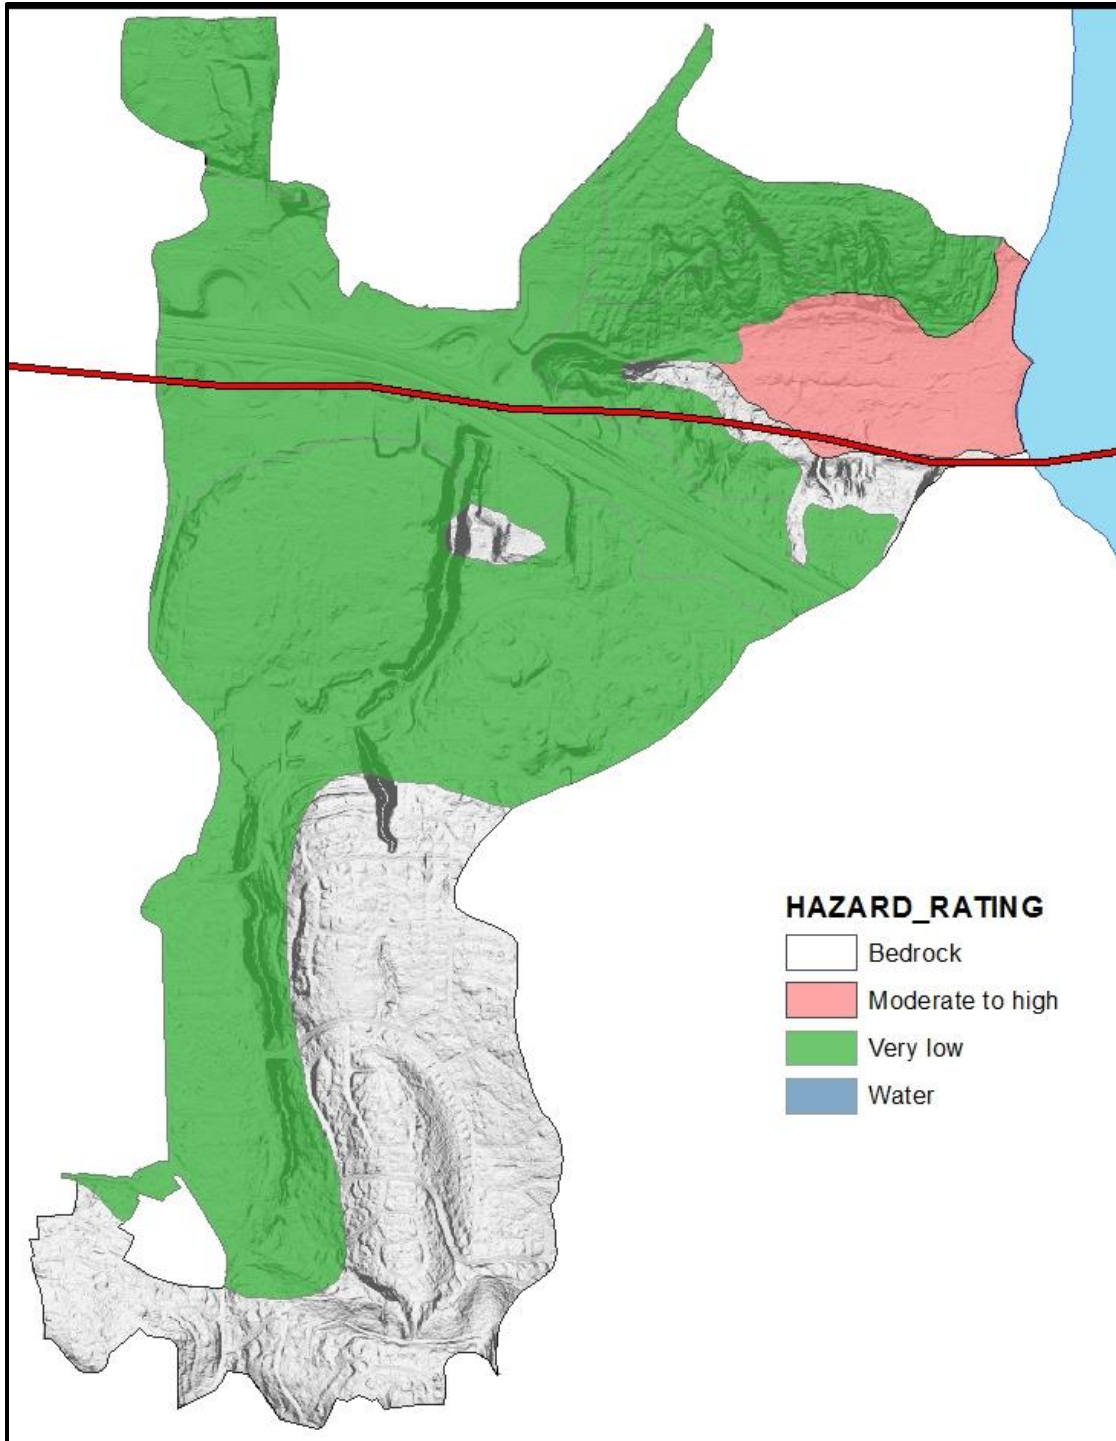
earthquakes affecting the site. These include the Whidbey Island Fault (WIF), Tacoma Fault (TF), and the Cascadia Fault (CF). An earthquake induced by WIF would produce very strong shaking and TF and CF would produce strong shaking. As a result, certain areas may be susceptible to liquefaction. These areas have been mapped by King County (Figure 11).

**Figure 11.** Liquefaction hazard map. The lower reach of Vasa Creek is most susceptible to liquefaction as it is within an alluvial fan deposit. Data provided by King County.

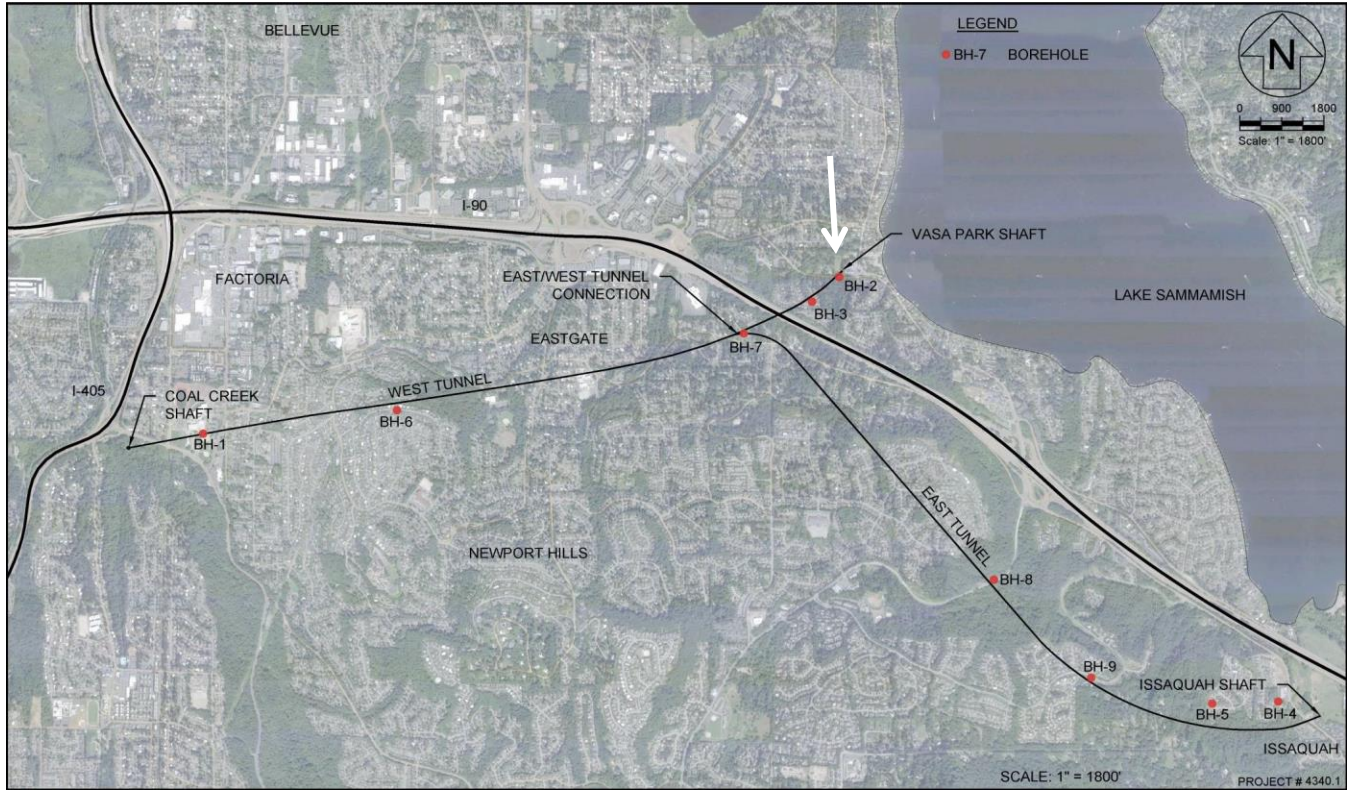
In a recent study completed by Sue Bednarz and Jacobs Associates in early August 2013, evidence of faulting near Vasa Creek was presented. Boreholes were drilled and sampled along a proposed wastewater tunnel location in Bellevue (Figure 12). The borehole labeled BH-2 is located within Vasa Park. At approximately 44ft below the ground surface, they discovered a completely weathered shear zone (Figure 13). The location of BH-2 is along the projected location of the VPF within the SFZ. According to Brian Sherrod (2002), the most recent earthquake event (16,000-4,500ya) created vertical offsets of approximately 6.5ft and horizontal offsets of 12ft along the VPF.

**Figure 12.** Borehole locations of Sue Bednarz’s west tunnel study. Borehole 2 (BH-2) is located in Vasa Park and its sample provided evidence of the Vasa Park Fault.

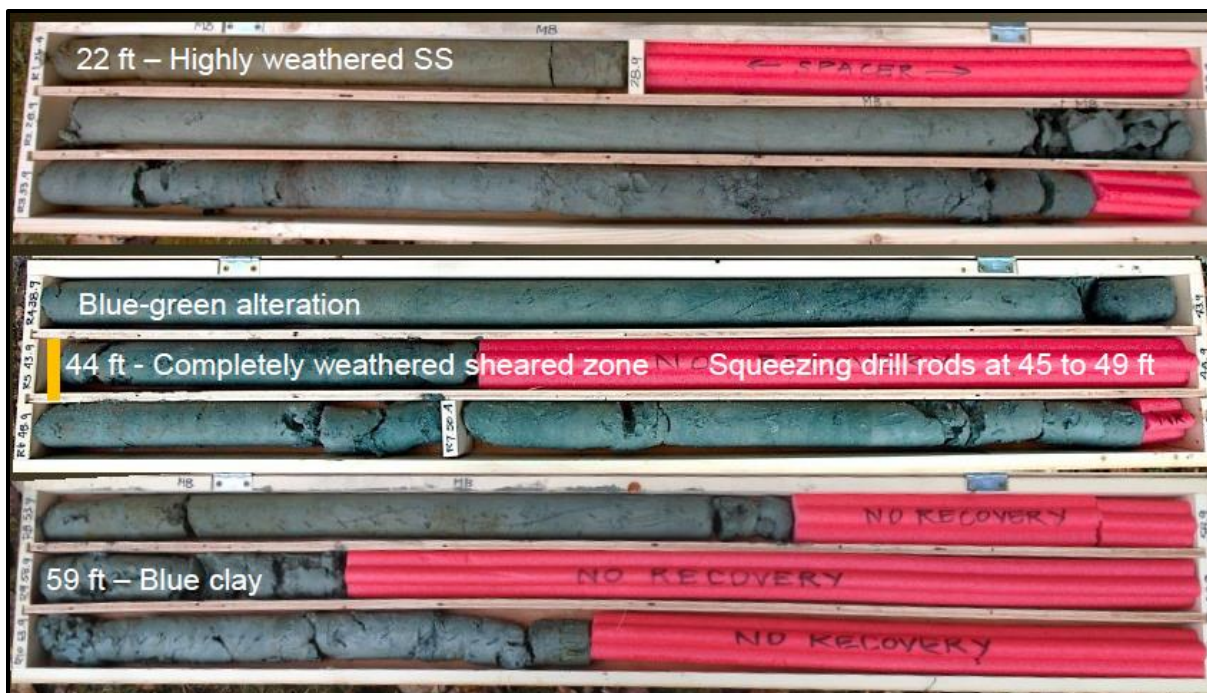
Figure 13. Photograph of the borehole sample collected at BH-2. Image from Sue Bednarz.

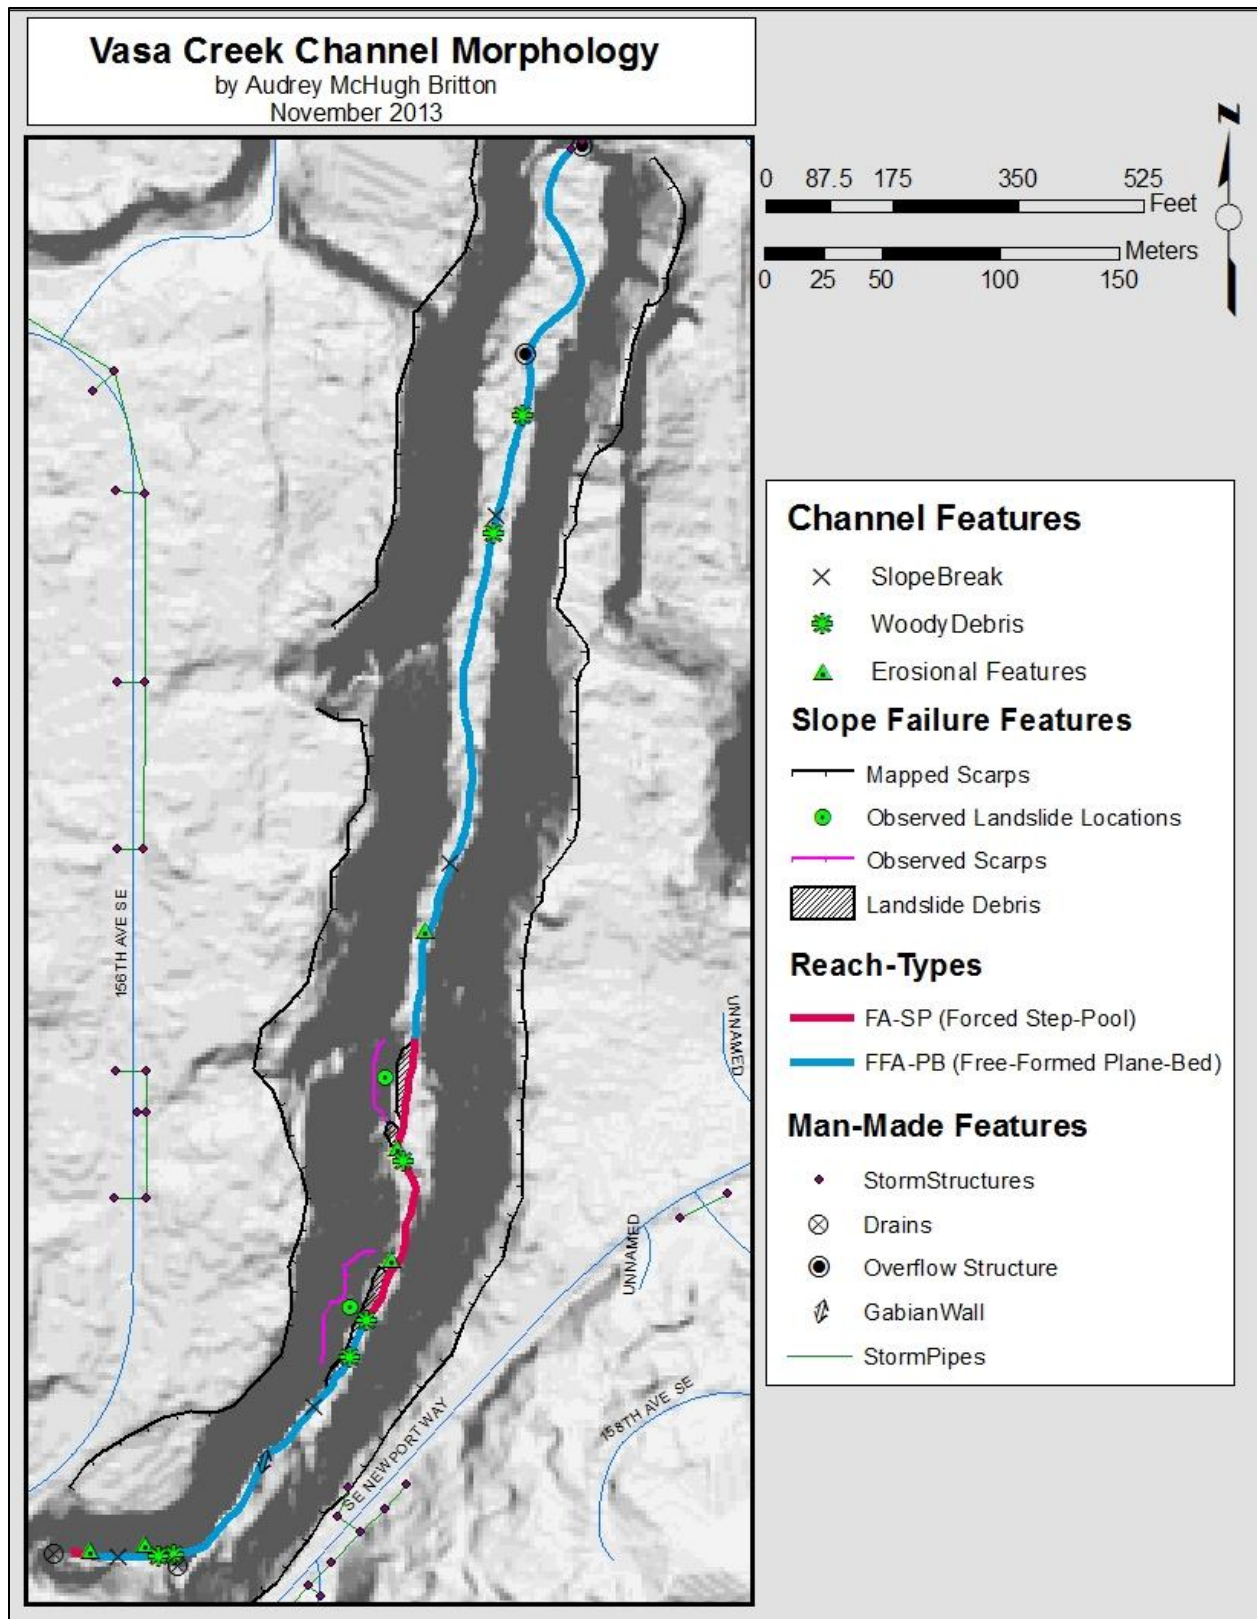
Within the free-formed step-pool reach, the walls expose glacial till. Qvt is also exposed near the top above Qva where the landslide scarps are located. Qva is also exposed in erosional features along the base of the slope. All exposures occur along the west side of the stream and are indicated on the resulting channel morphology map (Figure 25).

**Figure 25.** Channel morphology map of the Vasa Creek study-reach. Unoriginal data provided by the City of Bellevue and Kathy Troost.
