OBSERVATIONS OF JOINTS
PRESENT IN THE LAWTON CLAY MEMBER OF THE VASHON STADE,
EXPOSED AT A COASTAL BLUFF IN DISCOVERY PARK, SEATTLE, WASHINGTON

Amanda Dovich Ong

MASTERS OF EARTH AND SPACE SCIENCES: APPLIED GEOSCIENCES

UNIVERSITY OF WASHINGTON

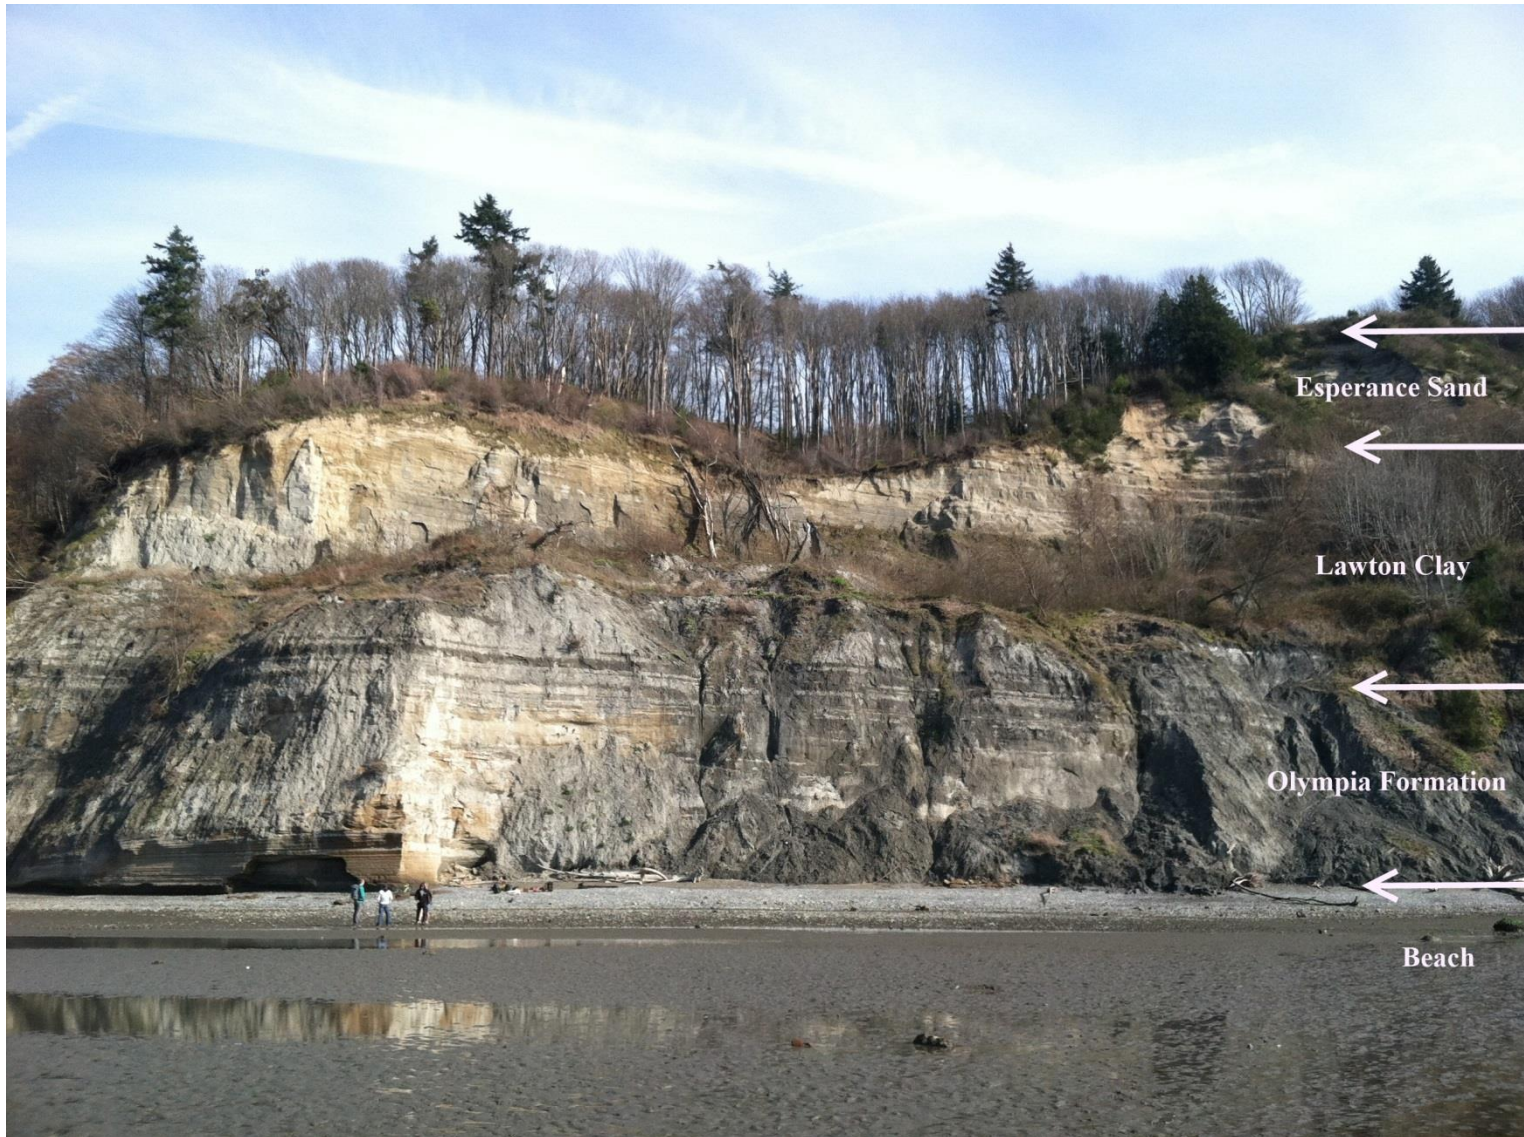
Figure 4: Photo from 3/6/2015, marking out unit locations on the bluff.

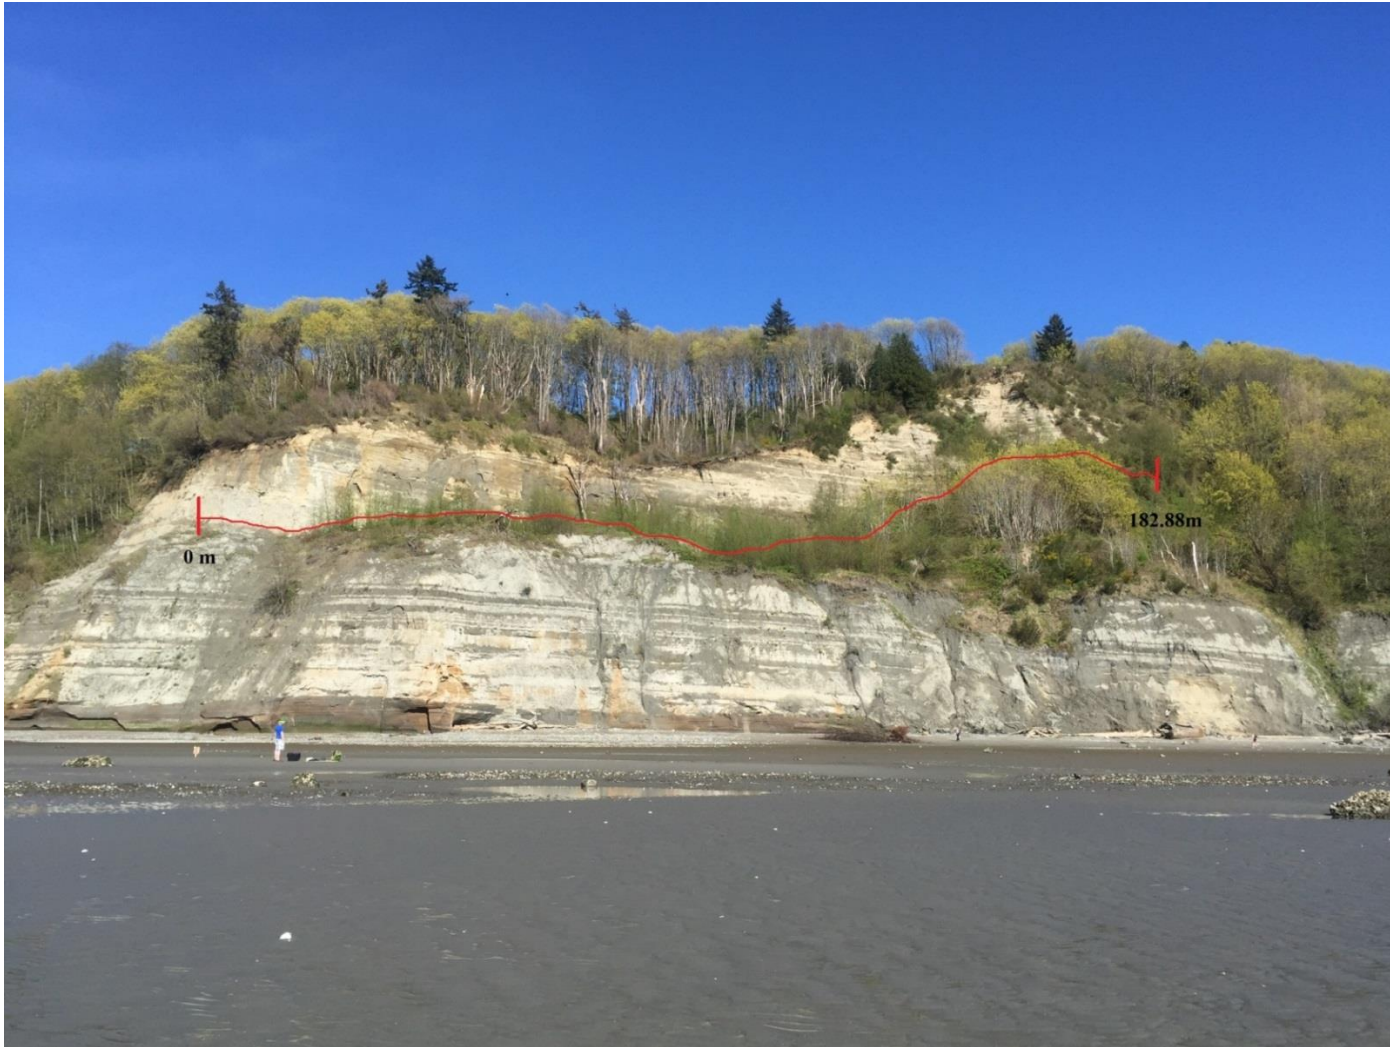
Figure 12: Beach view of bluff, with red line marking approximate path of tape measure, from 0m to 182.88m.

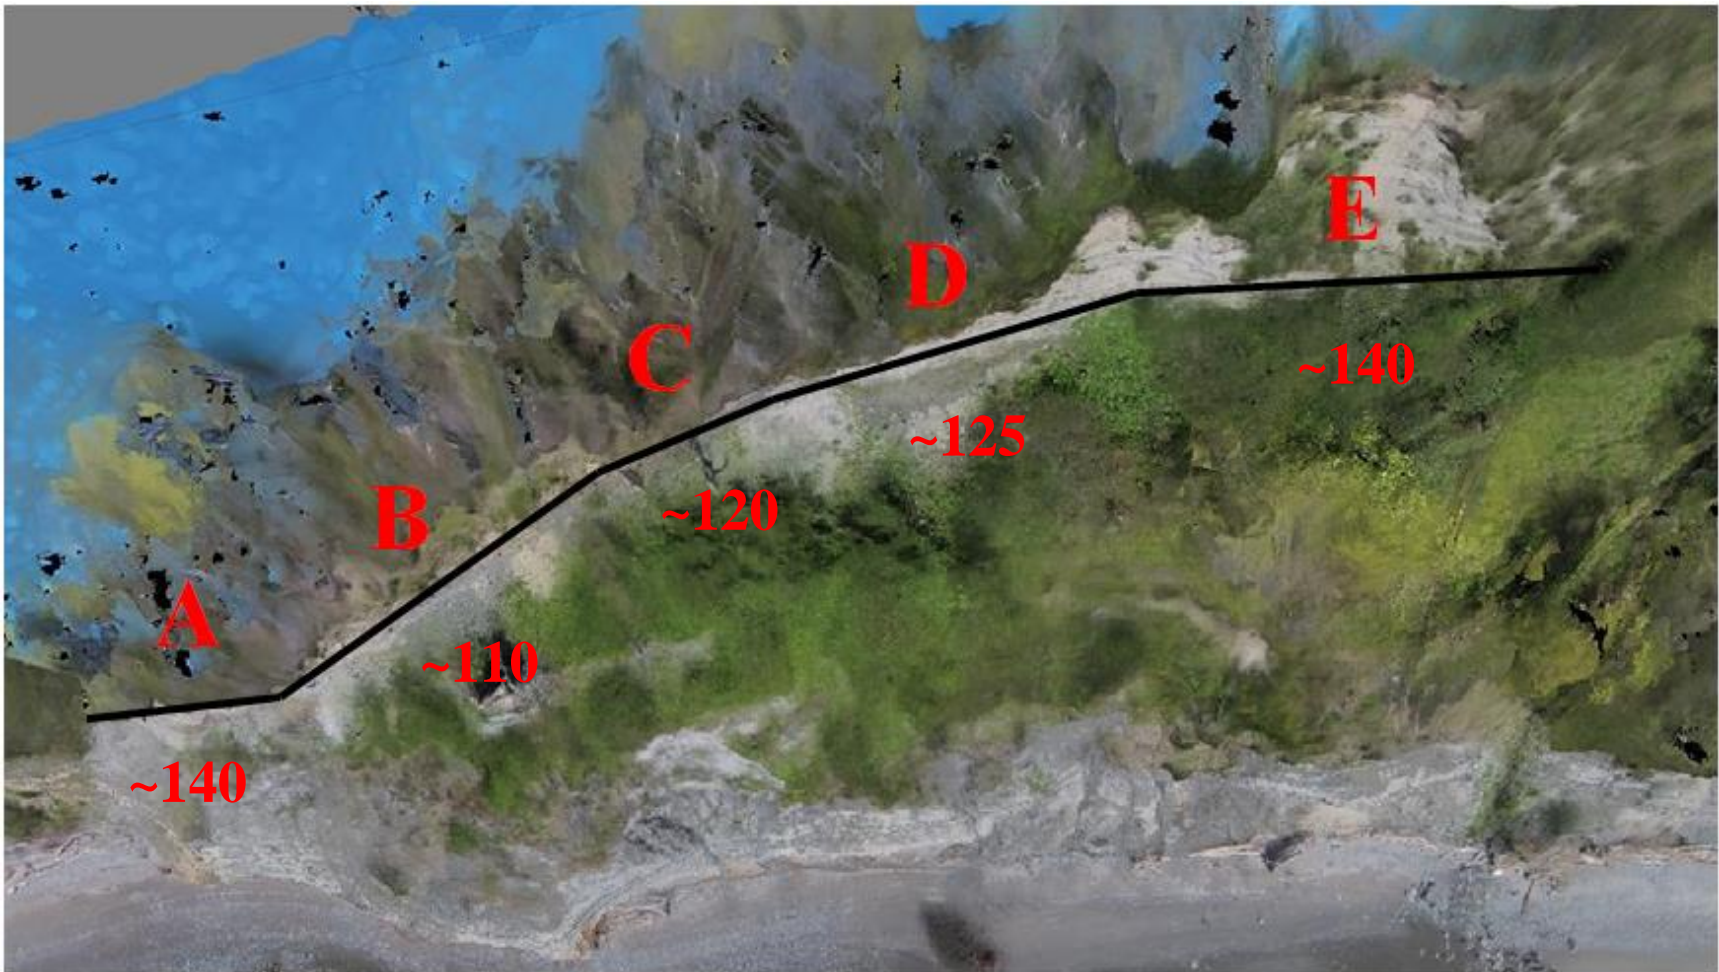
Figure 19 is identical to Figure 15 except where each domain is annotated with the approximate bluff strike for that domain.

Figure 19: Oblique view of SfM model showing corresponding bluff angles at marked domains.

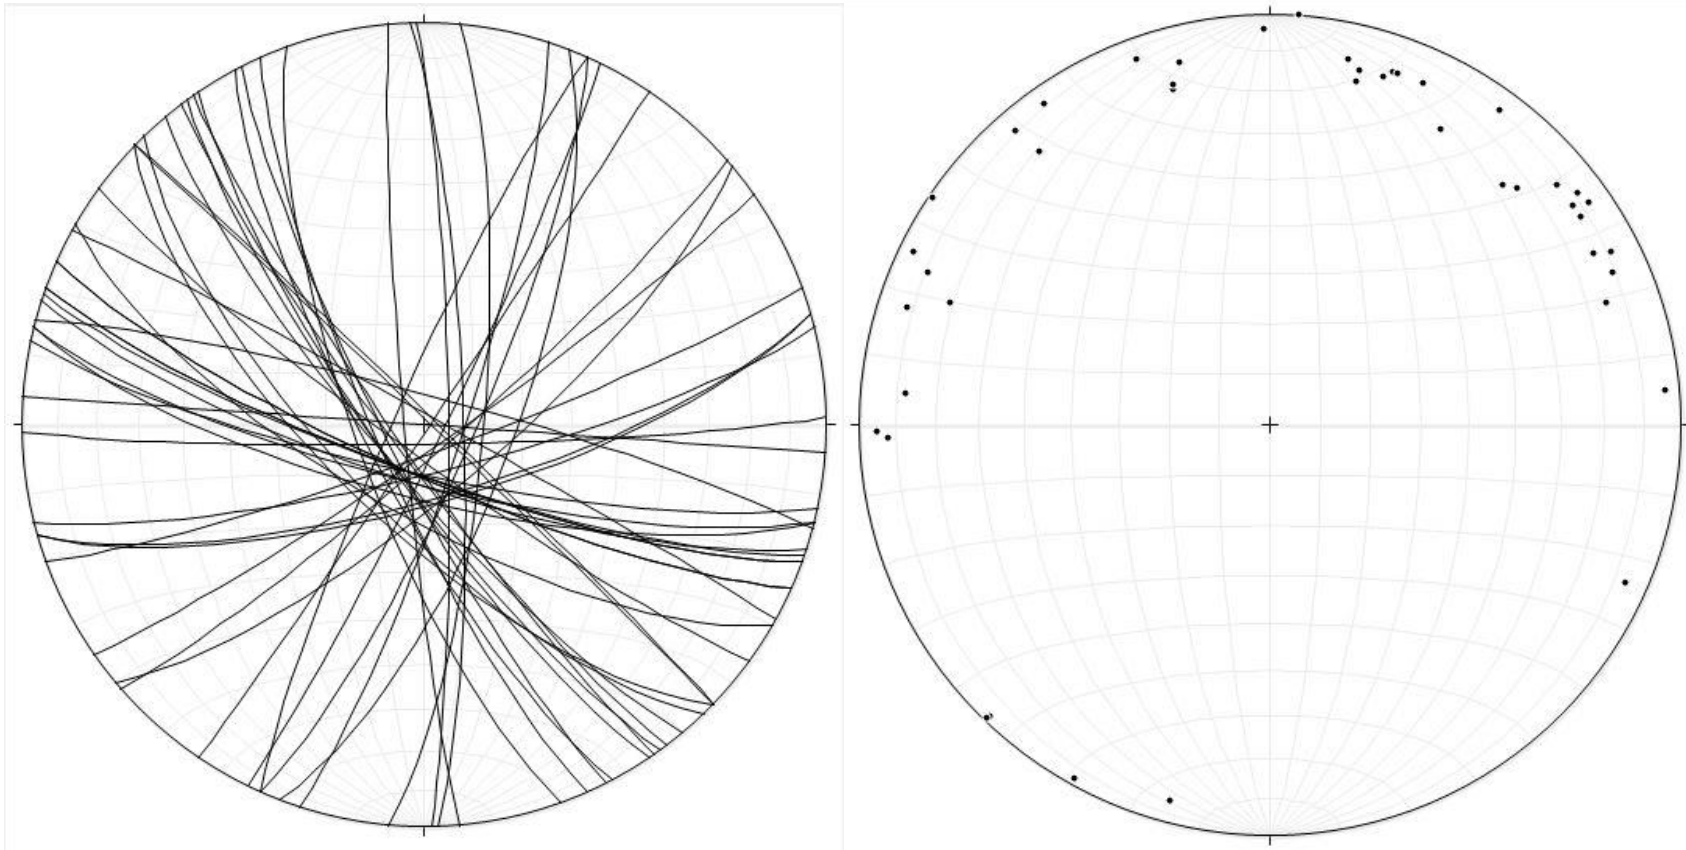
Forty-five joints were measured in all, with the majority of them clustered at the far northwestern end of the bluff in Domain A. Figure 20a shows a completed stereonet with all 45 joints plotted, and Figure 20b, a plot of all the poles to the plane, shows nearly a full-180 spread of strike orientations.

Figure 20a (left): Stereonet plot showing planes for all 45 joints measured.
Figure 20b (right): Stereonet plot showing poles to the measured joint planes.

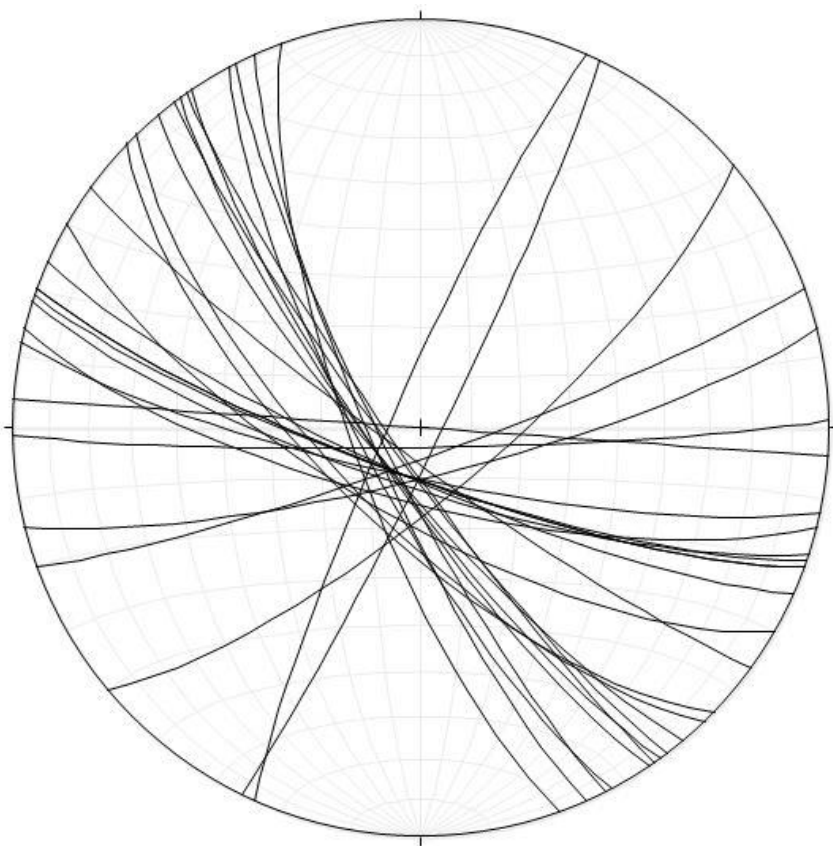
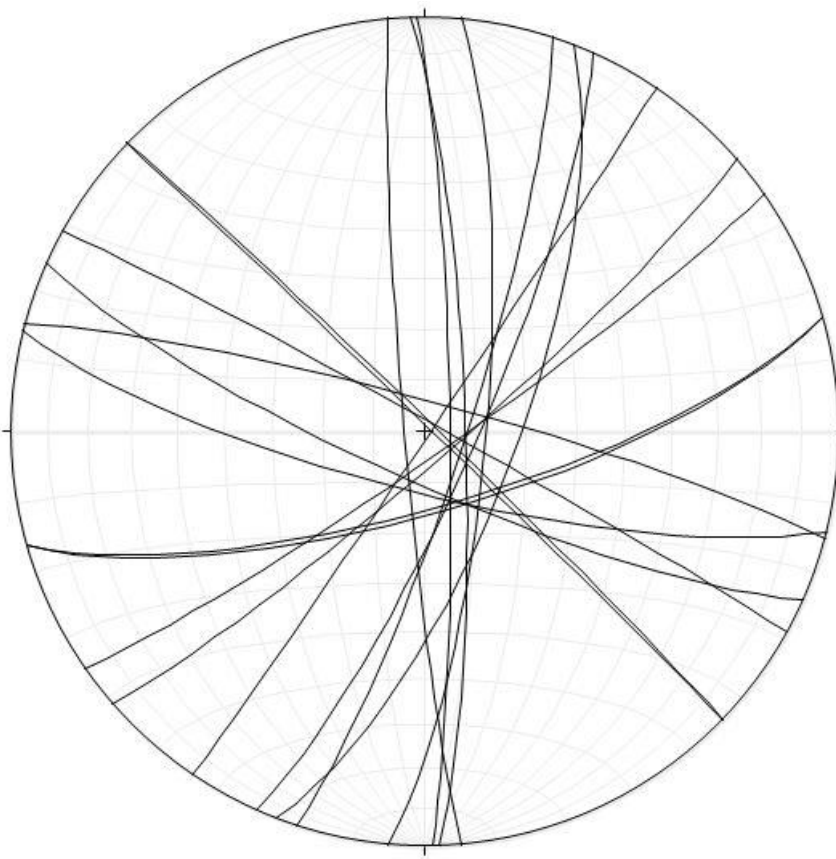
As observed in the field, the joints had two major orientations relative to the orientation of the bluff surface; joints that were roughly parallel to the local strike of the bluff face (Figure 21a) and joints that were roughly perpendicular to the strike of the bluff face (Figure 21b). Joints designated “parallel” mostly strike 100 – 160 degrees. The “perpendicular” fractures show a broad distribution with no clear common strike orientation (Figure 21b), which corresponds to field observations of their relative irregularity. Due to the fact that the perpendicular/parallel determination of joint orientations were taken relative to the local strike of the bluff at which the joint was measured, some of the parallel joints in Figure 21a do not fall within the average strike of the bluff within each domain where the majority of the other joints lie. The field determination of “parallel” vs. “perpendicular” was entirely dependent on the local variation in the bluff; I noted certain joints as “parallel” if my visual assessment of the joint plane relative to the localized block from which I was measuring it was approximately parallel, but this sometimes meant that those joints might not have been parallel to the bluff in a broader view. The determination of “perpendicular” joints was likewise, but I categorized “perpendicular” joints as any joint that was not definitively parallel to the bluff. All of the dips measured were high-angle, varying between 70 – 90 degrees with a calculated average of 80°.

Figure 21a (left): Stereonet plot showing only that appeared in the field to be parallel to the local bluff orientation.
Figure 21b (right): Stereonet plot showing only joints that appeared in the field to be perpendicular to the local bluff orientation.

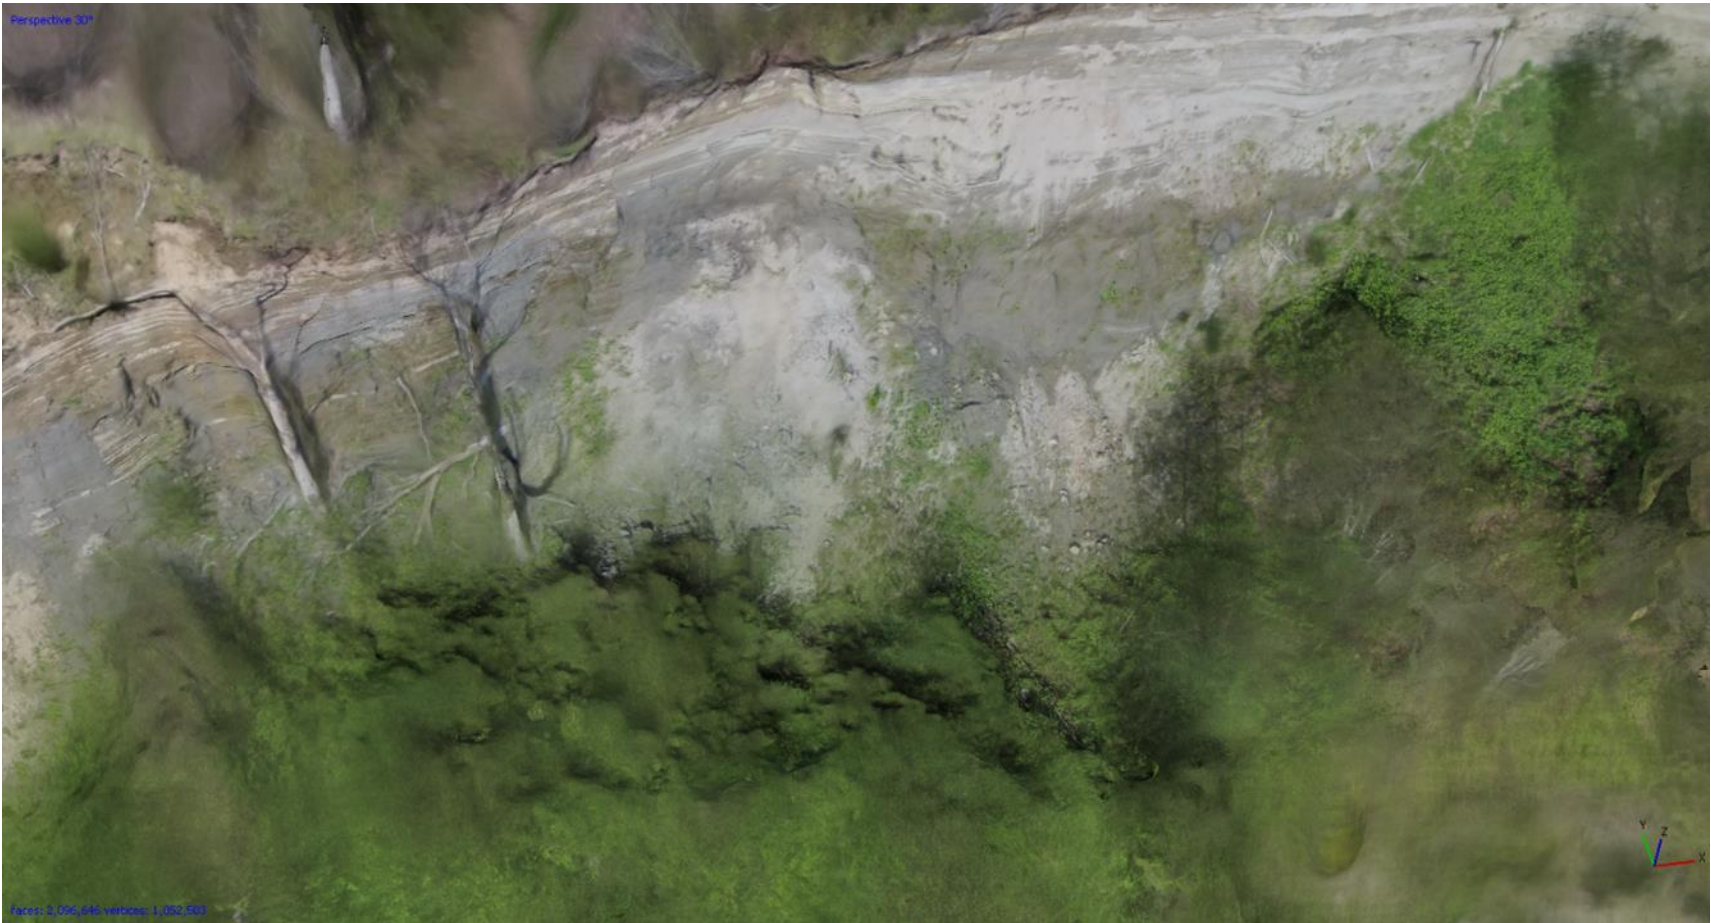
Close-up view of SfM model showing distinct shadows and vegetation blurring.
