# I-82 Prosser Landslide Investigation Benton City, WA

## **Technical Report**

**Re: Prosser Landslide site MP 91.9, I-82, Benton City, WA**

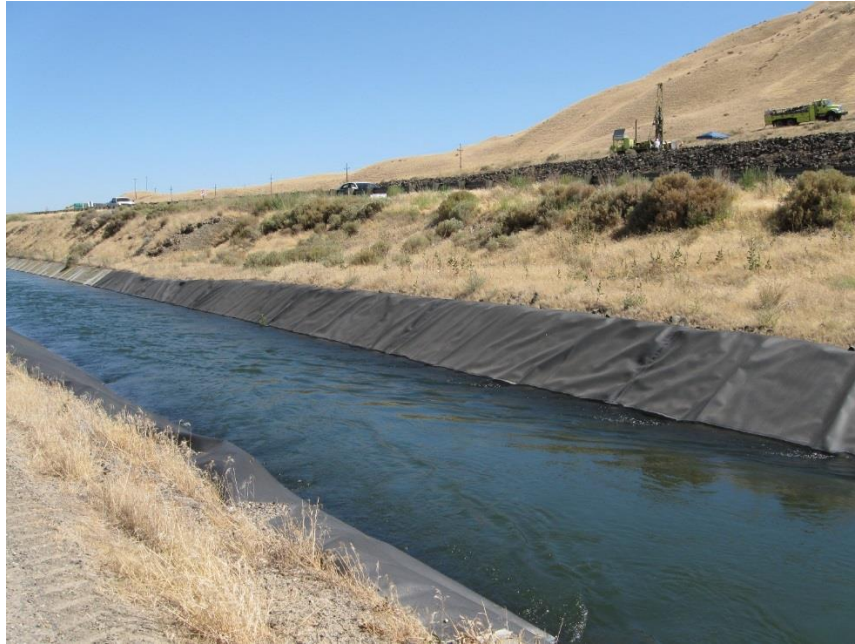
Figure 2: The KID Canal north of I-82 and the buttress. Cars on I-82 can be seen in the upper left of the photo. The shear-key buttress can be seen in the upper right with the WSDOT drilling crew during August 2013.

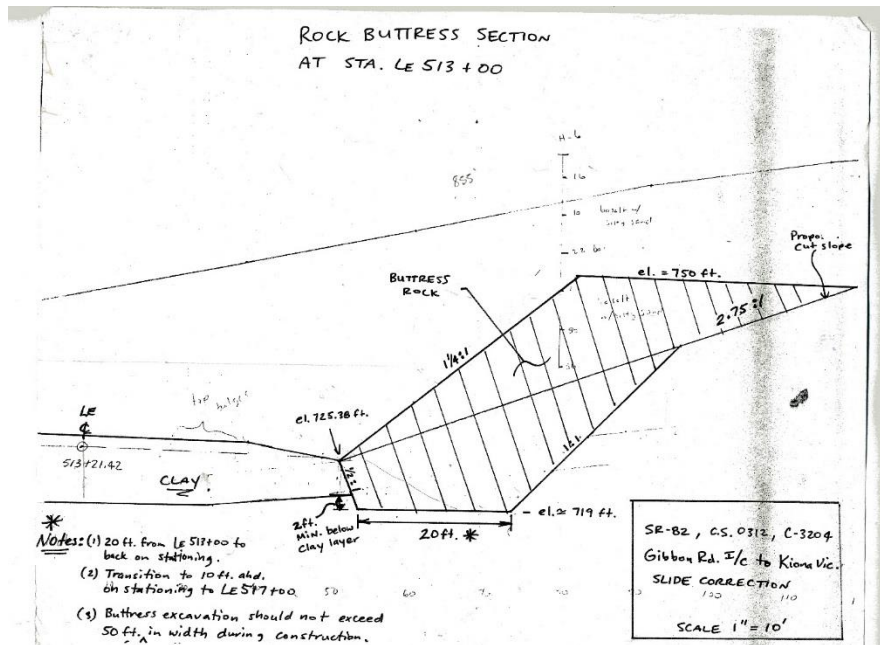
Figure 10: A scale drawing (originally 1 inch to 10 feet) of the butress as it was meant to be built on the west side of the project area. The clay unit depicted in the drawing was meant to be intercepted by the butress key in order to arrest slope failure. The butress was designed by Todd Harrison of WSDOT. Image courtesy of WSDOT via the Washington State Archives.

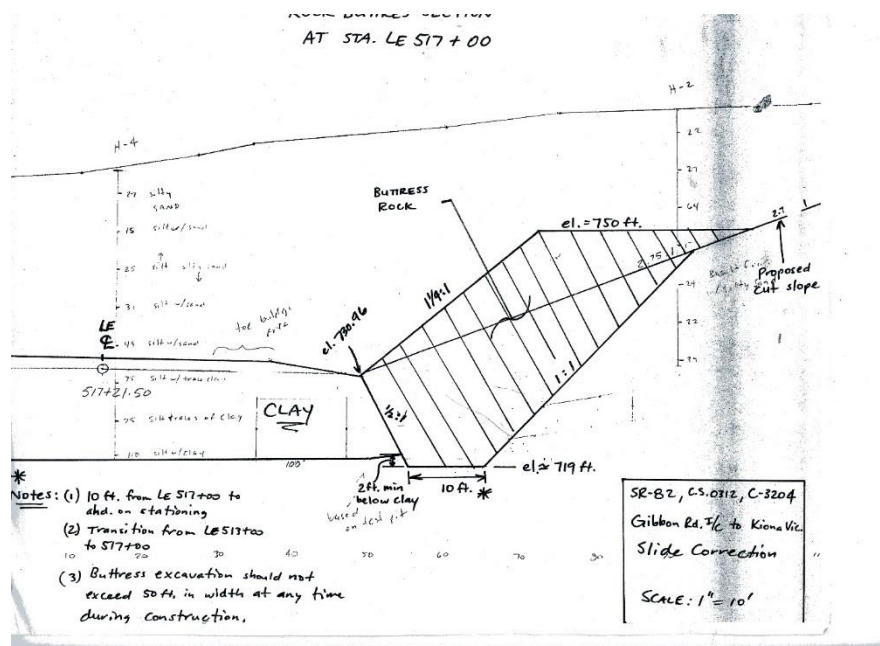
Figure 11: A scale drawing (originally 1 inch to 10 feet) of the butress as it was meant to be built on the east side of the project area. The clay unit depicted in the drawing was meant to be intercepted by the butress key in order to arrest slope failure. The butress was designed by Todd Harrison of WSDOT. Image courtesy of WSDOT via the Washington State Archives.

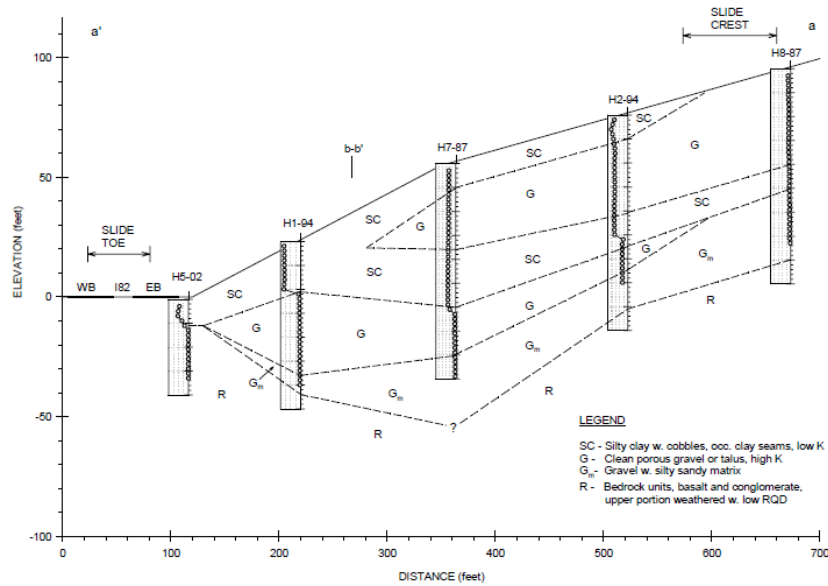
I developed two different slope failure scenarios based on previous modeling conducted in 1987 and 2004. The first model scenario described in the section is of a large landslide initiating at an elevation of about 900 feet similar to modeling conducted by Doug Anderson, and based on observations of tension cracks observed in 1987 and inclinometer data in the C-Core (2006) report and available from WSDOT. Inclinometer data indicate slope failure upslope of W Yakitat road (Figure 15).

Figure 15: C-Core’s cross section which was eventually used in both their limit equilibrium modeling and the finite element modeling. Absolute elevations are not given by C-Core and the buttress has not been incorporated into their model. Slope inclinometer data is superimposed on each borehole. There is a 2:1 vertical exaggeration of the image. From C-Core 2006 Figure 2.

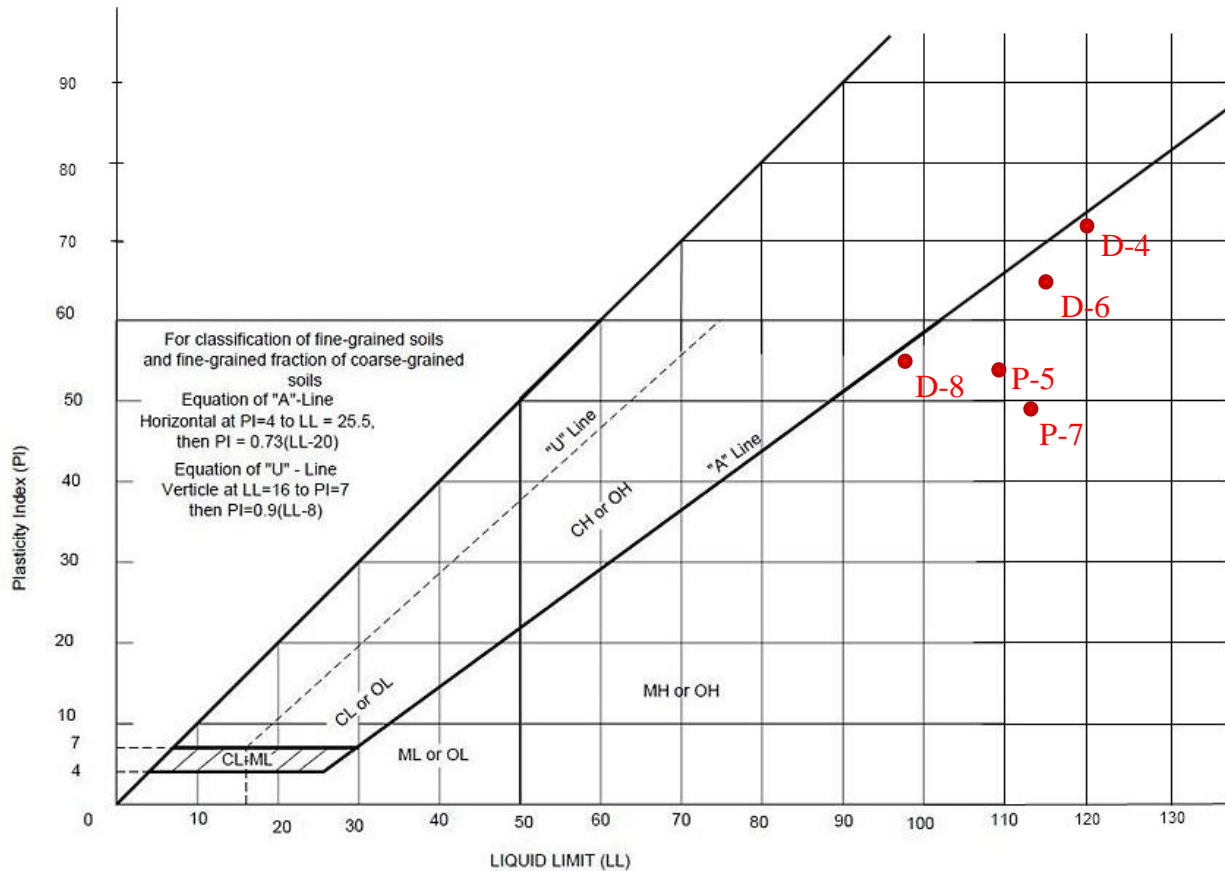
Figure 23: A modified Atterberg limits chart from ASTM D2487 – 11 showing recent materials testing results of samples retrieved from the Prosser Landslide in 2013 by WSDOT. The limits of the chart have been extended to accommodate the high liquid limits and plasticity indices of the sample. Despite having very high liquid limits, the soils fall into the elastic silt (MH) field. Sample labels correspond to samples reported in Appendix B.

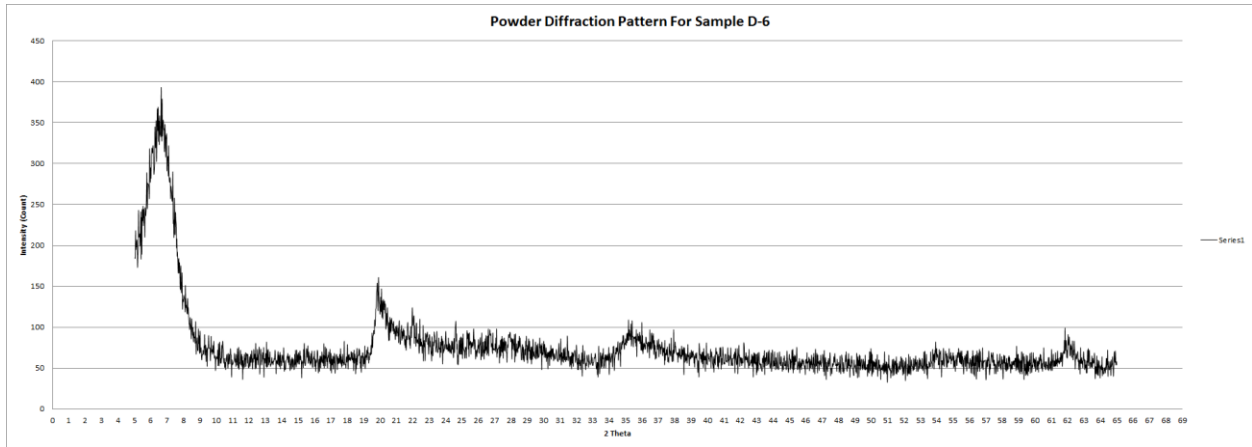
Major peaks from the powder diffraction pattern appear at between 6° and 7° 2 $\theta$ , 20° 2 $\theta$ , 35° 2 $\theta$ , and 62° 2 $\theta$  (Figure 24).

Upon visual inspection, the powder diffraction sample taken from the Prosser Landslide shows several strong peaks that are correlative to smectite-group clays (Figure 24). A strong visual correlation between the measured sample and illite-1M, saponite, nontronite, and montmorillonite can be seen in the sample. Given that smectite-species clays and illite are related (Moore and Reynolds, 1989; Selley, Cocks, and Pliner, 2005), this perhaps is not surprising. Of the 4 clay minerals mentioned, illite and montmorillonite had the strongest matches for major peaks, especially the high  $2\theta$  peak at  $62\ 2\theta$ .

Figure 24: The powder XRD peak distribution pattern for the D-6 sample taken from borehole H-101vwp-13. The first low angle peak is between  $6^{\circ}$  and  $7^{\circ}$   $2\theta$ , followed by peaks at  $20^{\circ}$   $2\theta$  and  $35^{\circ}$   $2\theta$ . Finally, there is a high angle peak at  $62^{\circ}$   $2\theta$ .

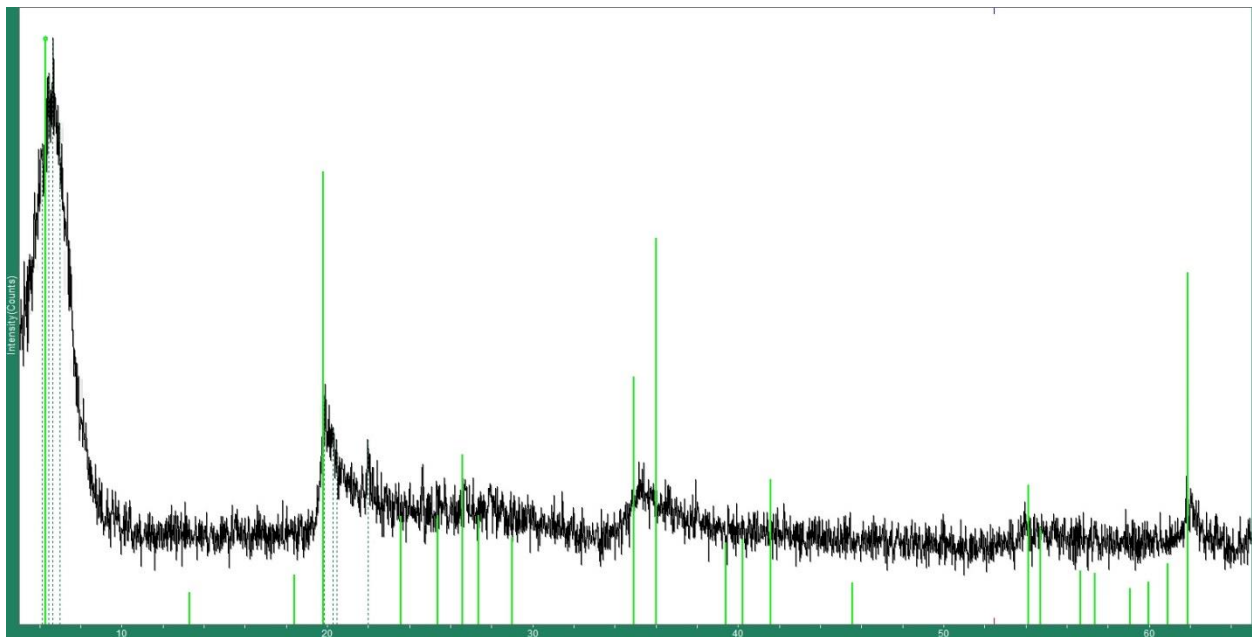
MDI Jade also allows for visual matching of peaks. Visual matches of peaks can be found in Appendix C: X-Ray Diffraction Mineralogy. Closest visual matches appear to be montmorillonite (Figure 25), saponite (Appendix C, Figure C.2), and illite-1M (Appendix C, Figure C.4). Significantly, the upper 2θ angle between the Sample D-6 and montmorillonite (Figure 25) are a close visual match.

Figure 25: Major and minor peaks from Montmorillonite PDF 00-060-0318 are superimposed on the powder sample peak pattern. Matches with major peaks, such as the low angle  $2\theta$  peak can be made. Image exported from MDI Jade.

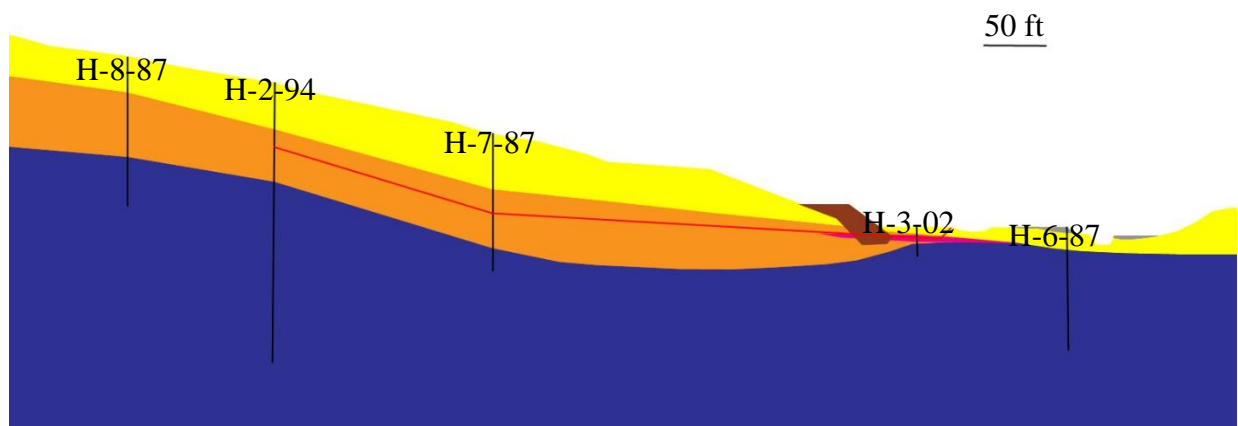
Even if the clays were able to swell and cause heave in the road, it appears unlikely that the shear key could act as a reservoir. The quarry spalls from which the buttress is made has a high porosity, as it is basalt rip rap. That porosity could provide space where water could pool. However, this would require that the water be able to stay within the key. This appears unlikely given the several drillers' accounts of being unable to keep water in the drill throughout drilling through the gravels at the site (Appendix: A). Drillers noted a water level at a depth 66 feet in H-101vwp-13. In 2002, drillers noted a water level of 24 feet in borehole H-5b-02 (same location as H-5b-02) which was drilled at the same elevation as the road surface of I-82 at the bottom of the shear key buttress. Silty clay in the same area below the road is seen from approximately 5 to 10 feet below the roadbed for about 5 feet (C-Core, 2006 Annex A) (Figure 13). Assuming some connection between the standing water elevations of H-101vwp-13 and H-5b-02, any saturated material is below the buttress key in the fractured basalt (Figure 27). Therefore, pooling in the buttress key seems unlikely.

Figure 27: A cross section of the Prosser Landslide on Section line A – A'. Yellow is the surface landslide debris. This cross section was made by interpolating between boreholes located near the section lines drawn in Figure 26. Orange is the gravels-with-matrix unit. Pink is the weak silty clay. Blue is basalt. Reddish brown is the buttress. Gray is artificial fill. Black vertical lines are boreholes. A red line defines a possible failure plane based on inclinometer data. Notice that the silty clay unit is likely quite small. No vertical exaggeration. I drew the original sections by hand then digitized them for clarity.

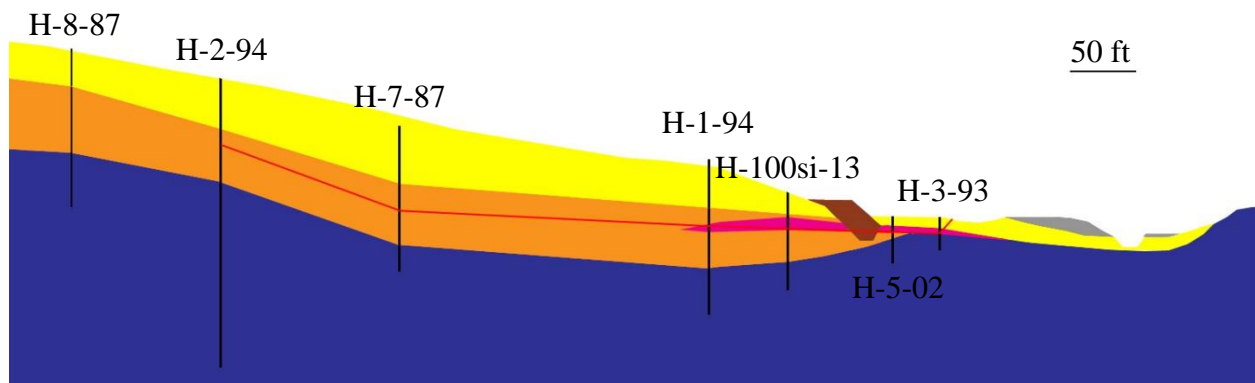
Figure 28: A cross section of the Prosser Landslide on Section line B – B'. This cross section was made by interpolating between boreholes located near the section lines drawn in Figure 26. Yellow is the surface landslide debris. Orange is the gravels-with-matrix unit. Pink is the weak silty clay. Blue is basalt. Reddish brown is the buttress. Gray is artificial fill. Black vertical lines are boreholes. A red line defines a possible failure plane based on inclinometer data. Notice that the silty clay is much larger in this section than A – A'. No vertical exaggeration. I drew the original sections by hand then digitized them for clarity.

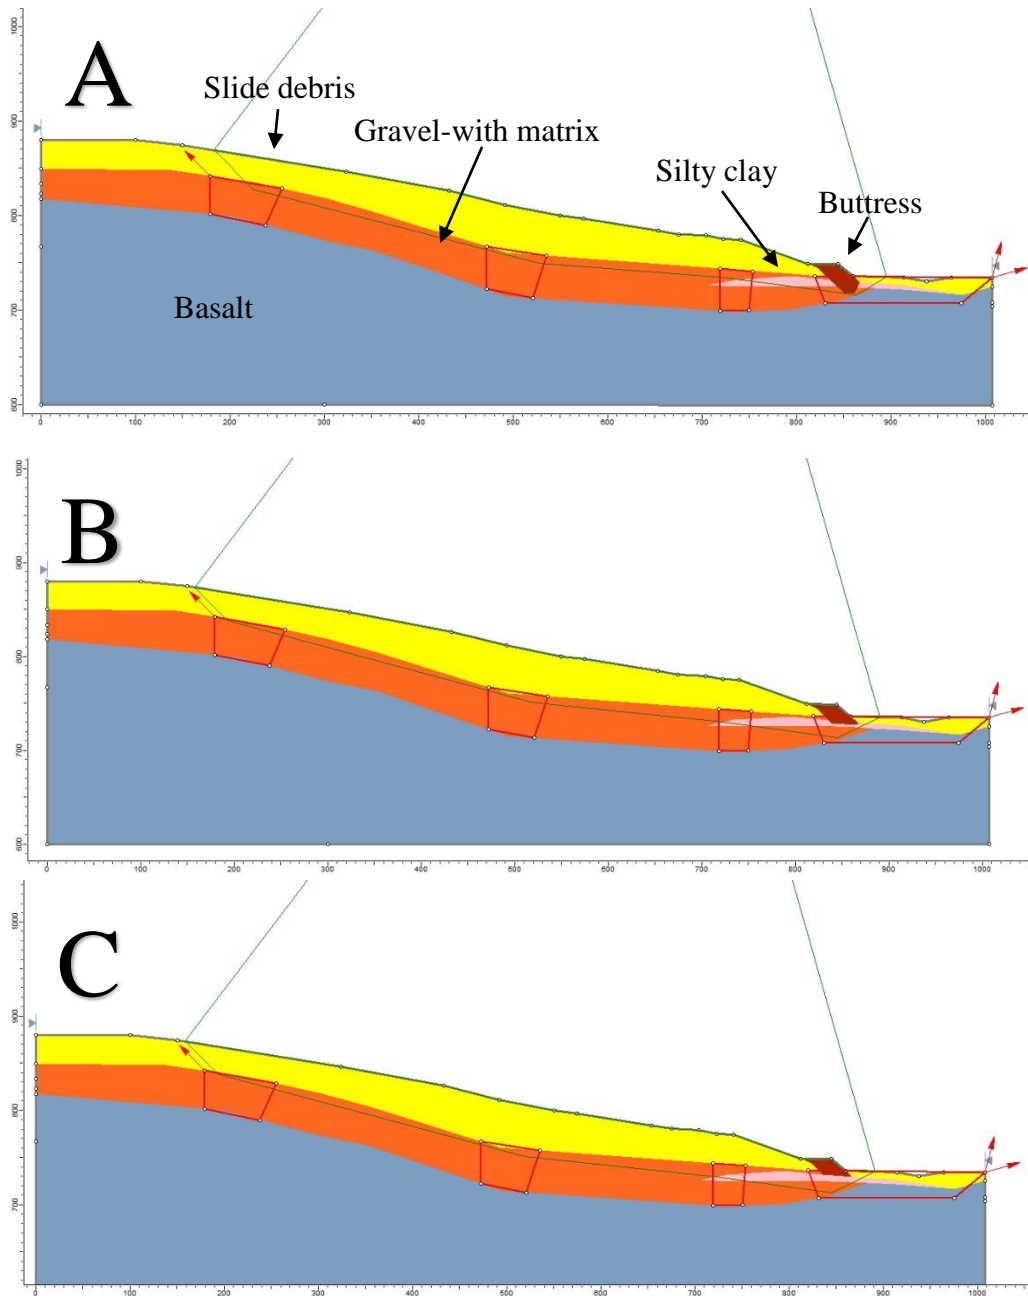
In cases where the Factor of Safety is below 1 and the buttress has a full key, the modeled slide plane avoids the buttress from underneath (Figure 29). In cases where the buttress is partially keyed or the key is absent, the modeled slide plane preferentially follows the clay unit. However, in nearly all scenarios, there did not appear to be a significant distinction between runs where the buttress was fully keyed and where the buttress was not.

Figure 29: Three images exported from Rocscience Slide showing the modeled failure plane (green line) for the large landslide scenario. The green lines ascending from the cross section point to the Factor of Safety associated with the modeled failure plane. The upper cloud of Factor of Safety points the lines point into has been cut off in order to show the cross section with better clarity. Yellow is the surface landslide debris. Orange is the gravels-with-matrix unit. Pink is the weak silty clay. Blue is basalt. Reddish brown is the buttness. The red boxes are the windows through which the software searches to find a viable failure plane. “A” depicts the large landslide with a fully keyed buttness. “B” depicts a buttness which is keyed halfway into the silty clay unit. “C” Depicts a buttness where the buttness key is absent and the buttness simply rests on top of the clay. The material properties for the units depicted here are the same as in the model run described by Appendix D: Table 1.

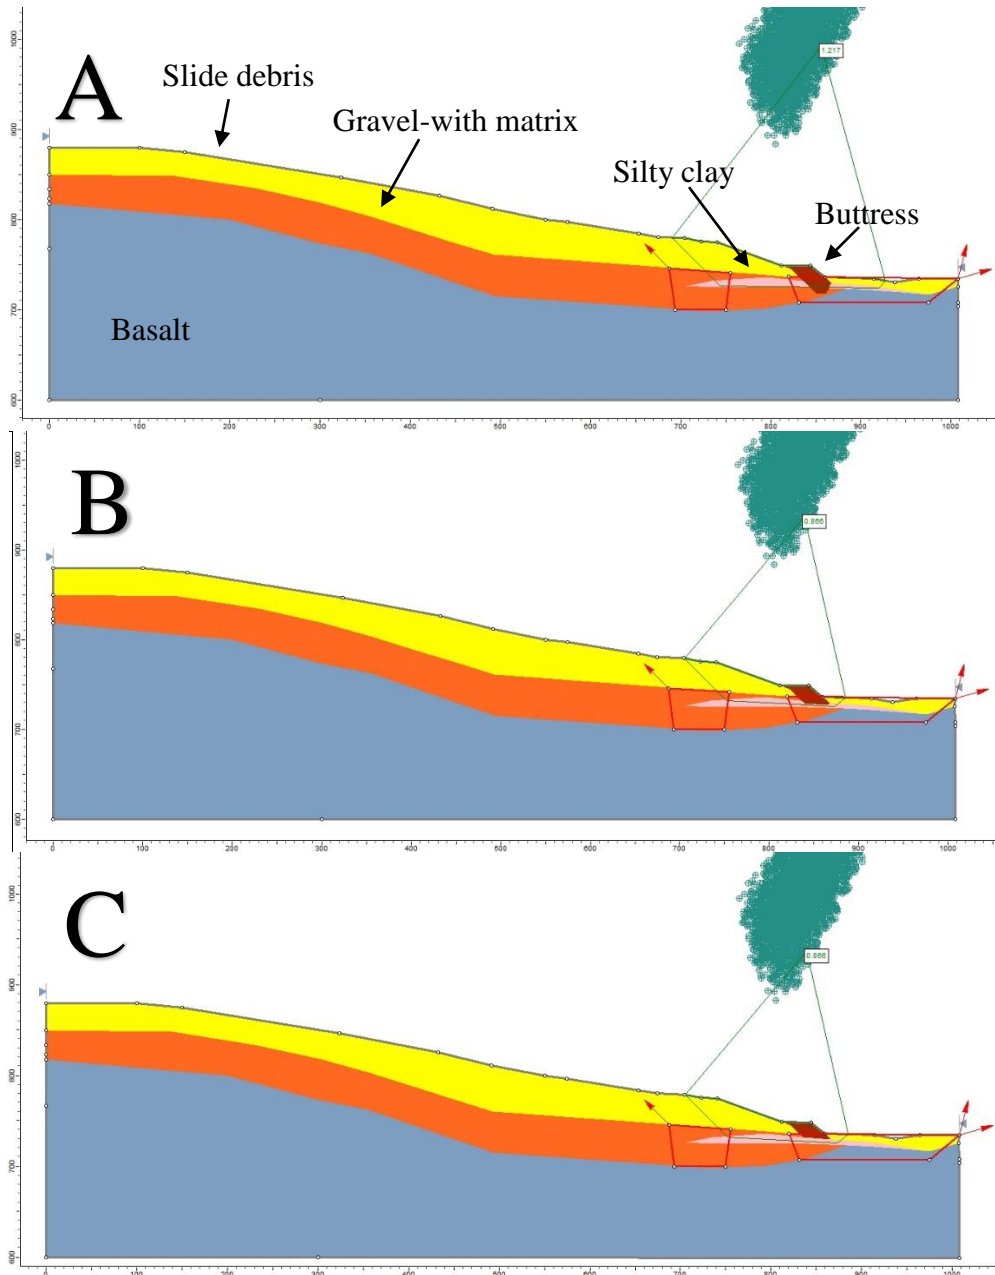
In scenarios where there is a partial or absent buttress key and the Factor of Safety is below 1, the failure plane created by the model (Figure 30) is plotted through where the buttress would be, following along the clay layer. In scenarios where there is a full buttress key and Factor of Safety is below 1, the slide plane circumvents the buttress from underneath. In all scenarios, the slide toe emerges in the eastbound lanes of I-82. In none of the scenarios modeled was it possible to fail the slide through the buttress or produce a toe in the median or the westbound lane.

Figure 30: Three images exported from Rocscience Slide showing the modeled failure plane (green line) for the small landslide scenario. The green lines ascending from the cross section point to the Factor of Safety associated with the modeled failure plane. The cloud of points is the Factors of Safety for the 5000 modeled failure planes. The upper cloud of Factor of Safety points the lines point into has been cut off in order to show the cross section with better clarity. Yellow is the surface landslide debris. Orange is the gravels-with-matrix unit. Pink is the weak silty clay. Blue is basalt. Reddish brown is the buttruss. The red boxes are the windows through which the software searches to find a viable failure plane. “A” depicts the large landslide with a fully keyed buttruss. “B” depicts a buttruss which is keyed halfway into the silty clay unit. “C” Depicts a buttruss where the buttruss key is absent and the buttruss simply rests on top of the clay. The material properties for the units depicted here are the same as in the model run described by Appendix D: Table 8.

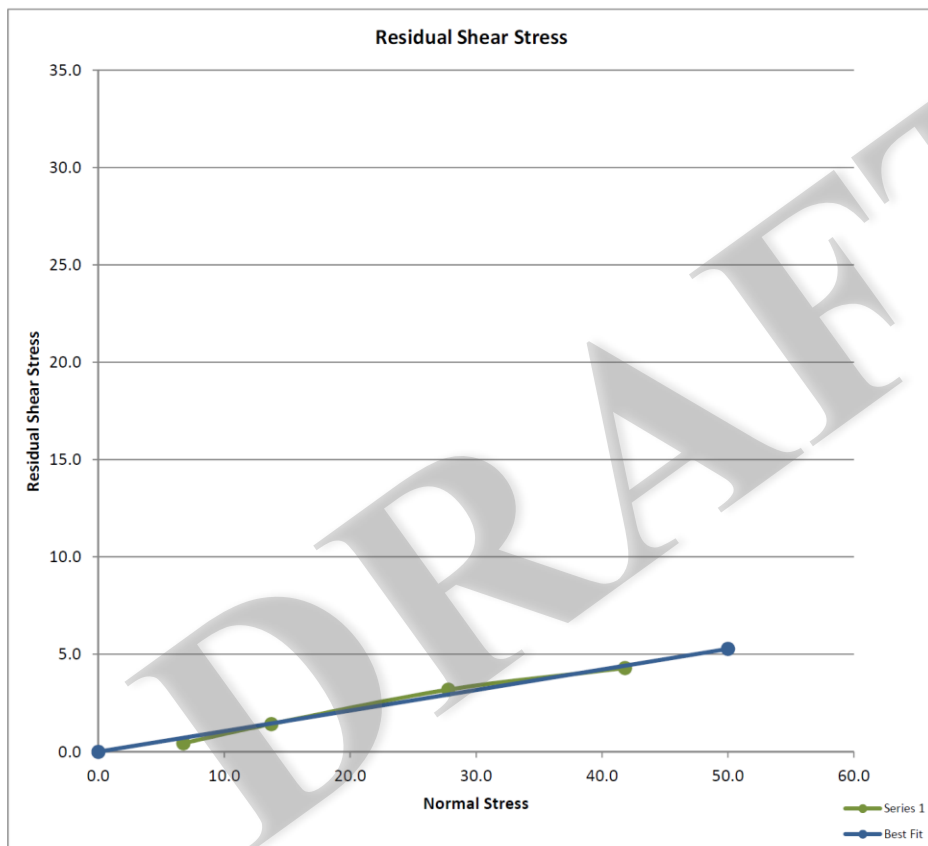
#### FINAL GRAPHS (3 of 3)

INITIAL	Specimen			
	A	B	C	D
Specimen Thickness (in)	0.200	0.200	0.200	0.200
Internal Ring Radius(in)	1.375	1.375	1.375	1.375
External Ring Radius(in)	1.970	1.970	1.970	1.970
Moisture Content (%)	69.0	69.0	69.0	69.0
SHEAR	A	B	C	D
Rate of Linear Displacement (in/min)	0.0007	0.0007	0.0007	0.0007
Rate of Angular Displacement (Deg/min)	0.0240	0.0240	0.0240	0.0240
Normal Stress (psi)	6.8	13.8	27.8	41.8
Residual Shear Stress (psi)	0.442	1.430	3.190	4.300
Linear Displacement (in)	0.063	0.168	0.126	0.134
Angular Displacement (Deg)	2.2	5.8	4.3	4.6
FINAL	A	B	C	D
Final Moisture Content (%)	76.0	76.0	76.0	76.0
Assumed Cohesion (psi)	0.0	0.0	0.0	0.0
Liquid limit	115.0	115.0	115.0	115.0
Plastic Limit	51.0	51.0	51.0	51.0
Plasticity Index	64.0	64.0	64.0	64.0
Specific Gravity	2.67	2.67	2.67	2.67
Angle of Residual Shear Resistance (Deg)	<b>6.0</b>

COMMENT/REMARKS			
Tested at in-situ moisture - 69%			
Tested By	LHB/SW	Date	10/31/2013
Checked By	RDG	Date	11/1/2013

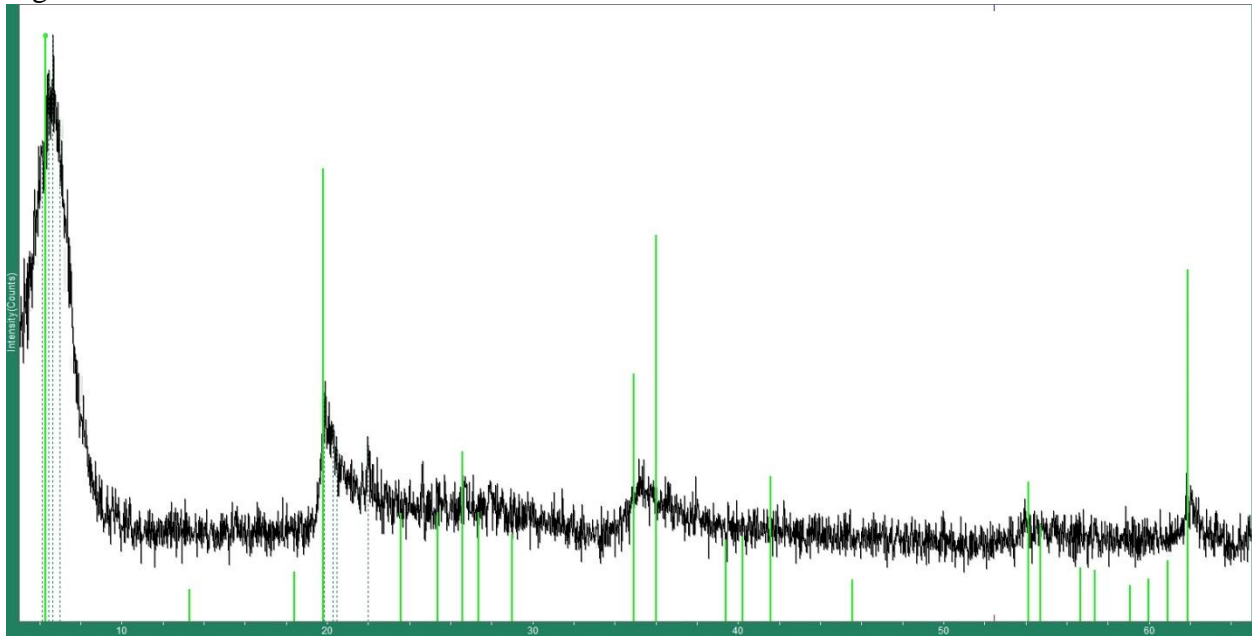
Figure C.1 - Montmorillonite

According to Reynolds and Moore (1989) montmorillonite (air-dried, non-solvated) has major peaks at between  $4^\circ$  and  $6^\circ$   $2\theta$ , at around  $18^\circ$   $2\theta$  and between  $62.22^\circ$  and  $61.67^\circ$   $2\theta$ . The green peak pattern given by PDF 00-060-0318 shows good correlation at the  $20^\circ$   $2\theta$  peak, peaks near  $35^\circ$   $2\theta$ , and the peak at  $62^\circ$   $2\theta$ . MDI Jade calculated that the large, low angle peak at between  $6^\circ$  and  $7^\circ$   $2\theta$  as statistically being a 100% match to montmorillonite. MDI Jade also calculated a 77% match on the  $20^\circ$   $2\theta$  peak.

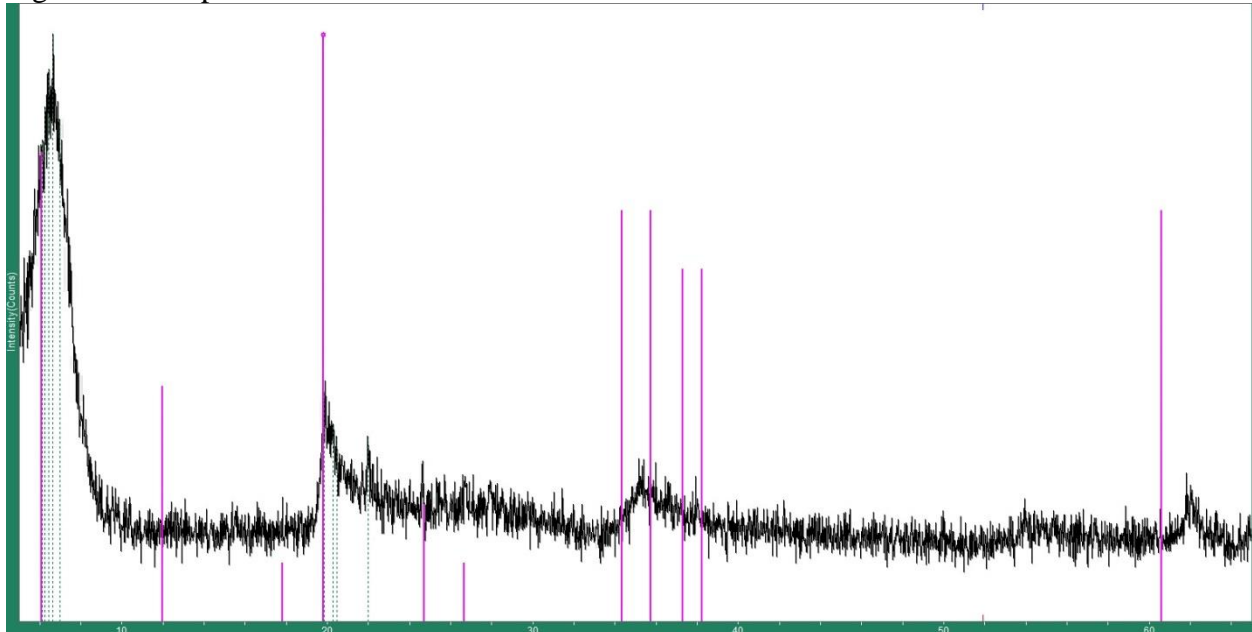
Figure C.2 - Saponite

The saponite peak pattern for PDF 00-030-0789 (pink) shows good visual matches at the  $20^\circ 2\theta$  peak. Weaker matches are seen at the low angle  $2\theta$  peak and near the  $35^\circ 2\theta$ . MDI Jade calculated an 80% match for the low angle  $2\theta$  peak and a 100% match at the  $20^\circ 2\theta$  peak.

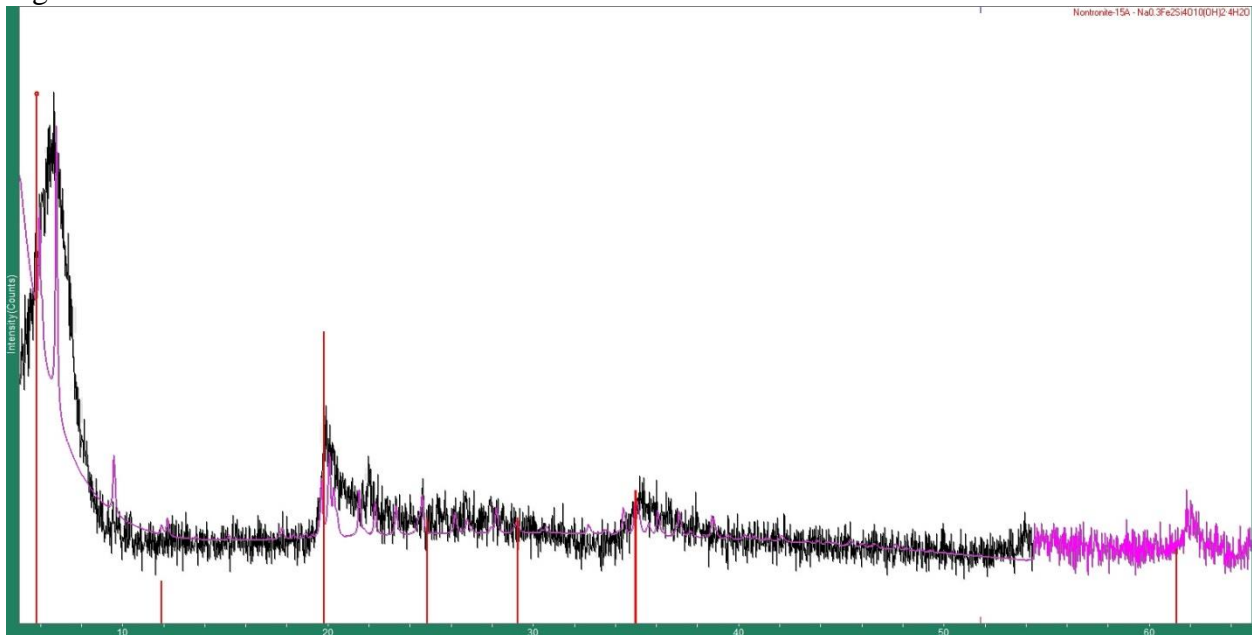
Figure C. 3 - Nontronite

For nontronite PDF 00-029-1497 (dark red), a strong visual match can be seen with the  $20^\circ 2\theta$  peak. A weak match can be seen at the  $35^\circ 2\theta$  peak. MDI Jade matched the low angle  $2\theta$  peak at 100% correlation.

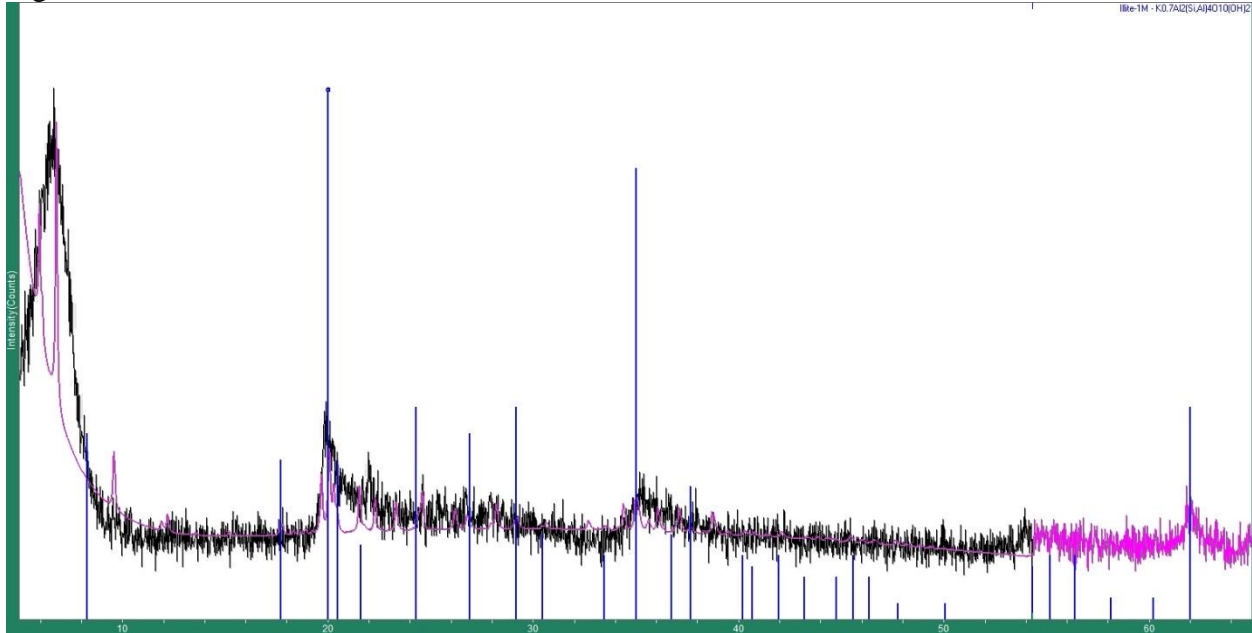
Figure C.4 - Illite

For illite PDF 00-029-1496, strong visual matches can be seen at 20° 2θ, 35° 2θ, and 62° 2θ. MDI Jade matched the 20° 2θ peak at 100%.

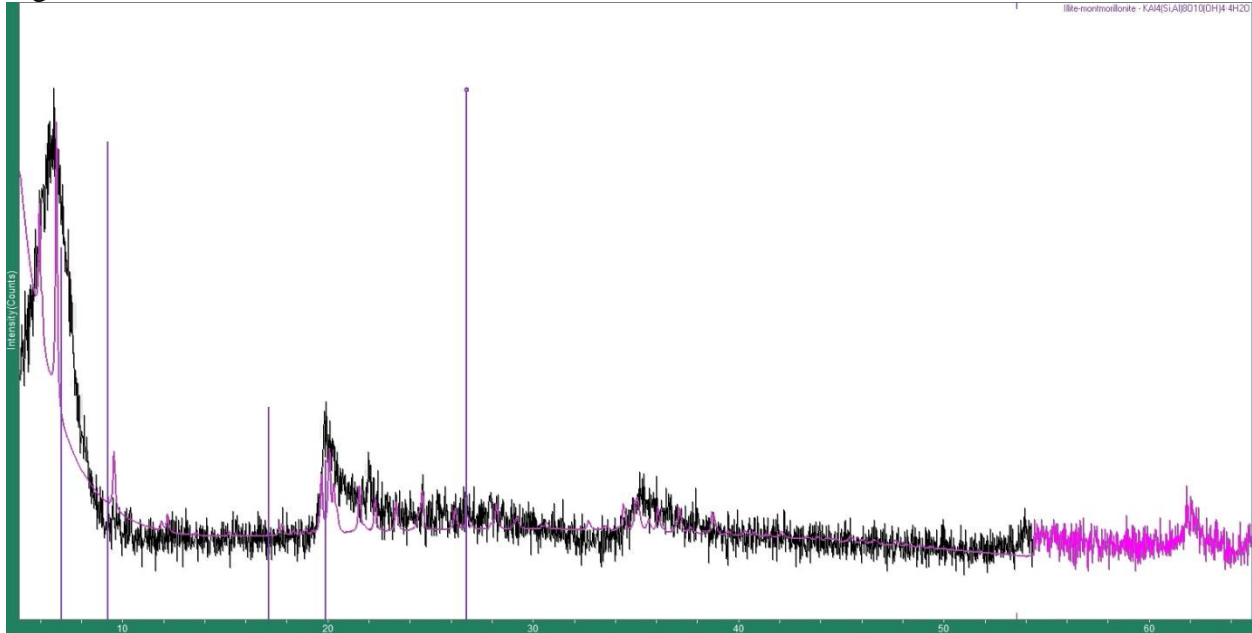
Figure C.5 - Illite-Montmorillonite

Illite-montmorillonite is a common mix of clay minerals (Moore and Reynolds, 1989). For this sample (PDF 00-035-0652), a strong visual match can be seen at near 20° 2θ, however, MDI Jade did not identify any matches.

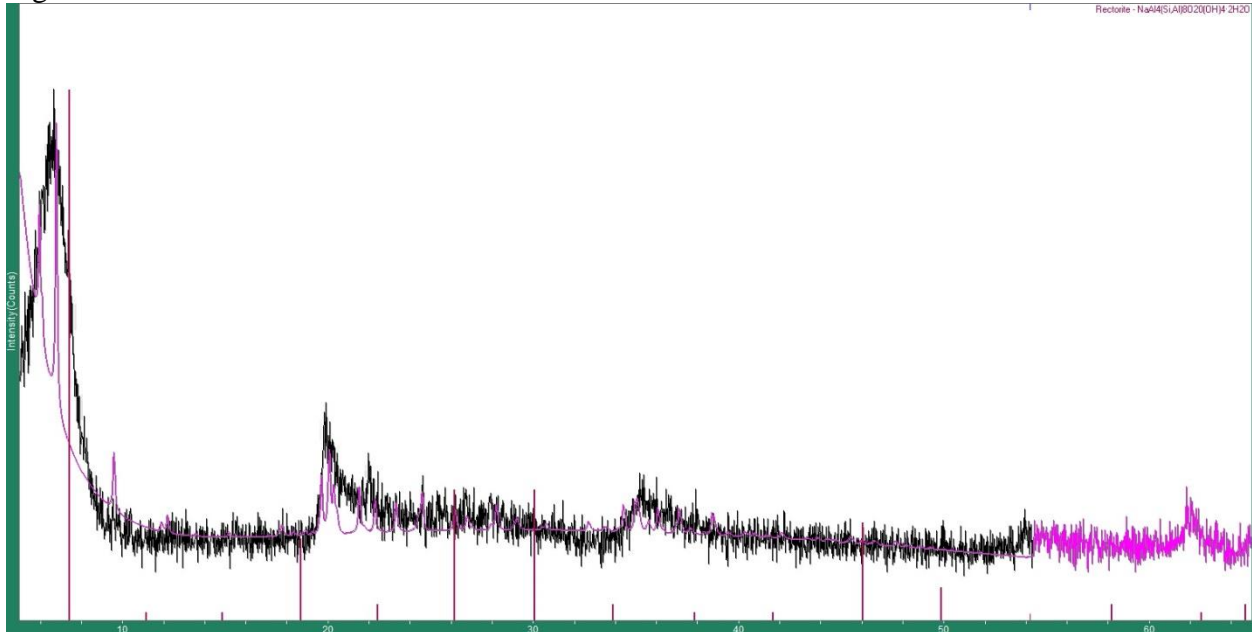
Figure C.6 - Rectorite

Rectorite is a regularly alternating (1:1) mixed clay consisting of a mica species and smectite (Moore and Reynolds, 1989). With this peak pattern (PDF 00-025-0781) a weak visual correlation may be made with the low angle 2θ peak. MDI Jade did not identify any statistical matches.

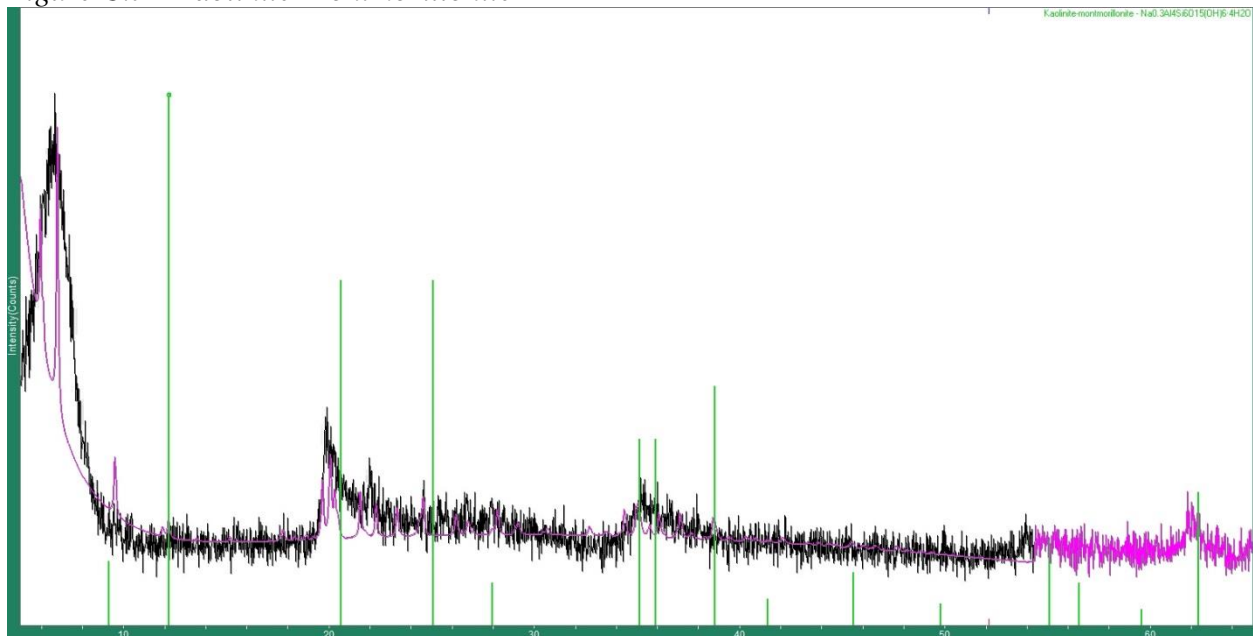
Figure C.7 - Kaolinite-Montmorillonite

Kaolinite-montmorillonite mixes kaolinite, which is non-expansive, with montmorillonite, which can be highly expansive (Moore and Reynolds, 1989; Bain, 1971). With this peak pattern (PDF 00-029-1490), a mediocre visual match may be seen at near  $35^{\circ} 2\theta$ . MDI Jade did not identify any statistical matches.
